DEC-12-HVRTP-A-D

**VR14 and VR20
troubleshooting
procedures**

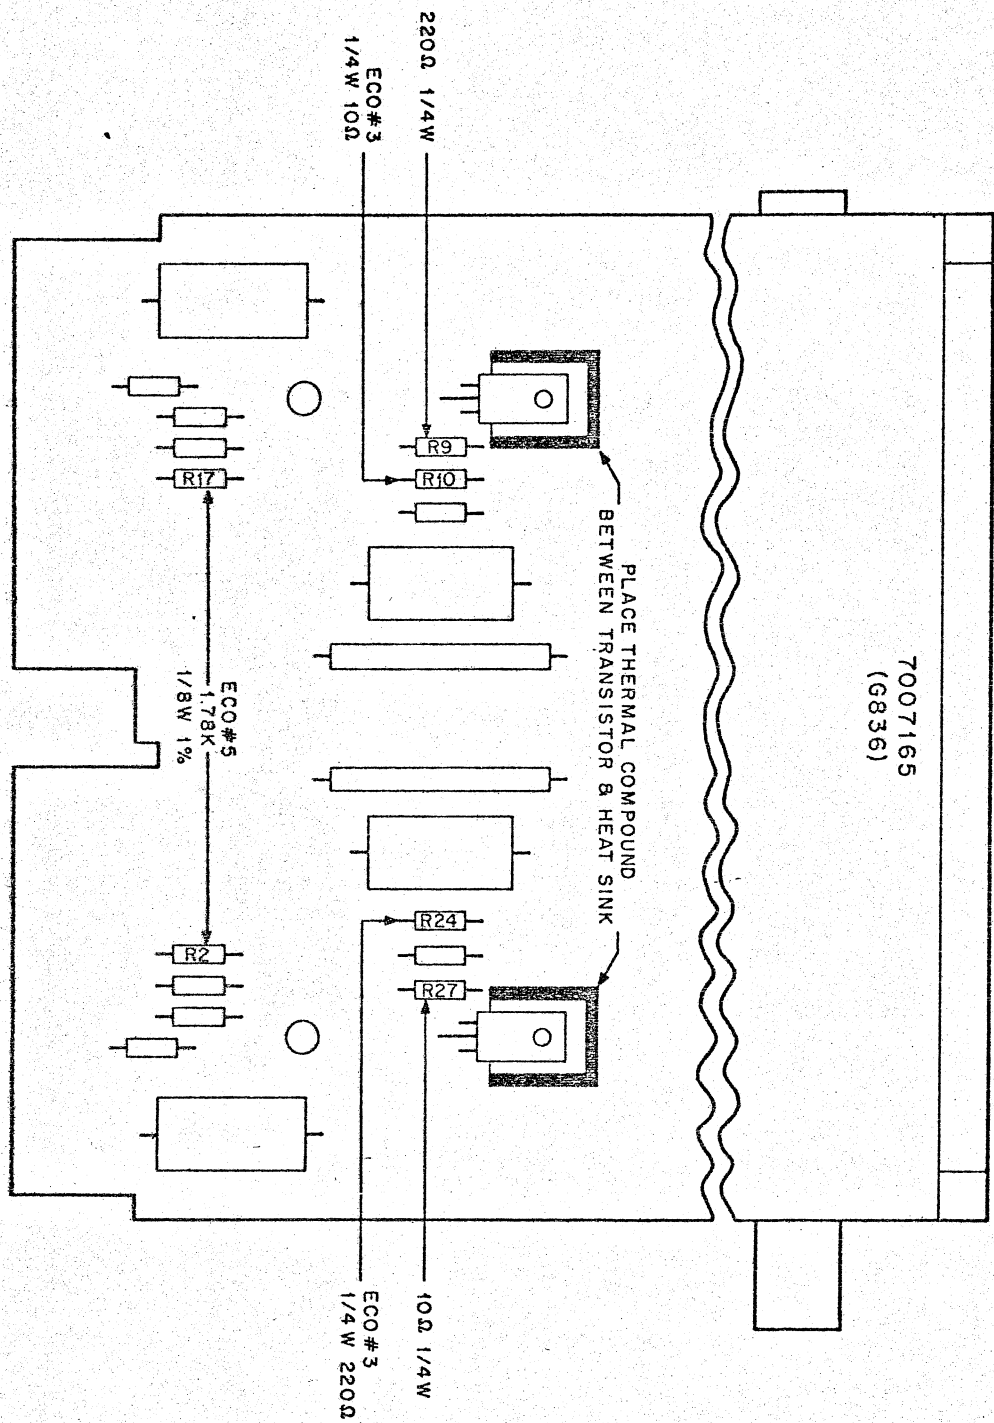
Figure 1 7007165 Power Regulator Assembly

4. Check the G836 regulator card on the 7007165 to ensure all ECOs have been incorporated (See Figure 1).
 - a. R9 and R24 should be 220Ω , not 1K.
 - b. R10 and R27 should be 10Ω , not 150Ω .
 - c. R2 and R17 should be 1.78K, 1% resistor, not 1.62K, 1%. This lowers the +24V to +22V.

Note that ECO #G836-5 (see Figure 1) changes the value of resistors $\pm 23/5V$ to $\pm 21.5V$, thereby reducing the deflection heating.

5. If power supply voltages drift or wander, change Q2 (2N4920), or Q4 (2N4923), E1 (709), and E2 (709) or obtain a new 7007165 regulator. Make certain that the board (G836) in the new regulator is *revision D* or higher. Reworked revision B boards with a decal are acceptable. Make certain that the A225 boards have ECOs 2, 4, 5, and 6 incorporated (Figure 2).

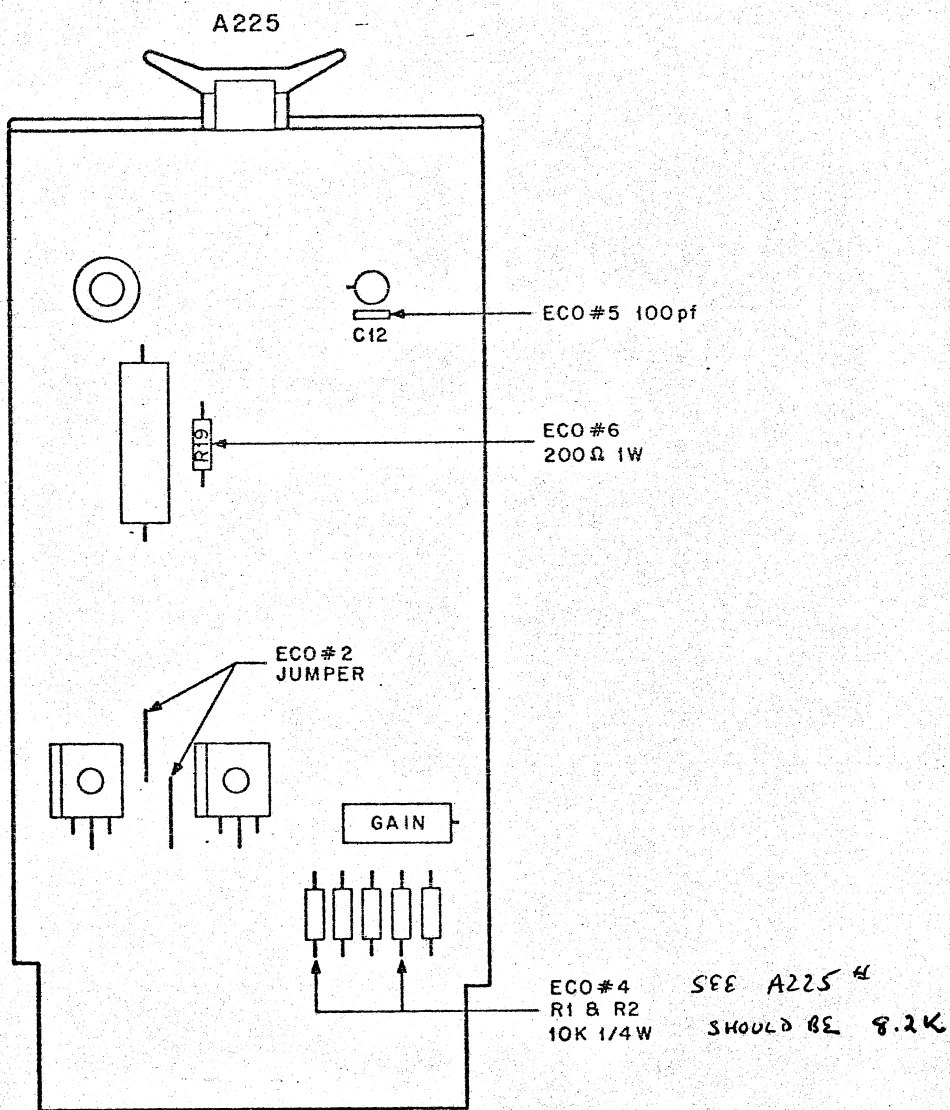
Figure 2 A225 D/A Converter

- ECO #2 R29 and R30 (22Ω) replaced by wires (Reduces runaway)
 ECO #4 R1 and R2 are $10K$ $1/4W$. (Reduces gain sensitivity)
 ECO #5 C12 is 100 pf. (Prevents internal oscillations)
 ECO #6 R19 is 200Ω $1W$. (Prevents internal latchup)

Make certain that resistor R19 on the A225 is 200Ω rather than 270Ω (see Figure 2). The resistor was changed by ECO #A225-6 to prevent a latch-up problem.

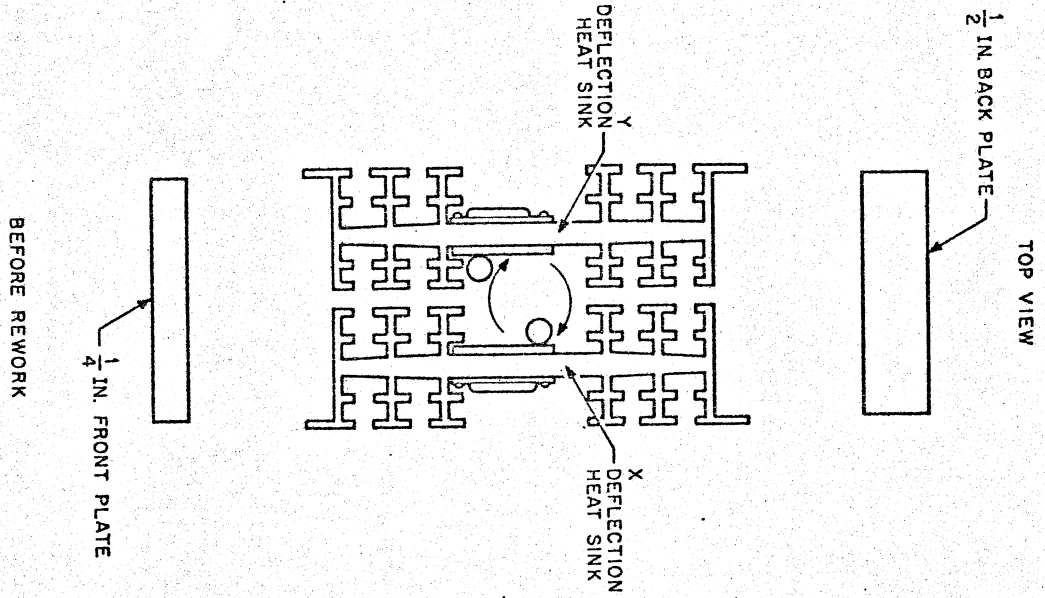
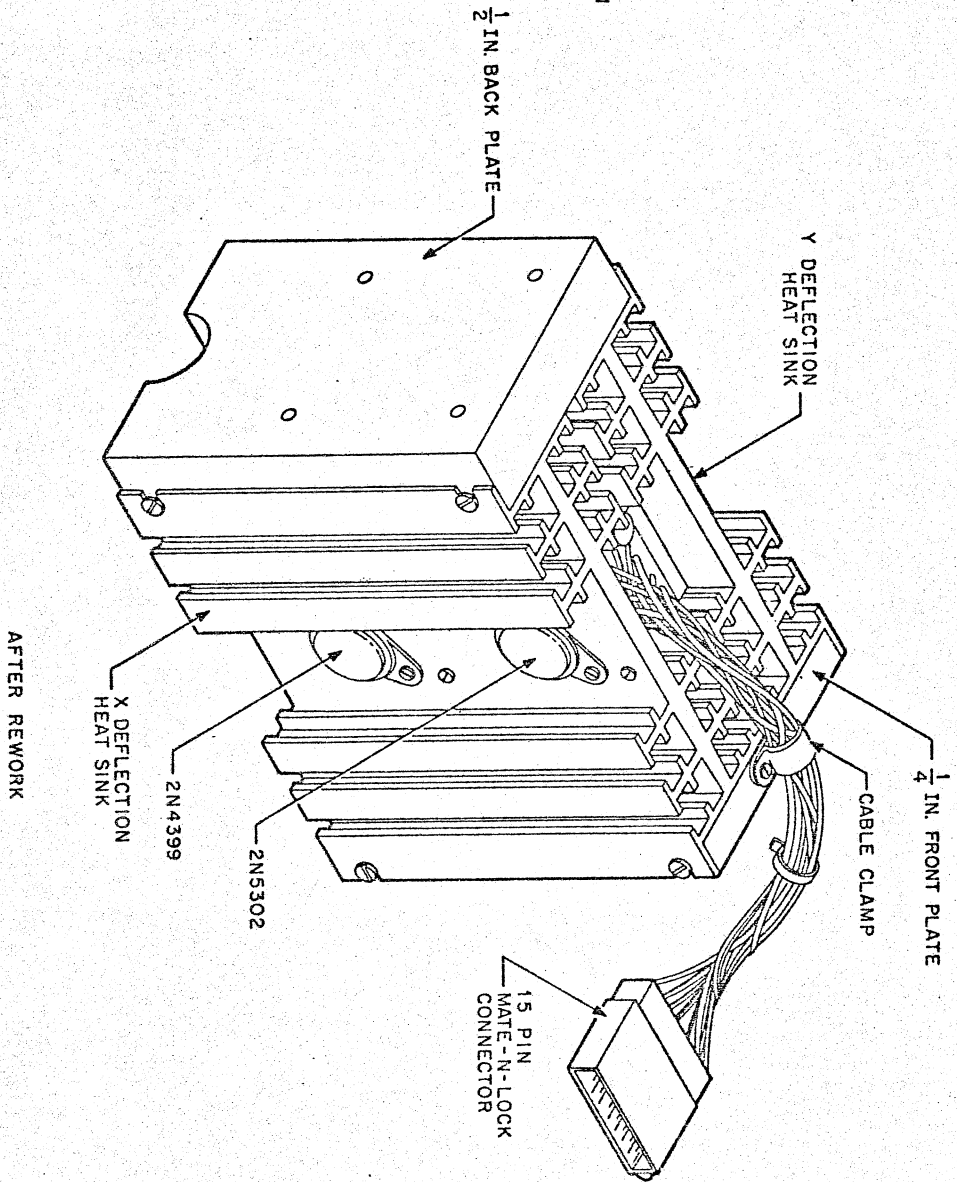
Figure 3 Deflection Heat Sink

6. In order to increase heat dissipation for the power transistors, ECO #VR14-15 must be installed. This ECO consists of physically interchanging the inside section (X) of the deflection heat sink assembly with the outside section (Y). This is done because the outside section receives better air flow. Since X generates more heat than Y, X requires more cooling air.

The interchange is accomplished by unscrewing the end plates of the heat sink assembly, exchanging the heat sinks so that X heat sink is on the outside, and then replacing the end plates.

Before reassembly, remove the thermal cutout on the X heat sink and replace it with a 6-32 screw to hold the terminals on the inside. Place a jumper plug across the thermal cutout leads because the cutout is no longer used and the line circuit must be completed.

1. Remove deflection heat sink assembly from the VR14.
2. Remove 6-32 X 3/8 screw that secures cable clamp to 1/4-inch front plate.
3. Remove eight 6-32 X 1/4 screws that secure X and Y heat sinks to front and back plates.

4. Remove thermal cutout from X deflection heat sink and place a 6-32 X 1/2 pan head screw in the hole.
5. Place 1/2-inch back plate on a flat surface with the two mounting screws (used for securing heat sink) facing up and half-circle cutout facing the bottom.

6. Secure the X deflection heat sink (identified by grey wire on transistor collectors) to the 1/2-inch back plate, using two 6-32 X 1/4 screws. Make certain the 2N4399 transistor is on the bottom.

7. Place 1/4-inch mounting block on other side of the X deflection heat sink with the cable clamp screw hole facing the top. Secure with two 6-32 X 1/4 screws.

8. Secure the Y deflection heat sink (identified by violet wire on transistor collectors) to the opposite side of the assembly, ensuring that the 2N4399 is on the bottom.

9. Secure the cables from X and Y deflection heat sinks to the top of the 1/4-inch front plate with cable clamp and 6-32 X 3/8 screws.
10. To complete the AC line circuit, place a jumper plug (7007006-3) in the 2-pin connector that was connected to the plug for the thermal cutout.

11. Replace deflection heat sink assembly in the VR14.

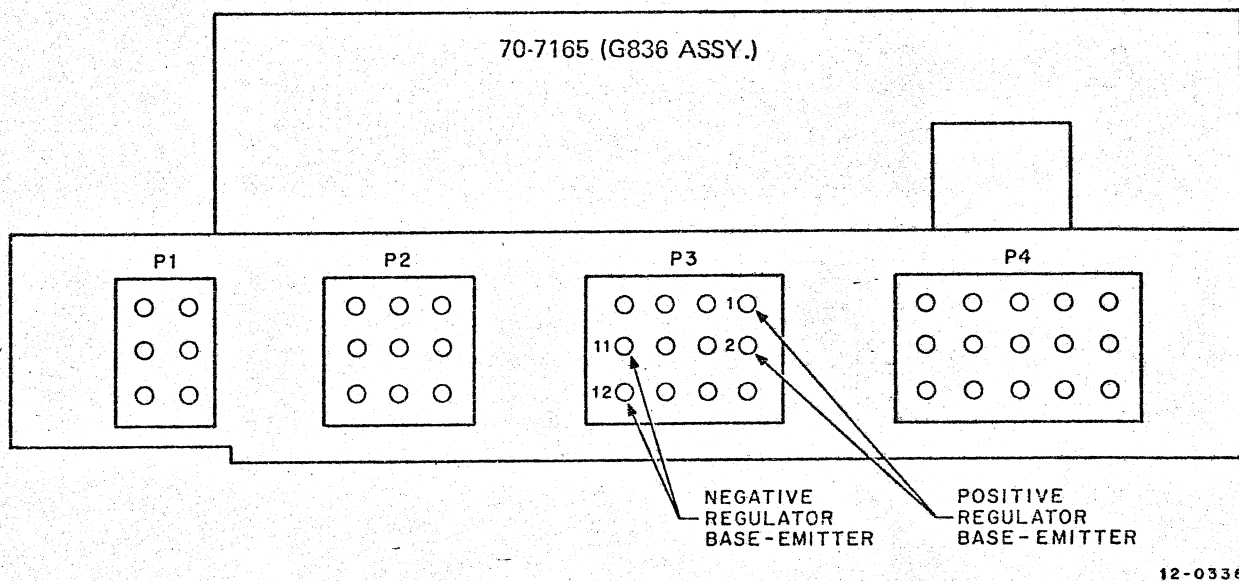
Figure 4 Base-Emitter Voltage Drop, Test Point Location

12. Refer to Figure 4. Measure the base-emitter voltage drop in the power supply heat sink assembly. Because only the positive supply is being used, it should indicate full drop, 1.2V, while the negative supply should indicate only standby drop 0.5V. If the positive supply measurement indicates 2.4V base-to-emitter drop, then one of the 2N4399 transistors is open. Replace both 2N4399 transistors!
