S229 - 4002 - 3

**088  
Customer  
Engineering  
Service  
Information  
Manual**

**General Systems Division**

Fourth Edition (May 1975)

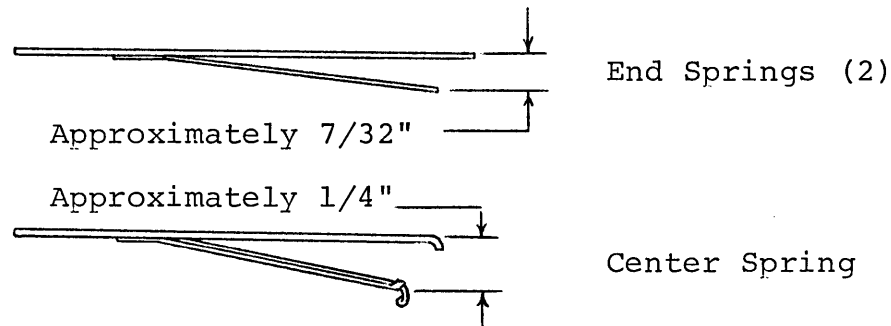
Misfeeding may occur when feeding the last few cards in the primary hopper because of card weight adjustment. The dimensions for adjusting the card weight springs are as follows:

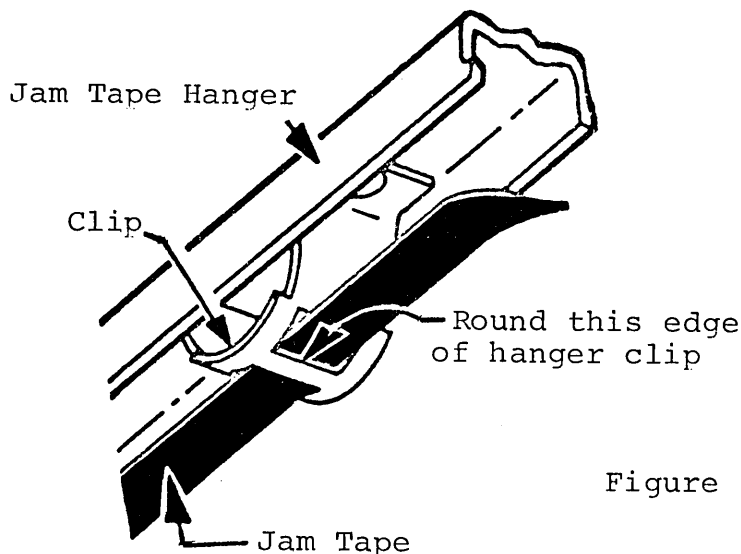
Figure 4

1. Jam tape support clips must be perfectly smooth with no trace of a square edge in the slot. With the jam bar assembly moved toward the left or right end, the clips can be stoned smooth. See Figure 4.
2. Pocket deflectors - clearance between spring steel deflectors (attached to the pocket 2 and pocket 4 selector magnets) and the card guide plates should be from .003" to .005". Less than .003" clearance can cause skewing and card jamming.

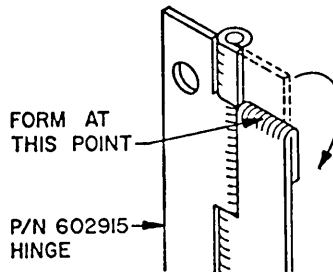
A cable chafing and grounding exposure exists on all TX 088s (serials over 15000) prior to P3 suffix. The exposure exists on the RC panel hinge at the upper end. To correct this exposure, form the top of the hinge as indicated in the figure below.

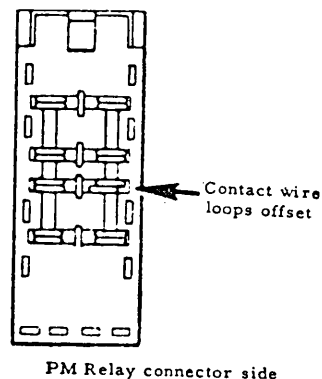
Figure 1

This condition is difficult to see even though the machine failure has been localized. The contact wire loops will be offset from each other when the wires are crossed. See Figure 1.

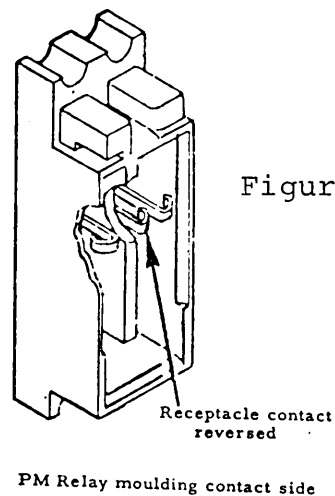
Figure 2

Cases have been found where an extremely intermittent failure was traced to the relay molding receptacle. The exposure is very limited; however, it is well to be aware of a possible reversal of the receptacle contacts in the molding. A reduced contact tension will result. See Figure 2.

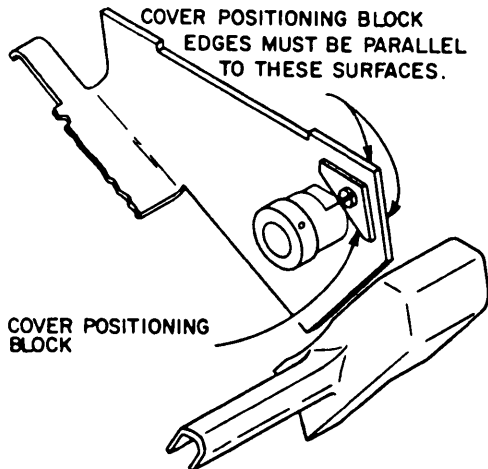
B/M 605071 - Cover Positioning Block

Two positioning blocks are available to provide more rigid support of the file feed lower magazine feed roll cover. Loosening of cover screws allows the cover to shift and bind against the feed rolls.

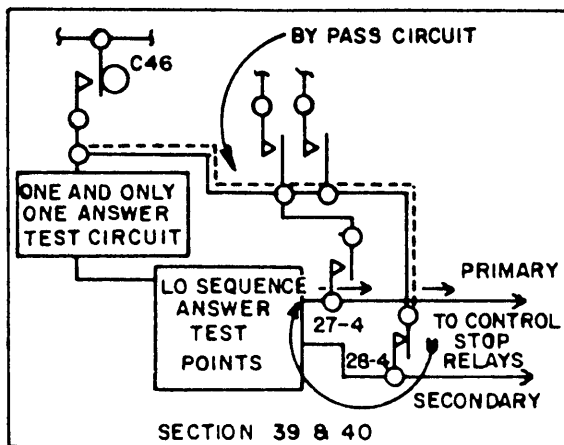
A back circuit exists which will bypass the "one and only one answer" circuit in machines wired to W/D 602700\* and A. This condition causes various machine malfunctions such as failure to merge, match, select or control stop. The back circuit is shown in the following sketch.

B/M 605189 relocates diodes D6 and D7 to eliminate this back circuit. This correction should be installed as soon as possible on all machines affected.

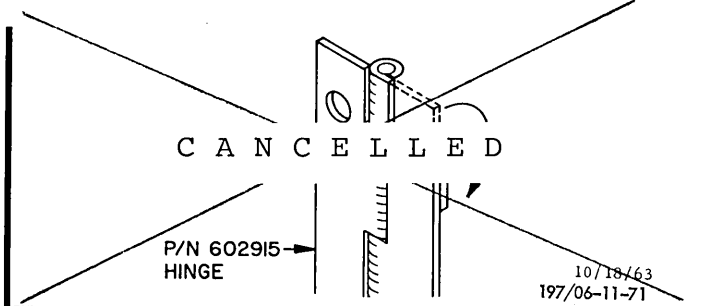
A cable chafing and grounding exposure exists on all TX 088s (serials over 15000) prior to P3 suffix. The exposure exists on the RC panel hinge at the upper end. To correct this exposure, form the top of the hinge as indicated in the figure below.

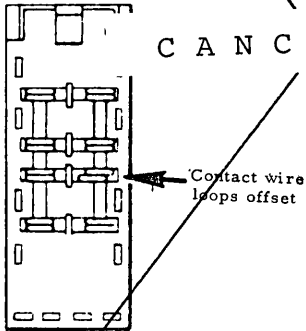
Figure 2

This condition is difficult to see even though the machine failure has been localized. The contact wire loops will be off set from each other when the wires are crossed. See Figure 2.
