Doc. No. 78-1367-14 Rev. A0

Catalyst 1200 Series Switch Release Note for Release 4.26

Supplement to DOC-CATALYSTUG5 (Document Number 78-1264-05)
Boot Firmware Version 1.1
Data Movement Processor (DMP) Flashcode Version 4.26
Network Management Processor (NMP) Flashcode Version 4.26

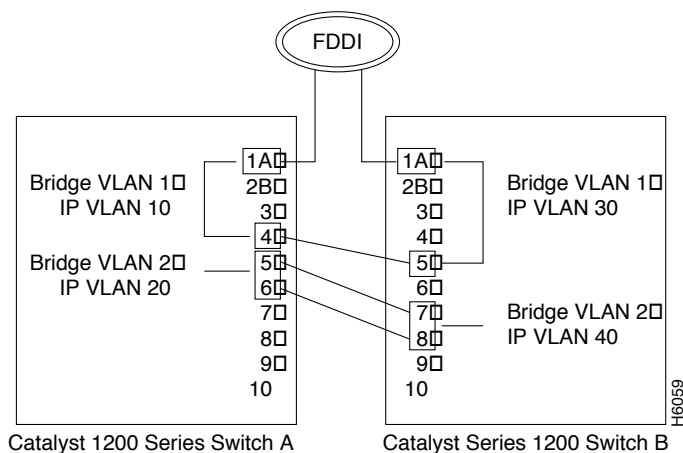
Figure 1 Example of Catalyst 1200 Series Switches in a Looped Configuration

- 2 When Catalyst 1200 series switches are connected in a looped configuration, you must define IP VLANs and Bridged VLANs identically on each Catalyst 1200 series switch. If these are not set correctly, the switches might not route properly.

Catalyst 1200 series switch A has ports 1 and 4 in bridge VLAN 1 and ports 5 and 6 in bridge VLAN 2. This same switch has ports 1 and 4 in IP VLAN 10 and ports 5 and 6 in IP VLAN 20. This switch is connected in a looped configuration to Catalyst 1200 series switch B.

Catalyst 1200 series switch B has ports 1 and 5 in bridge VLAN 1 and ports 7 and 8 in bridge VLAN 2. This same switch has ports 1 and 5 in IP VLAN 30 and ports 7 and 8 in IP VLAN 40.
