Release Notes for Catalyst 1200 Series Switch Software Release 4.29

**Supplement to DOC-CATALYSTUG5 (Document Number 78-1264-05)
Boot Firmware Version 1.1
Data Movement Processor (DMP) Flashcode Software Release 4.29
Network Management Processor (NMP) Flashcode Software Release 4.29**

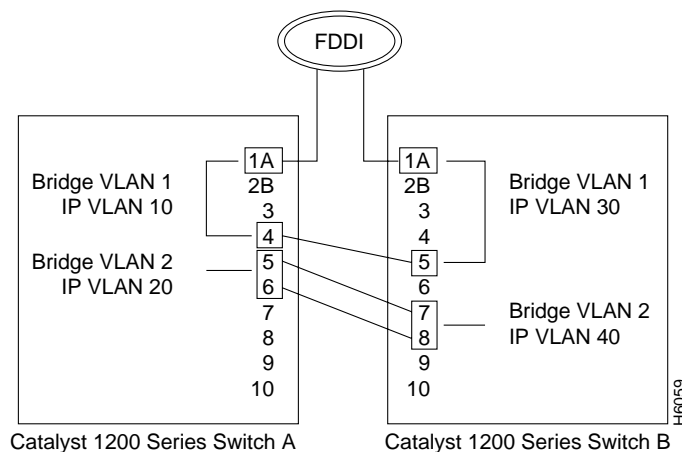
Figure 1 Example of Catalyst 1200 Series Switches in a Looped Configuration

- When Catalyst 1200 series switches are connected in a looped configuration, you must define IP VLANs and bridged VLANs identically on each Catalyst 1200 series switch. If these are not set correctly, the switches might not route properly.

Catalyst 1200 series switch A has ports 1 and 4 in bridge VLAN 1 and ports 5 and 6 in bridge VLAN 2. This same switch has ports 1 and 4 in IP VLAN 10 and ports 5 and 6 in IP VLAN 20. This switch is connected in a looped configuration to Catalyst 1200 series switch B.

Catalyst 1200 series switch B has ports 1 and 5 in bridge VLAN 1 and ports 7 and 8 in bridge VLAN 2. This same switch has ports 1 and 5 in IP VLAN 30 and ports 7 and 8 in IP VLAN 40.
