CENTURY DATA

TECHNICAL NOTES

GENERAL AUTOMATION, INC.  
1055 S. East St.  
Anaheim, California 92805

April 1, 1973

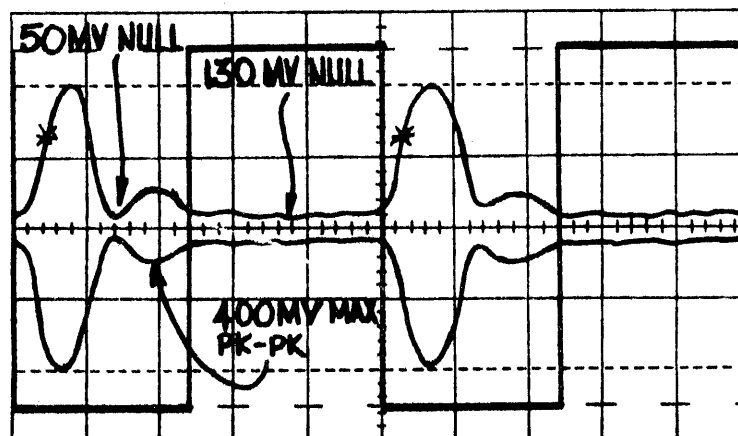
Figure 1. Final Positioning Waveform

The amplitude of the small peak (overshoot) may vary from cylinder position to cylinder position but must not exceed 400 millivolts.

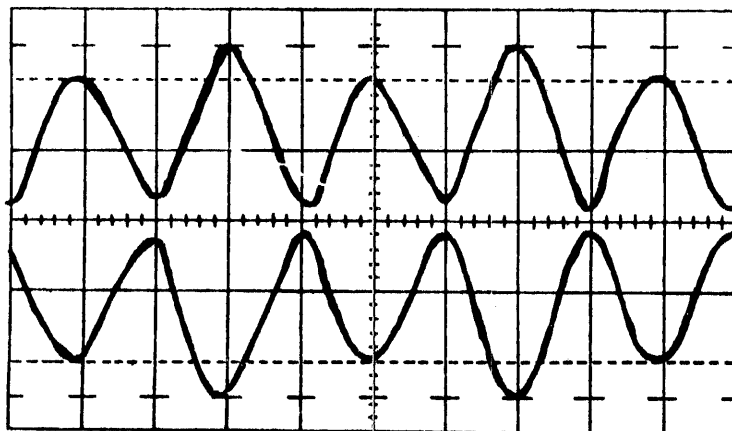
Figure 4. Tooth-to-Tooth Relationship

Observe the difference in amplitude between two adjacent teeth must not exceed 20% of the amplitude of the larger tooth.

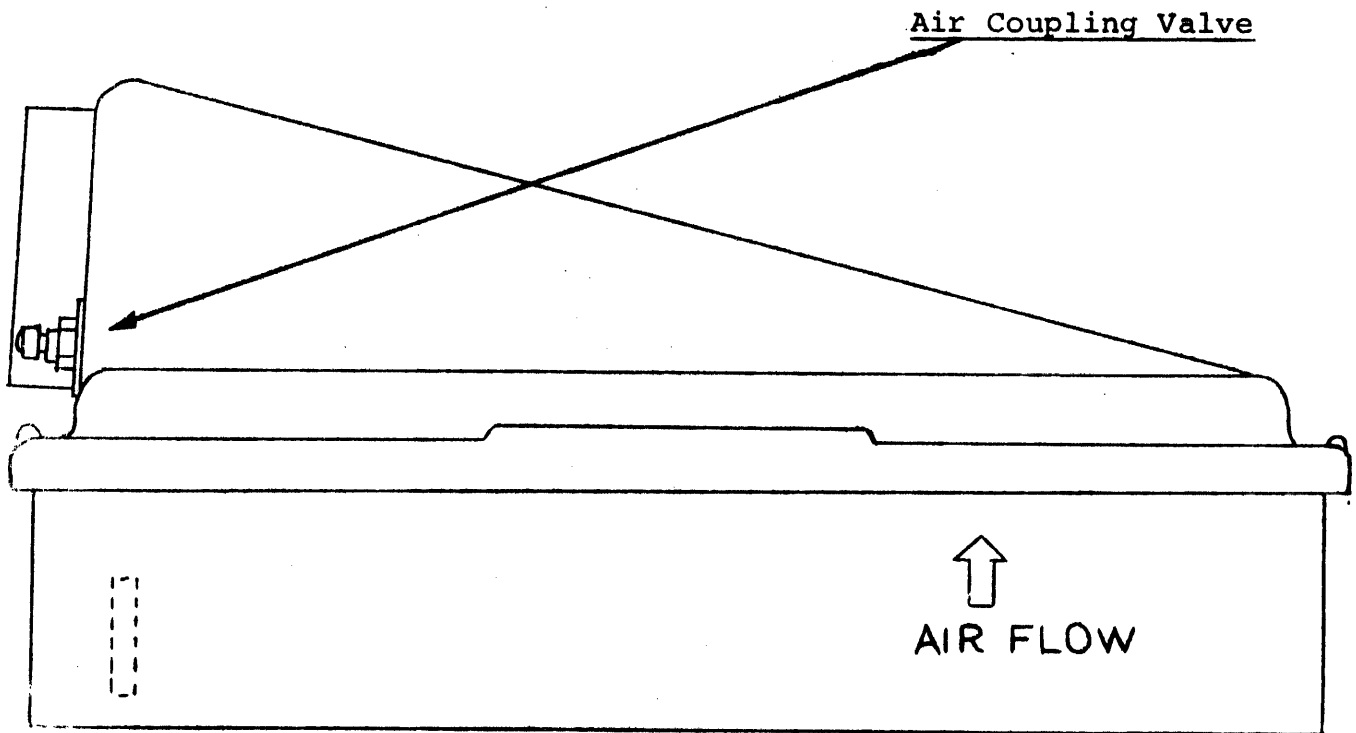
Figure 2. Model 114 Filter Assembly - Top View.

- c. If a positive pressure is indicated, 0.05" H<sub>2</sub>O or greater, the filter is functioning properly.
- d. If no pressure is indicated; investigate the blower, absolute filter, or the pre-filter.
- e. After the check is completed replace the front panel.

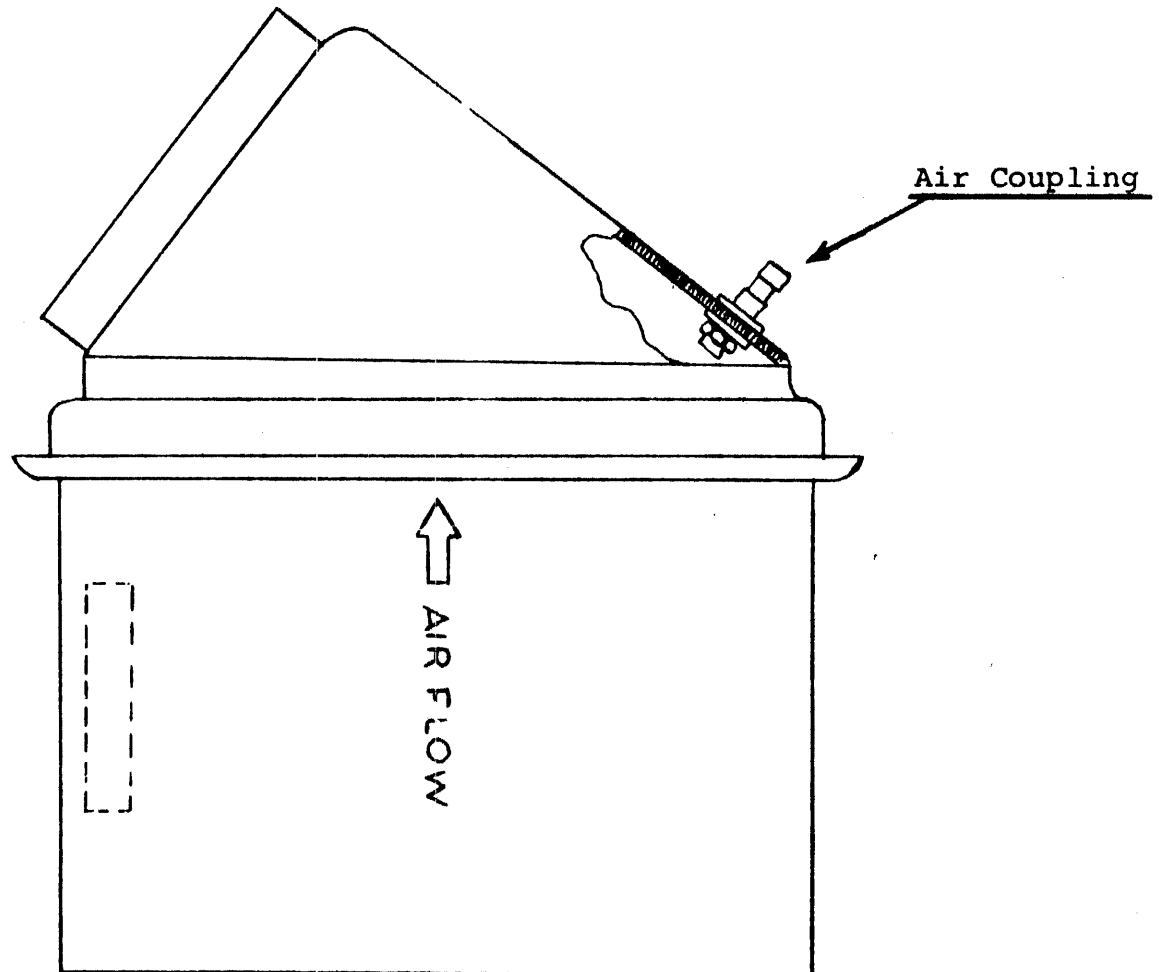
Figure 3. Model 214 Filter Assembly - Top View.

- c. If a positive pressure is indicated, 0.05" H<sub>2</sub>O or greater, the filter is functioning properly.
- d. If no pressure is indicated, investigate the blower, absolute filter or pre-filter.
- e. After the check is complete, restore the drive to its normal mode of operation.

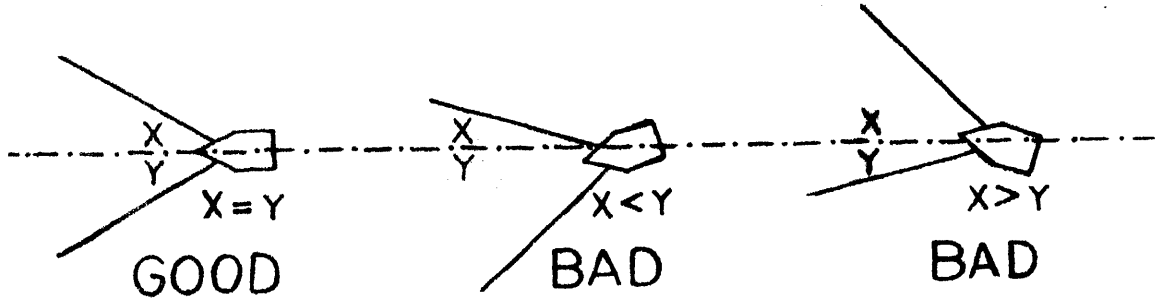
Visually inspect the brushes for the correct angularity as indicated in the illustration below. Do not remove the brush head unless it is required for replacement.

If the angle above the horizontal center is equal to the angle below the horizontal center, the brush head is installed correctly.

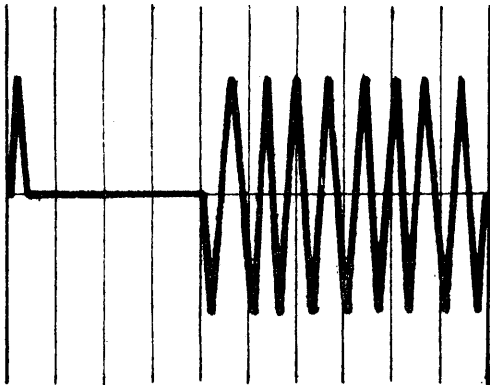
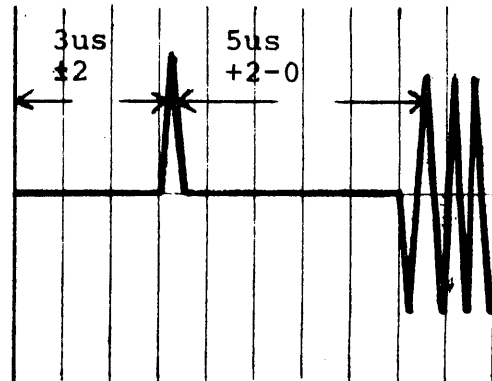
Picture is:

Picture should be:
