CENTURY DATA

TECHNICAL NOTES

GENERAL AUTOMATION, INC.  
1055 S. East St.  
Anaheim, California 92805

April 1, 1973

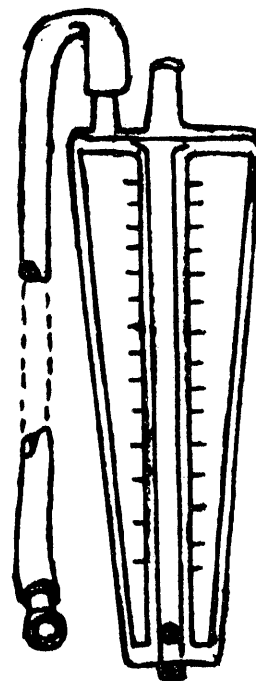
Figure 1. Gauge

The differential air pressure switch monitored the difference in pressure between the input to absolute filter and the output from the absolute filter. It has been determined that all that is required to check the efficiency of the filter is to have a positive pressure in the filter's output plenum. The portable air pressure gauge provides the means to check this positive pressure. The following paragraphs describe the procedure for checking the positive pressure and should be performed on a monthly basis.

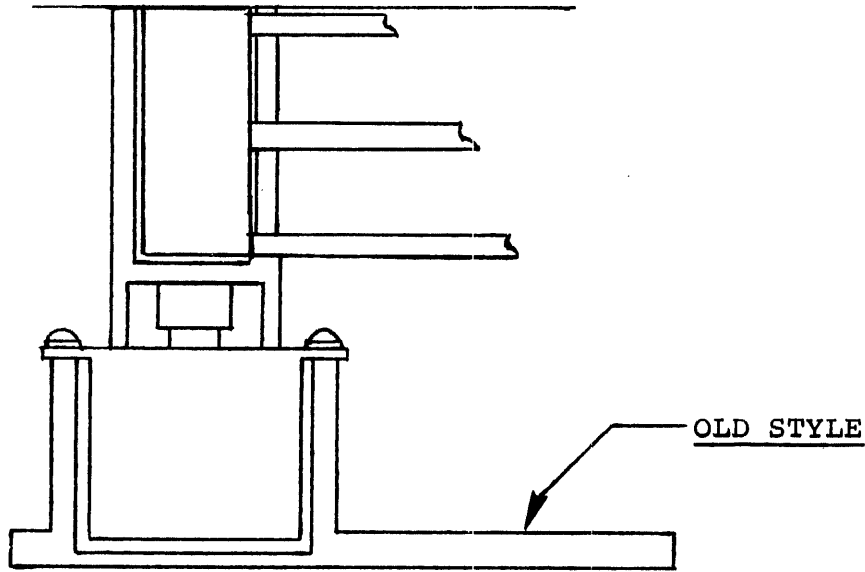
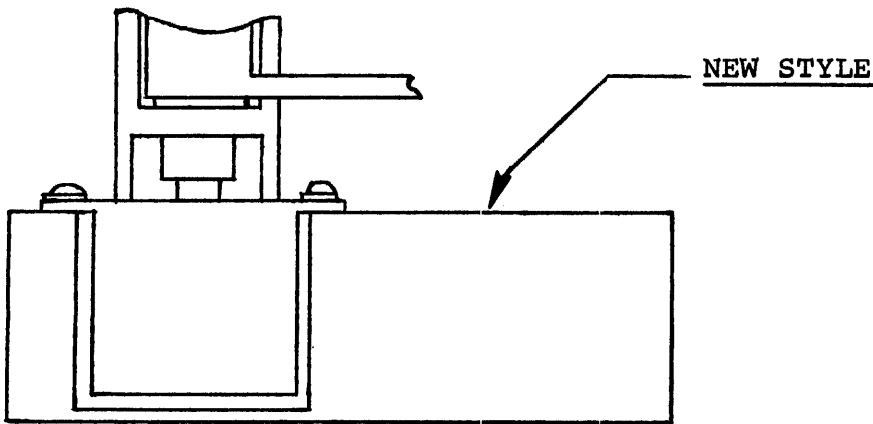
FIGURE 3

There are two brush drive assemblies in use, an old style and a new style. They can easily be identified by the thickness of the base of the assembly. The old style has a thinner base. See figure 3. If it becomes necessary to replace an old style assembly, it will be necessary to also order screws (2) each, CDS P/N 90448-052. The screws could also be purchased locally, the screws are: 10/32 by 1 3/4", pan head slotted. Also on the very early 114's, it will be necessary to splice in more wire for the wires to the brush drive switch. The wire used is 18 gauge, CDS P/N 90537-818.

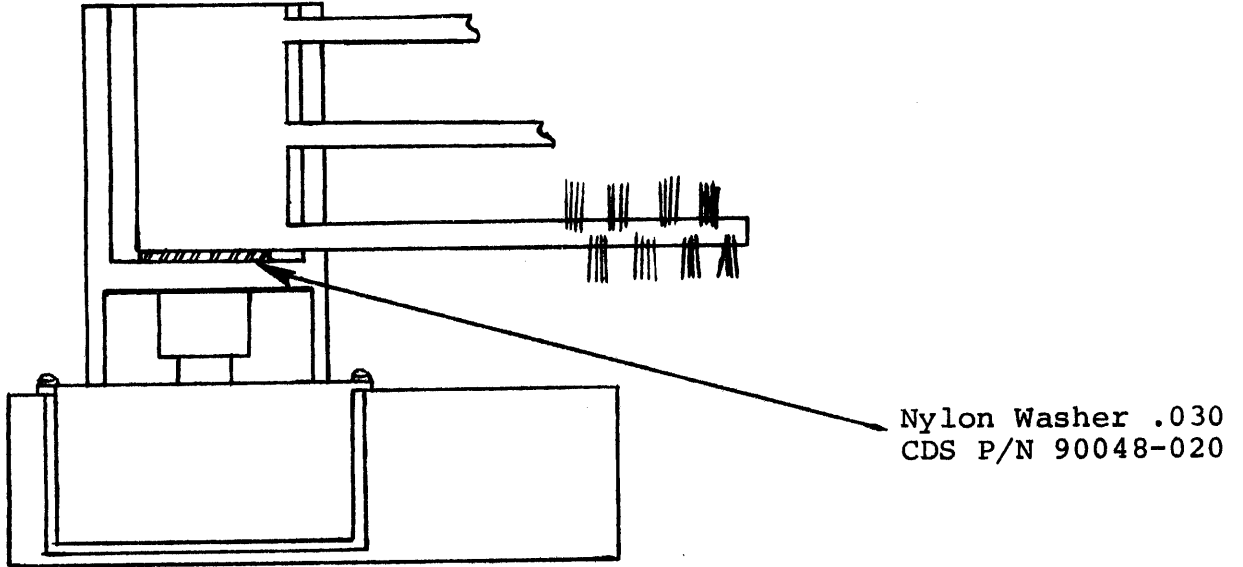
FIGURE 1

If the arms enter the pack low, there is a nylon washer available, CDS P/N 90048-020, that can be installed at the bottom of the shaft to give necessary clearance. See Figure 1.

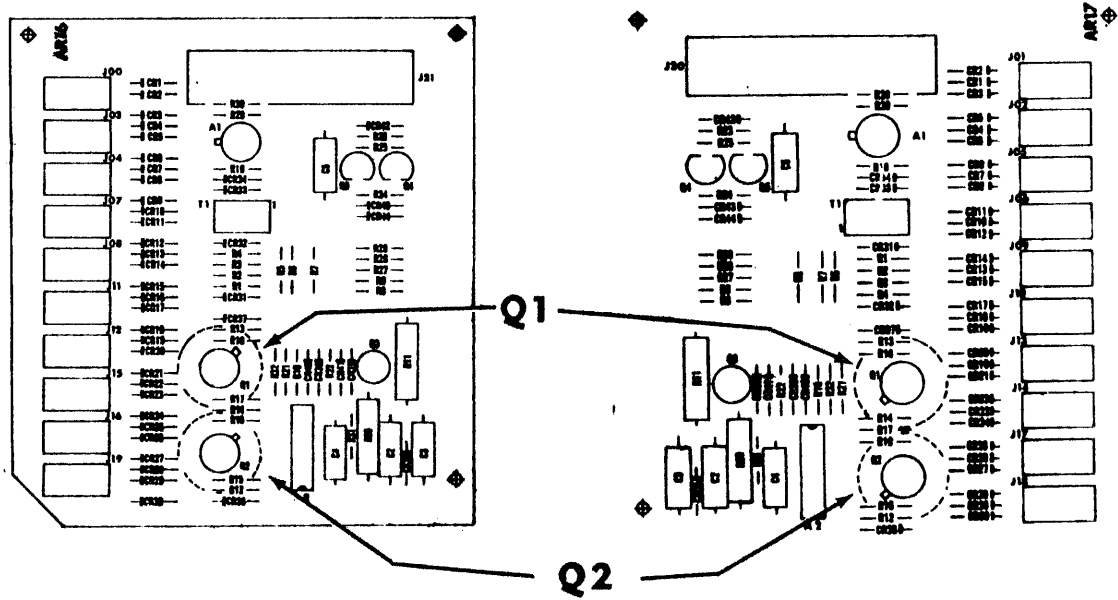
Figure 1. Locations of Transistors Q1, Q2 - 114,166,212,214

AP23	91101-001	114, 166, 212, 214
AP12	91852-001	213, 215, 815
8. Utilize an exerciser or the controller in-line diagnostic (50) to perform a read operation on Head 00, any cylinder.
9. Monitor the test points indicated in Table 1 and verify the appropriate voltage levels.
10. Perform a read operation on Head 01, any cylinder.
11. Monitor the indicated test points and verify the appropriate levels.
12. If the voltage levels at 03C06 or 03C12 are more positive than -2.5 vdc, replace the write driver module, AR18 (91057).
13. If the voltage levels on the power transistors are more positive than -20 vdc, replace the write driver module, AR18 (91057).
14. Refer to Figure 1 and Figure 2 for the location of the write power amps on the left and right preamps. To monitor their voltage level, place the scope probe right on the exterior "can" of the transistors.
