S229 - 4002 - 3

**088  
Customer  
Engineering  
Service  
Information  
Manual**

**General Systems Division**

Fourth Edition (May 1975)

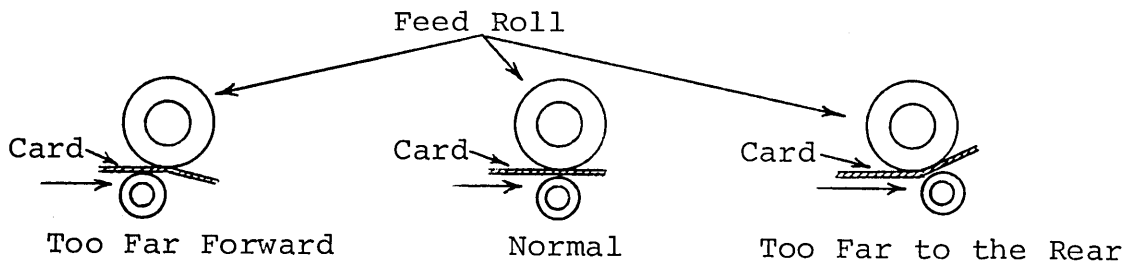
Figure 1

Note: If pressure rolls are moved to an extreme, either forward or to the rear of center, card jamming may be experienced due to card interference at either the feed roll station or the shear plate.

Tension - Should be within 1 1/2 to 2 1/2 pounds pull. (Measure with strip of card and push pull scale P/N 9900012 pulled through rolls.) It is important that tension does not vary more than 1/4 pound between front and rear.

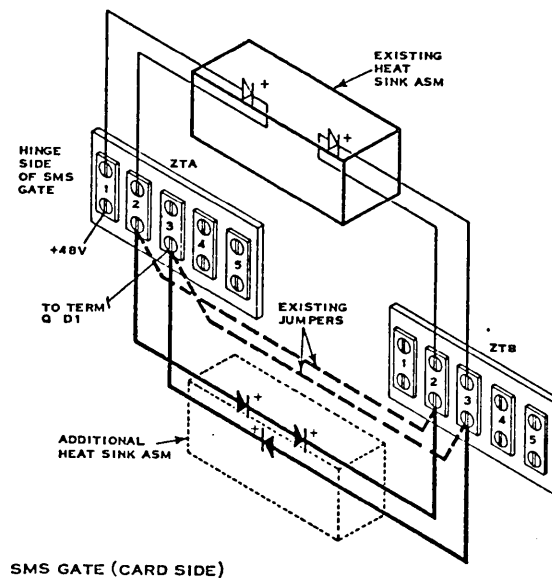
Most customer applications do not require the full amount of circuit desensitizing provided by this feature. Reduced machine efficiency results and is aggravated by the added resistance of aged components.

A Bill of Material is available to add to selection circuit. This circuit provides the Customer Engineer with various taps to select a desense bias voltage to suit individual machine requirements. Either one, two or all three of the diodes shown below may be connected to reduce the present bias by approximately 1 volt increments.

This change effectively reduces the effect of the desense feature in the interest of improved overall machine operation.

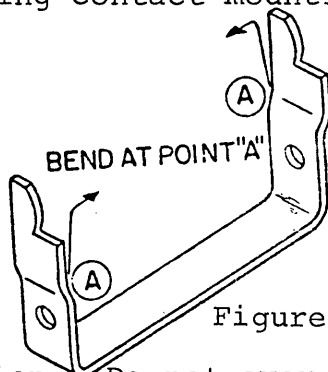
Figure 1

Shrinkage of plastic contact holders can warp the metal frame of the contactor causing the restoring bail to bind.

1. Turn off machine and remove main line power cord before checking contactors.
2. Check for binding armature by manually depressing the armature and watching for full closure of the contacts. Form ears (Figure 1) at the end of the restoring bail for free operation. Check the operating contact mounting screws for snugness. Fig. 2.

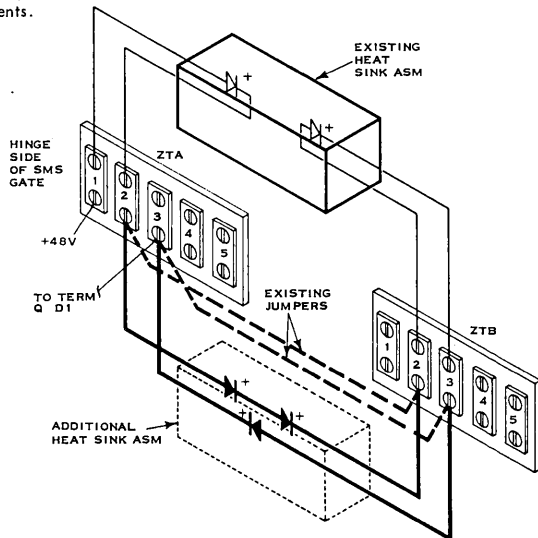
SMS GATE (CARD SIDE)

Most customer applications do not require the full amount of circuit desensitizing provided by this feature. Reduced machine efficiency results and is aggravated by the added resistance of aged components.

A Bill of Material is available to add a selection circuit. This circuit provides the Customer Engineer with various taps to select a desense bias voltage to suit individual machine requirements. Either one, two, or all three of the diodes shown below may be connected to reduce the present bias by approximately 1 volt increments.

This change effectively reduces the effect of the desense feature in the interest of improved overall machine operation.

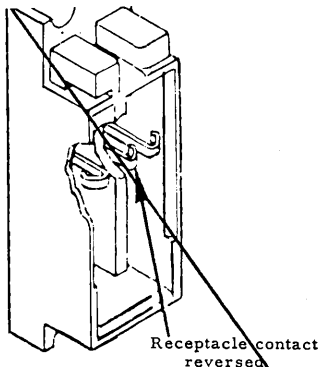
Figure 3

Cases have been found where an extremely intermittent failure was traced to the relay moulding receptacle. The exposure is very limited, however, it is well to be aware of a possible reversal of the receptacle contacts in the moulding. A reduced contact tension will result. See Figure 3.

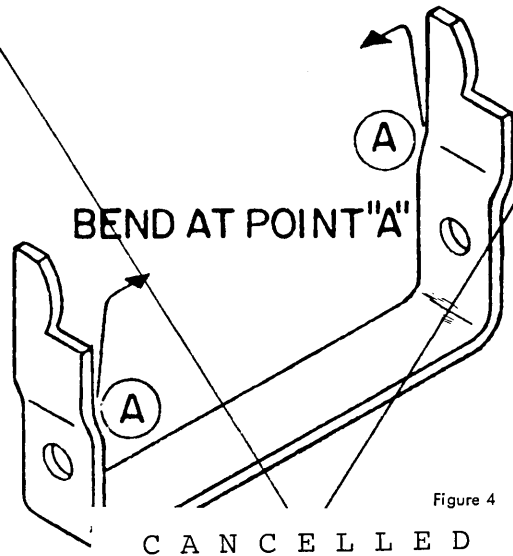
Figure 4

Shrinkage of plastic contact holders can warp the metal frame of the contactor causing the restoring bail to bind.

- A Turn off machine and remove main line power cord before checking contactors.
- B Check for binding armature by manually depressing the armature and watching for full closure of the contacts. Form ears (Figure 4) at the end of the restoring bail for free operation. Check the operating contact mounting screws for snugness.

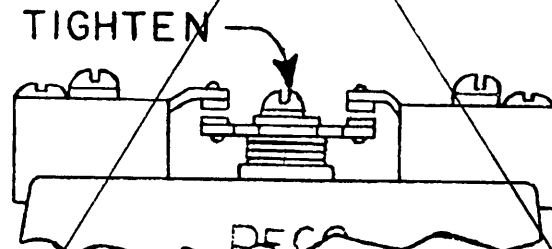
Figure 5

CAUTION: Do not over-tighten. (Figure 5). Failure of the K contact will result in no ready light.
