Collating List of Pages

This reference drawing contains the collating sequence, page side, and EC level of pages for *IBM 3480 Magnetic Tape Subsystem Maintenance Information Manual (MI) Volume A05, SY32-5061-13*.

PUBLICATIONS REFERENCE DRAWING

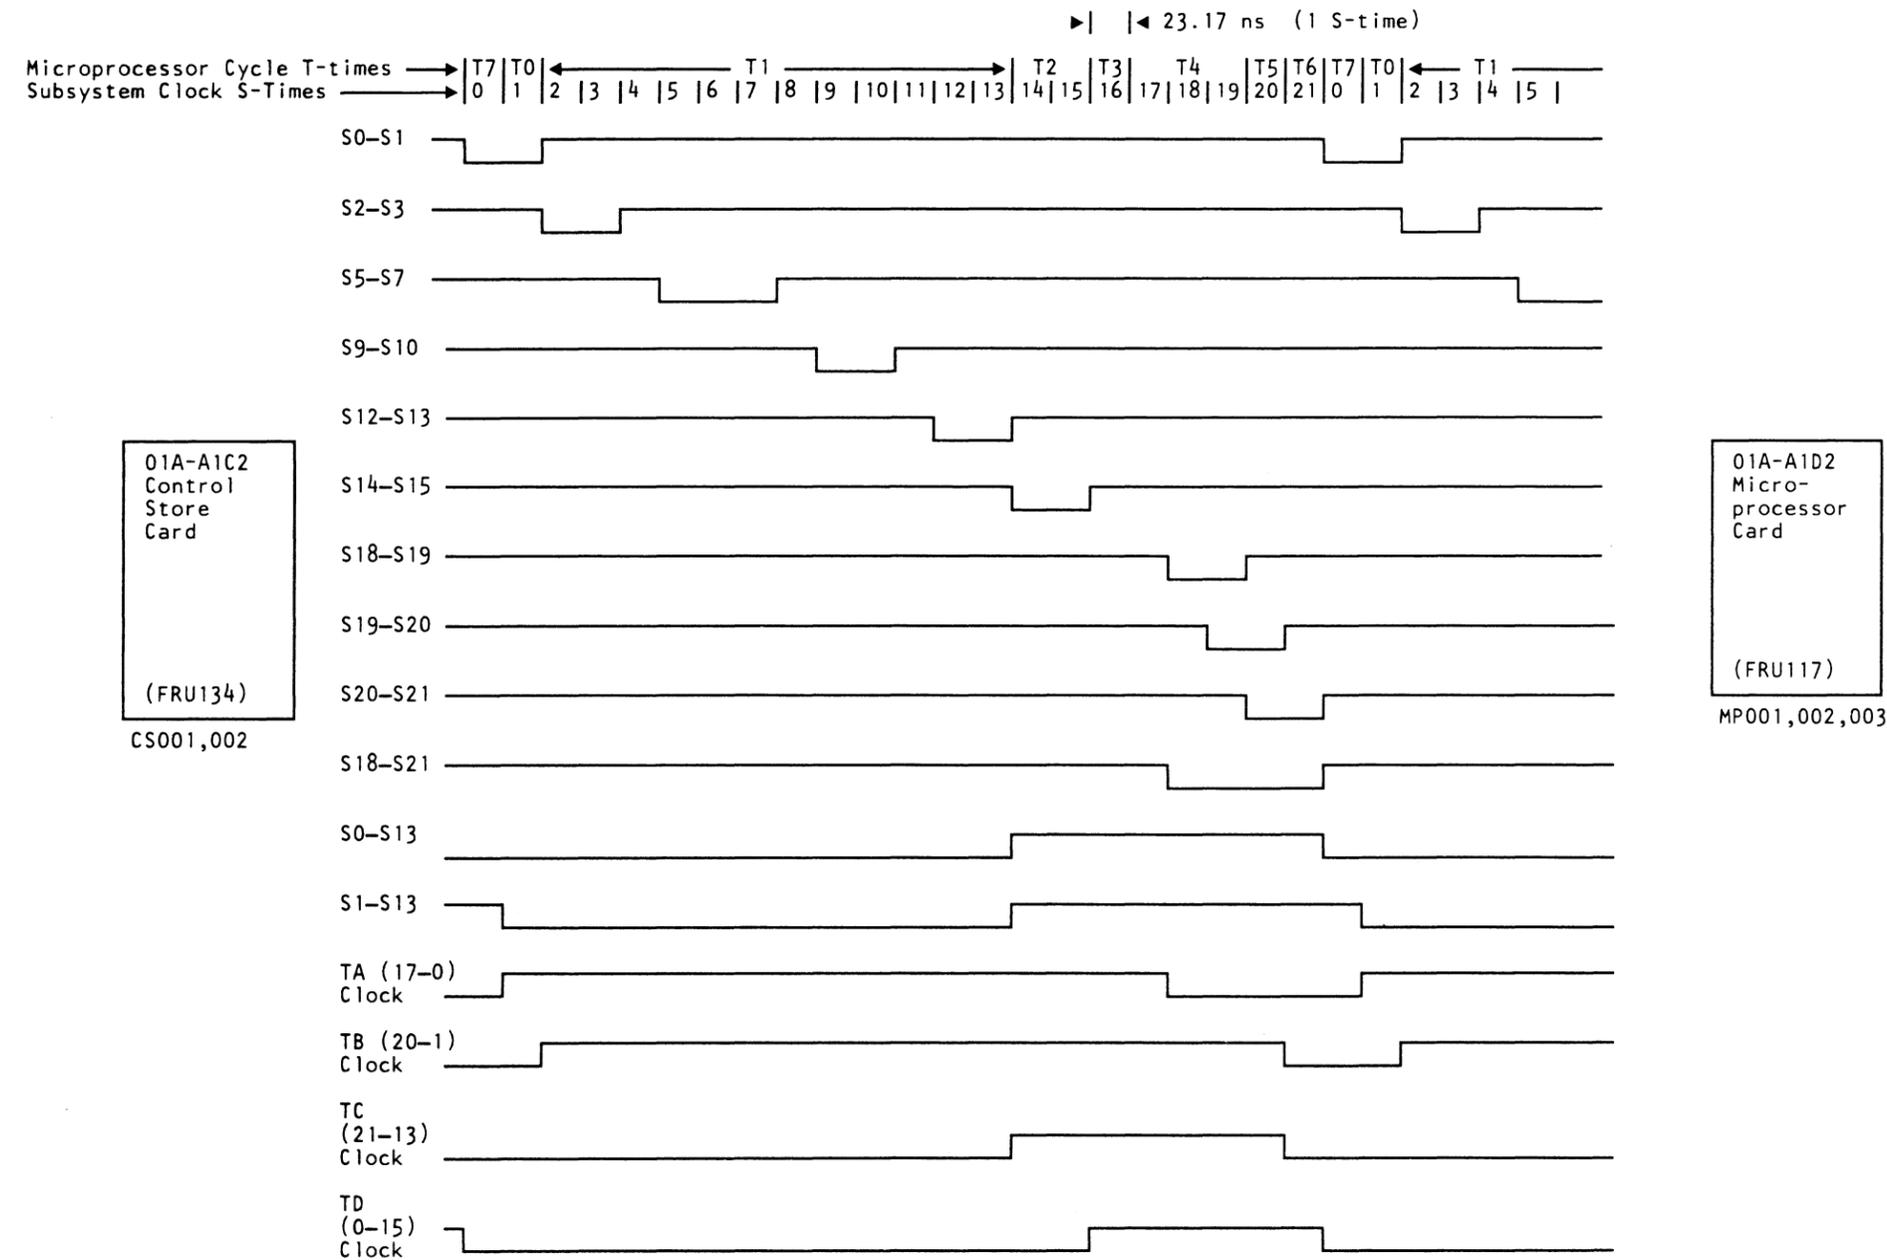
Control Storage Clocks Timing Chart

Subsystem Clocks to the Microprocessor Card

The main oscillator on the control storage card (01A-A1C2) runs a ring counter to develop s-time clock pulses. The ring counter output is decoded to make a combination of timing pulses for the functional area cards in the control unit. The s-times and clocks that go to the microprocessor card are shown in the timing chart.

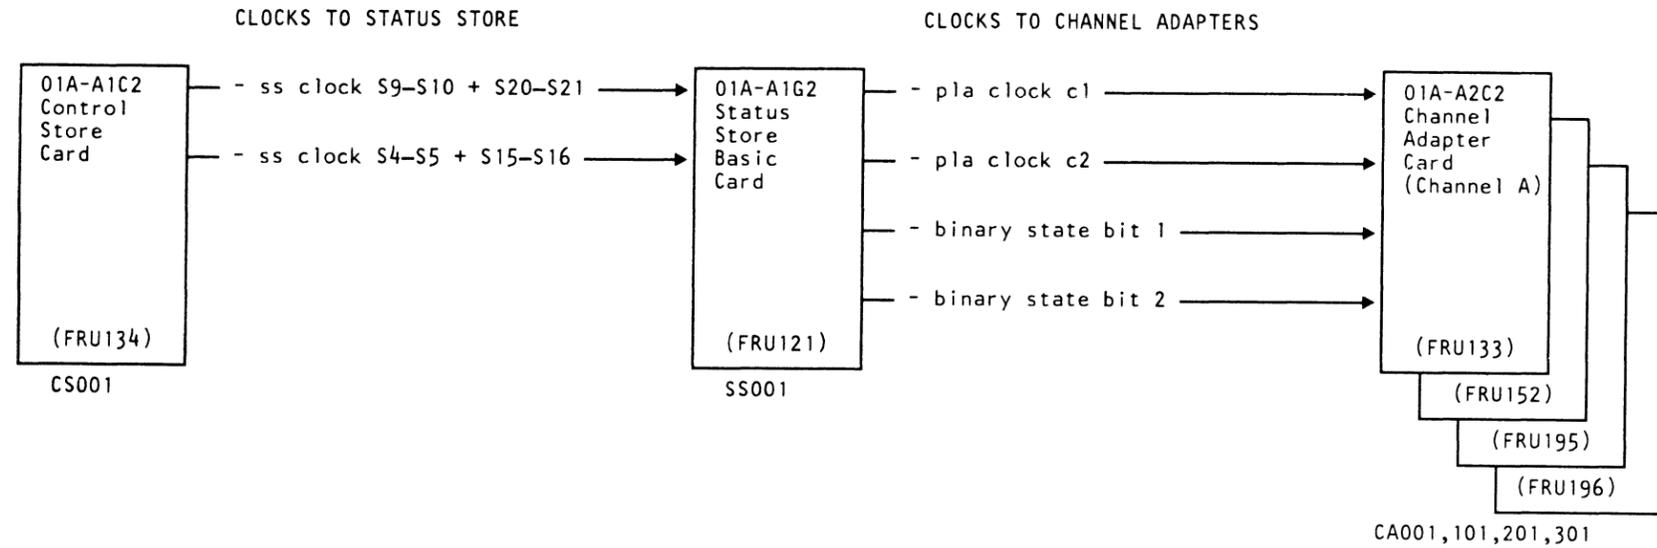
Status Store to Channel Adapter Interconnection States					
Interconnection state	IS0	IS1	IS2	IS3	IS0
Line Name					
- PLA clock c1	[Timing diagram showing periodic pulses]				
- PLA clock c2	[Timing diagram showing periodic pulses]				
- Binary state bit 1	[Timing diagram showing a square wave]				
- Binary state bit 2	[Timing diagram showing a square wave]

Each IS time = 255 ns
 PLA clock c1 minus time = 46 ns
 PLA clock c2 minus time = 46 ns
 Time between c2 going not active and c1 going active = 69 ns

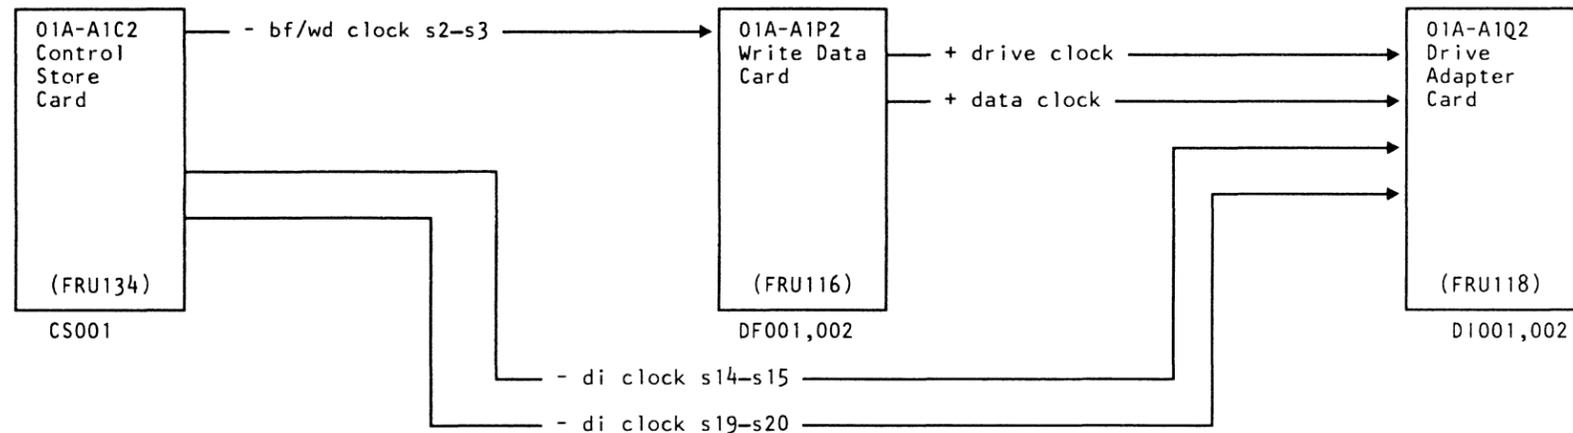
Clocks to the Drive Adapter Card

(For system clock timings see EAD 6.)

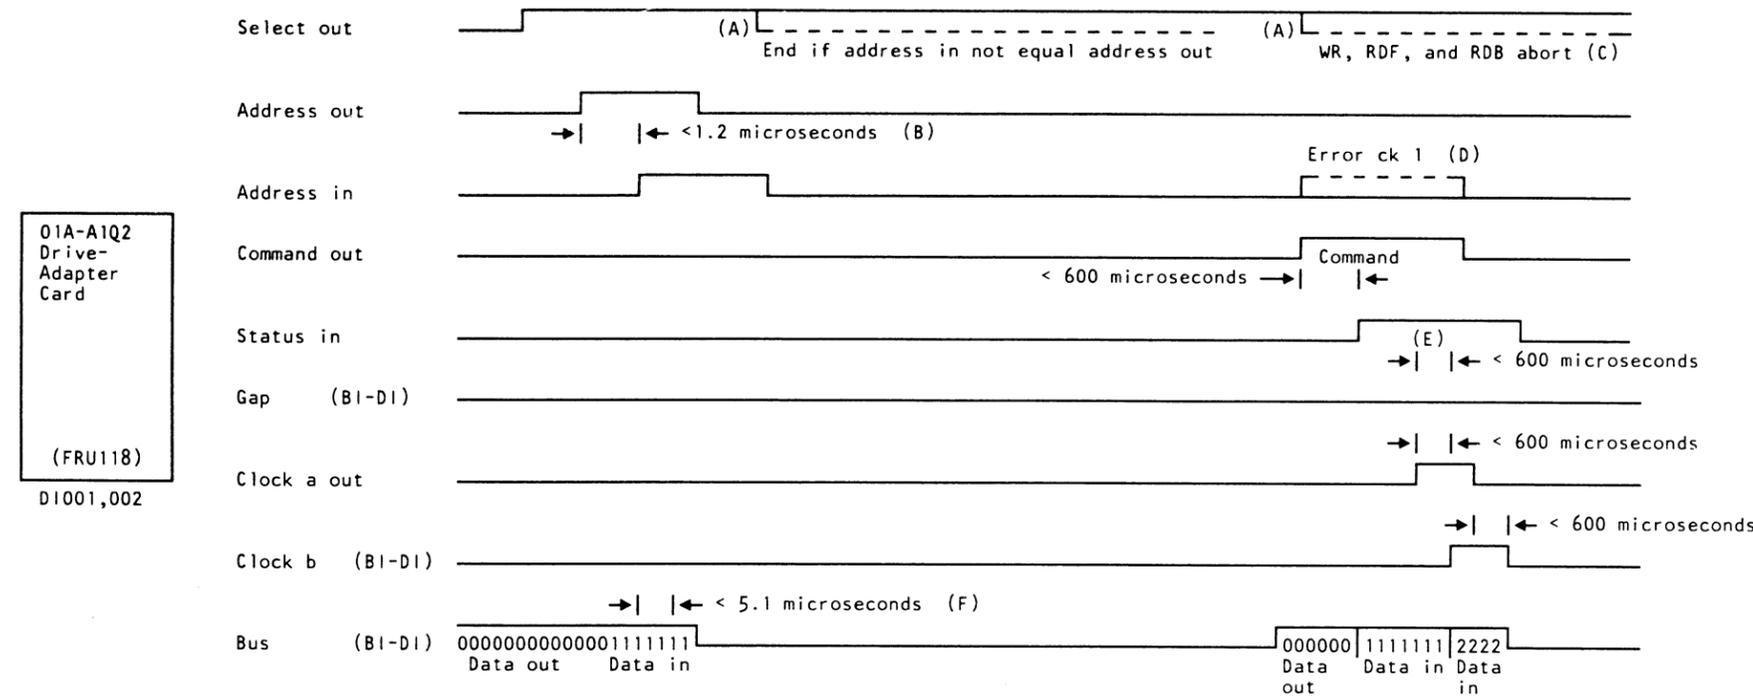
Initial Selection Sequence from the Control Unit to the Drive

* This FRU is EC sensitive.
See CARR-DR 4.

01A-A1Q2
Drive-
Adapter
Card

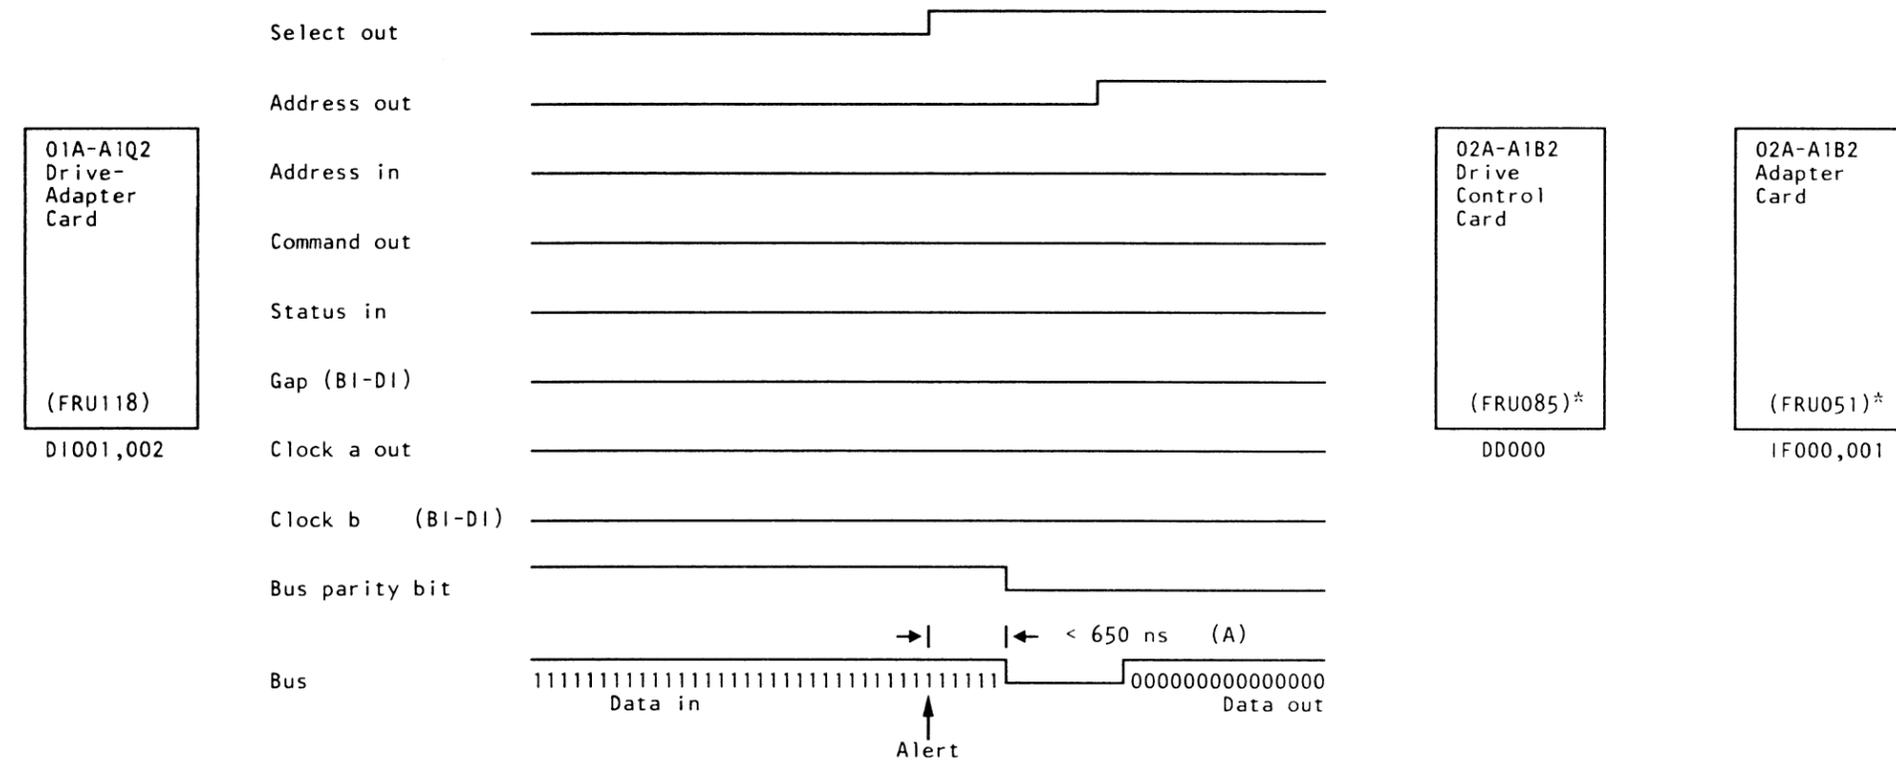
Alert Sequence from the Drive to the Control Unit

(A) All pending alerts from the drive must be removed in 650 ns.

The drive uses this sequence to get the attention of the control unit for:

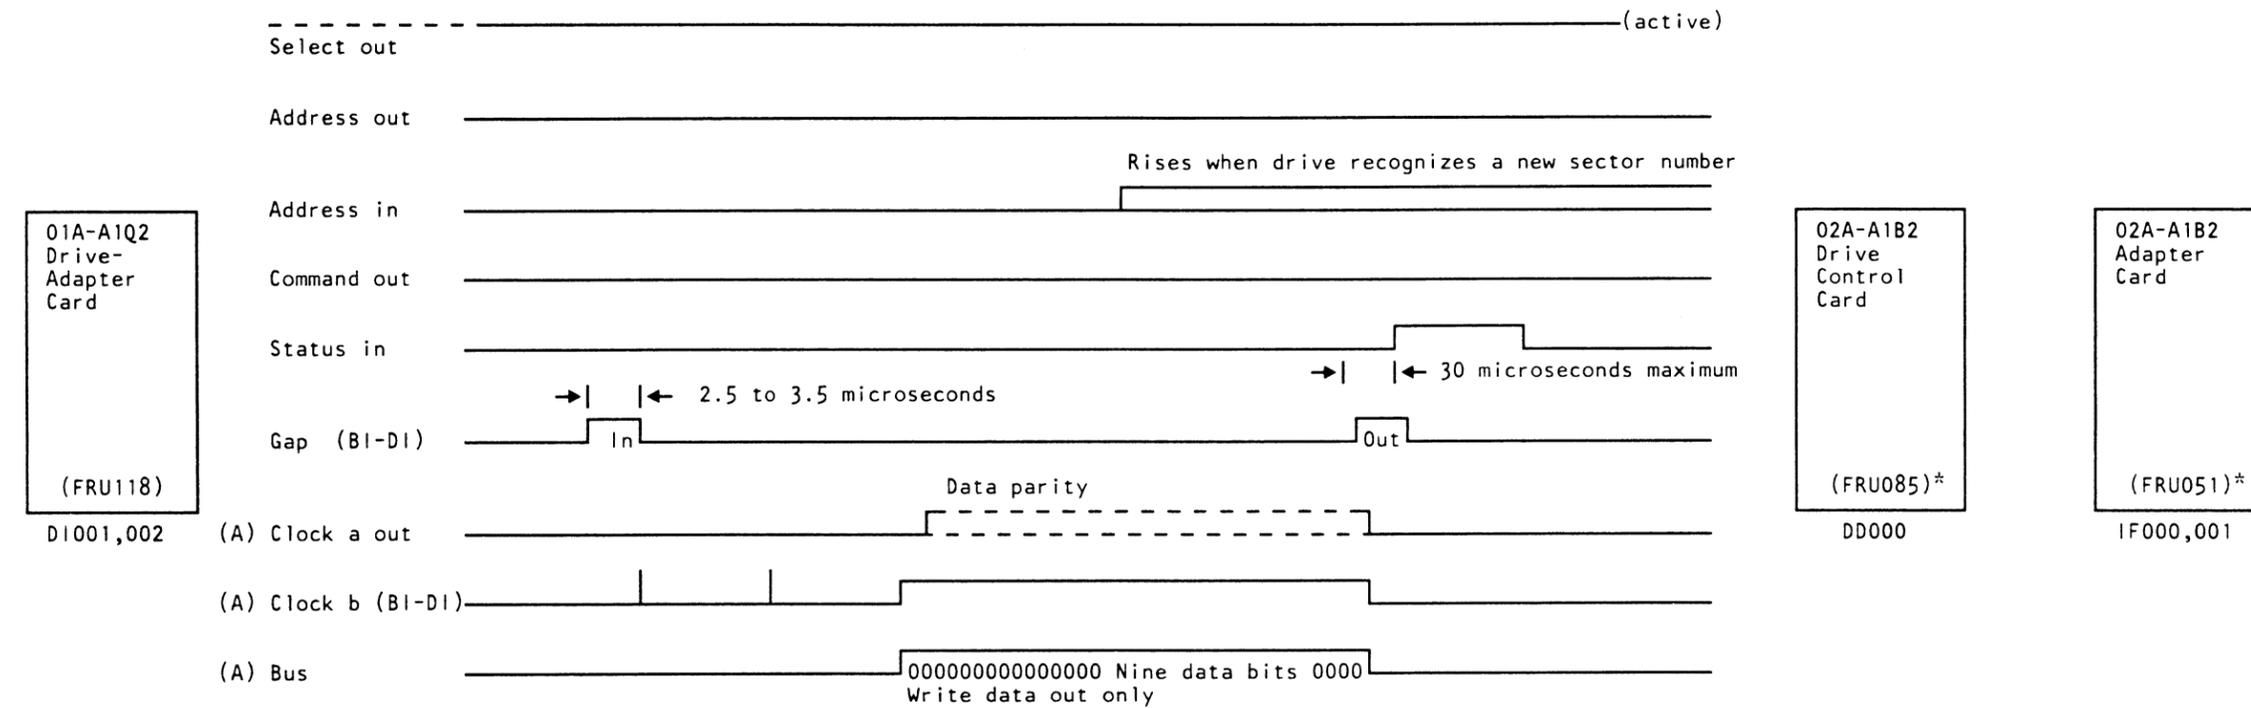
Data Transfer Sequence between the Control Unit and the Drive and WTM, Write Erase Gap Sequence

(A) These line are 'don't care' during a read data sequence.

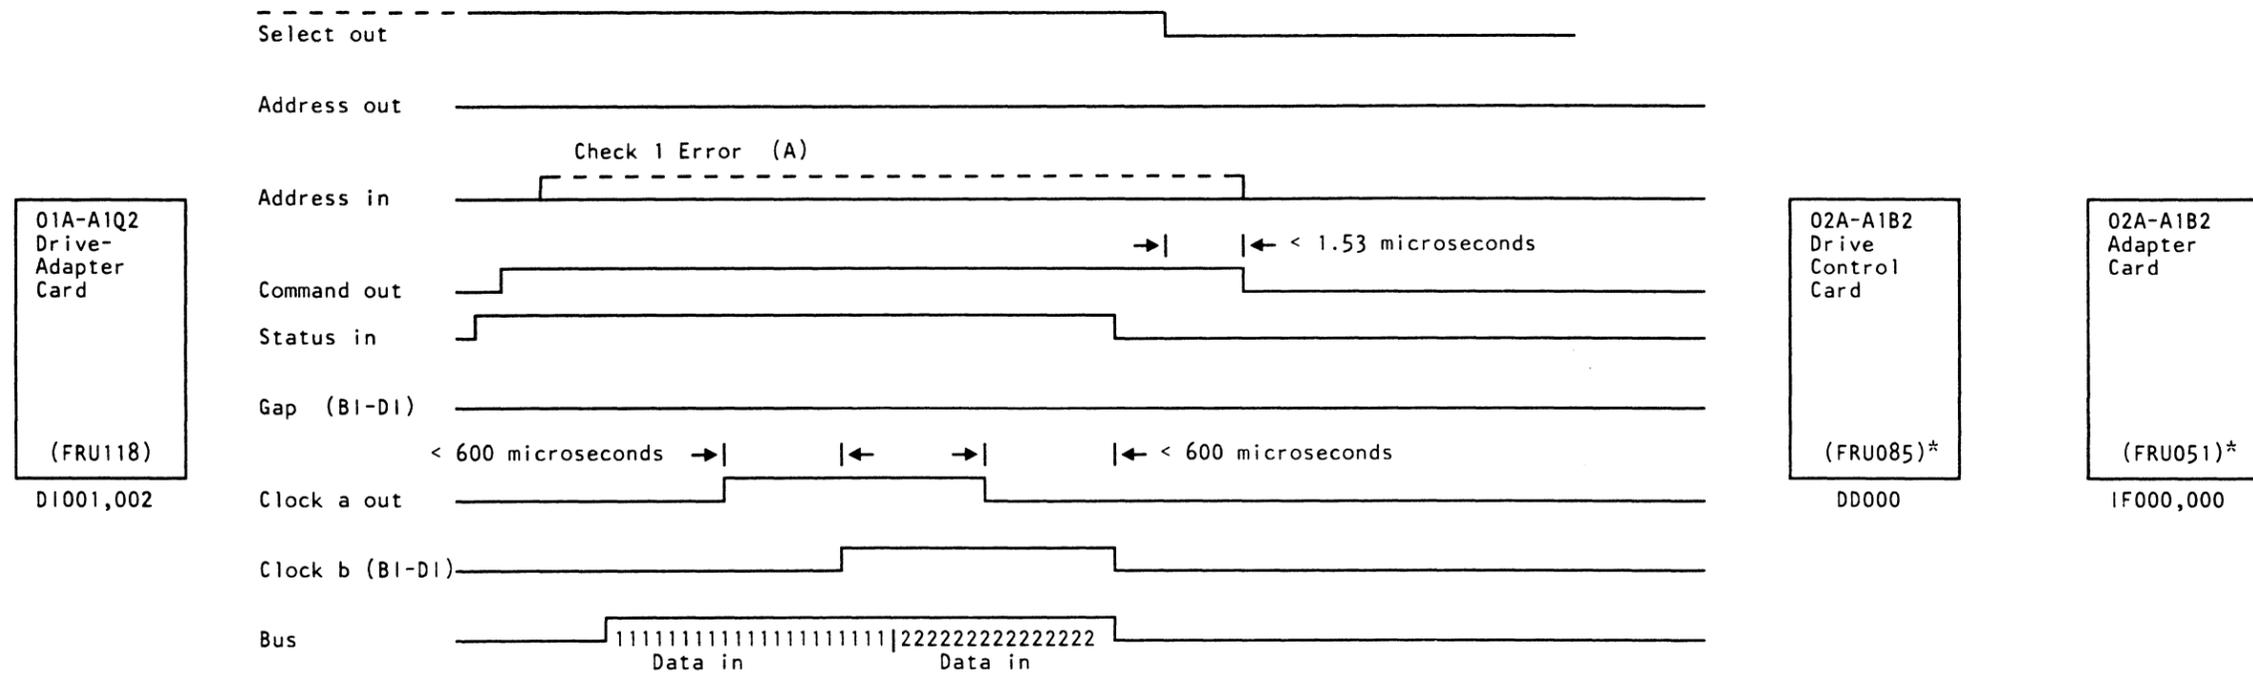
Sense Control Transfer

(A) If 'address in' becomes active during this time, the control unit indicates a check 1 was detected from the drive.

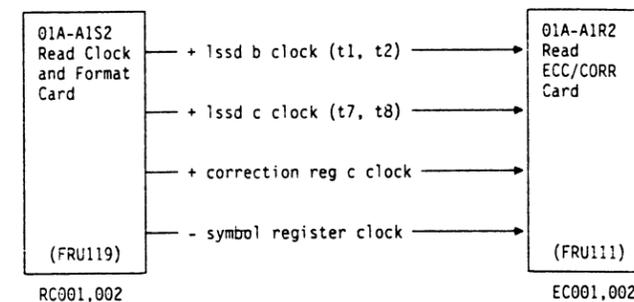
Clocks to the Read ECC/CORR Card

Note: For system clock timings (s and t times), see EAD 6.

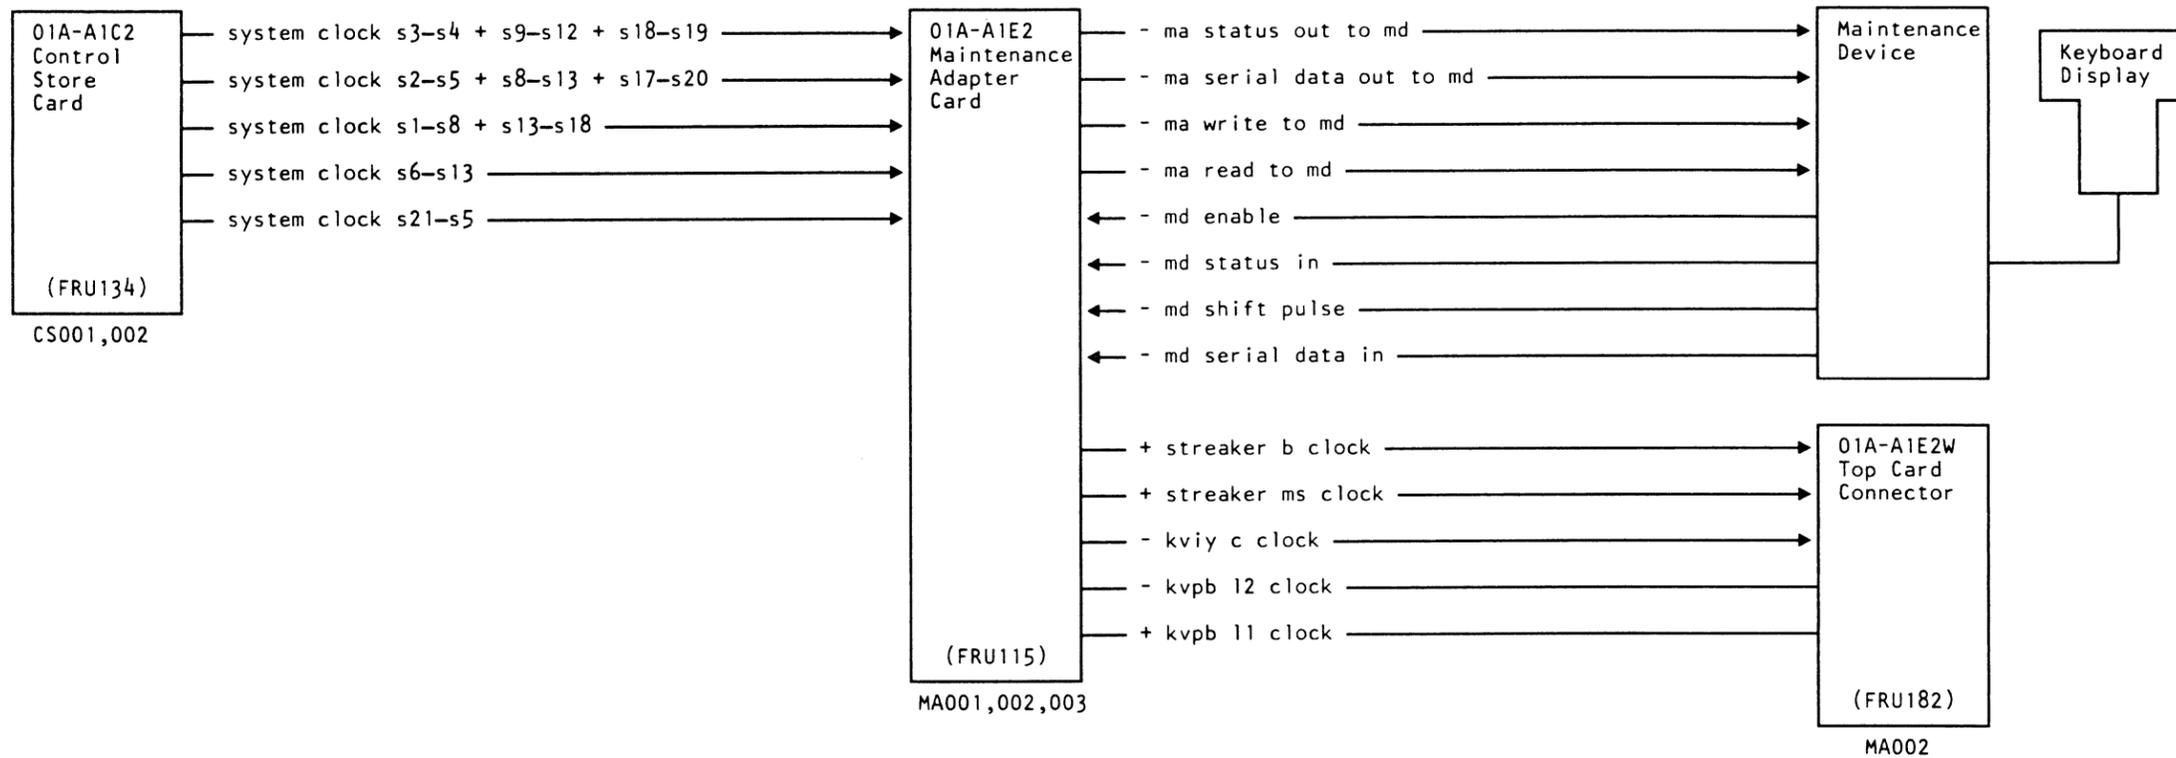
Clocks to and from the Maintenance Adapter

The control storage card and microprocessor card supply clocks to the maintenance adapter card. The maintenance adapter card supplies clocks to the maintenance device and the microprocessor card.

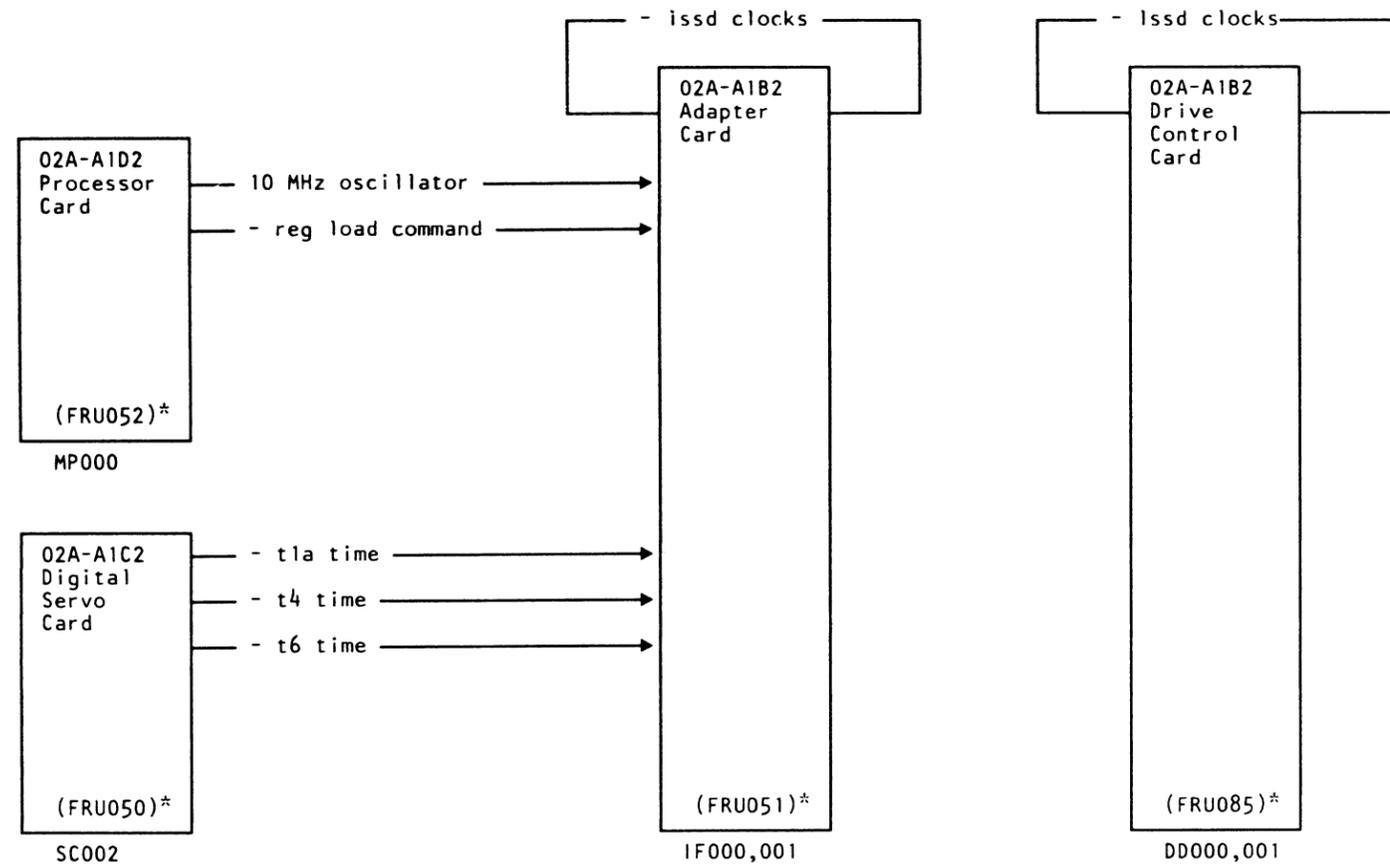
Clocks to the Adapter Card

Note: At EC 333293 all clocks are internal.

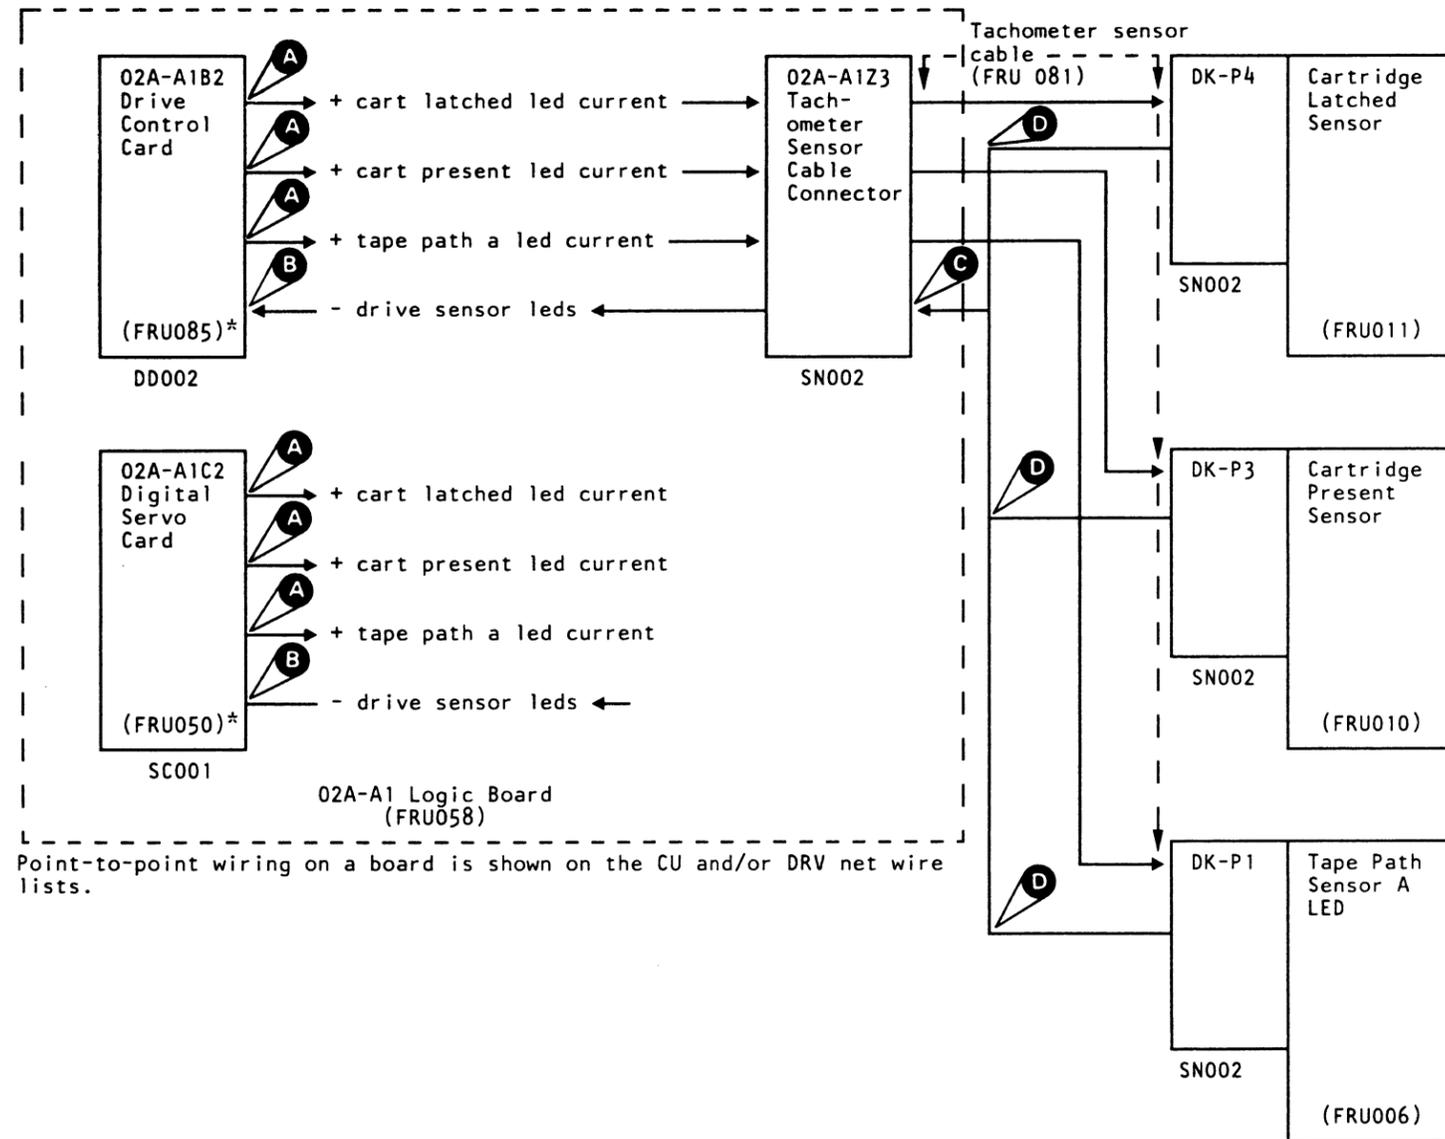
Error Diagram

Plug DK-P1, P2, and P4 (Pin Side)

6. If **A** is less than +2.2 volts at all three points. Suspect FRU085*.
7. **If you have performed a repair action**, verify correct operation by running the program that detected the failure and select one of the following:

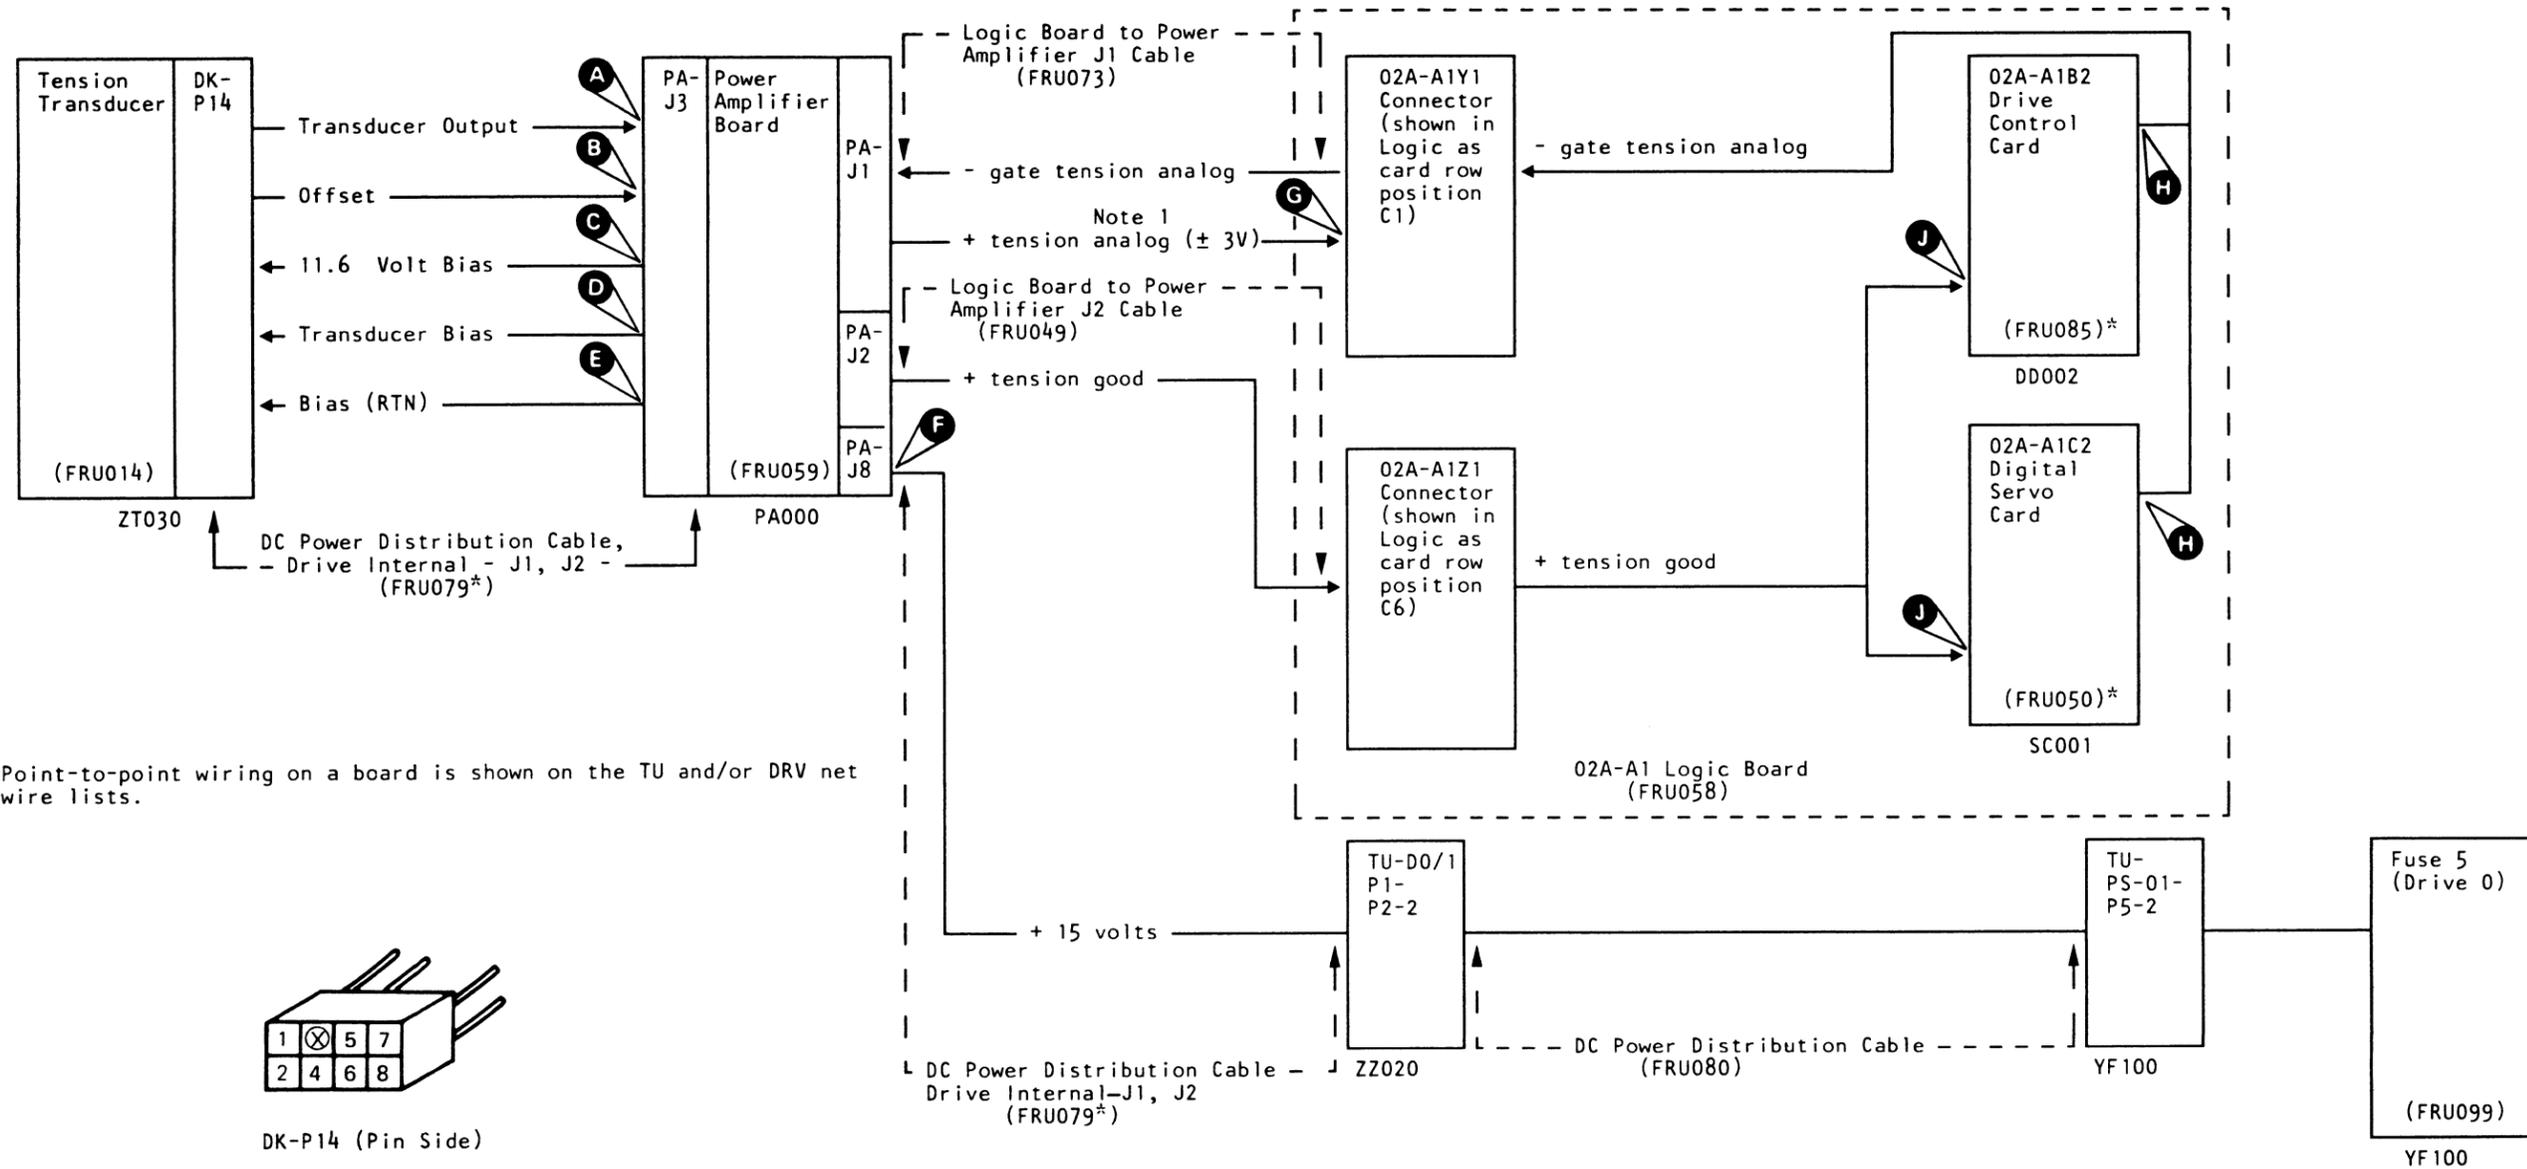
Error Diagram

*Point-to-point wiring on a board is shown on the TU and/or DRV net wire lists.

- f. If either test fails, the problem is in the area of FRUs 014, 059, the cables between them, or source voltages. Go to step 5.
5.
 - a. Point **F** in the error diagram should be +15 volts. If the voltage is not correct, use the logics to follow its path back to the power supply.

- c. If all points are correct, replace FRUs 059 and 014 again. Go to step 8.
6. Point **J** in the error diagram varies from +5 volts to 0 volts. Connect the oscilloscope to **J** and attempt to load a cartridge. The logic level should go from +5 volts to 0 volts then back to +5 volts. If the logic level fails to vary correctly, the problem is in the area of FRUs 059, 049, or 085*.

7. Point **H** in the error diagram varies from +3 volts to 0 volts. Scope **H** and load a cartridge. The value is +3 volts before the cartridge latch engages, on drives without the automatic cartridge loaders, or before the load motor completes its cycle on drives with the automatic cartridge loaders, goes to 0 volts momentarily, then goes back to +3 volts. If the value fails to vary, the problem is in the area of FRUs 059, 073, or 085*.

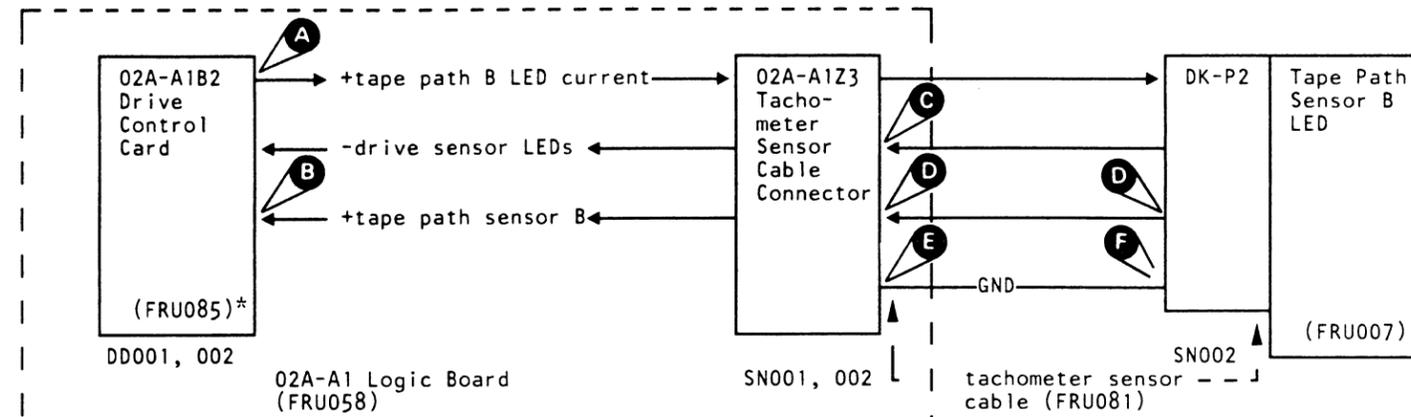
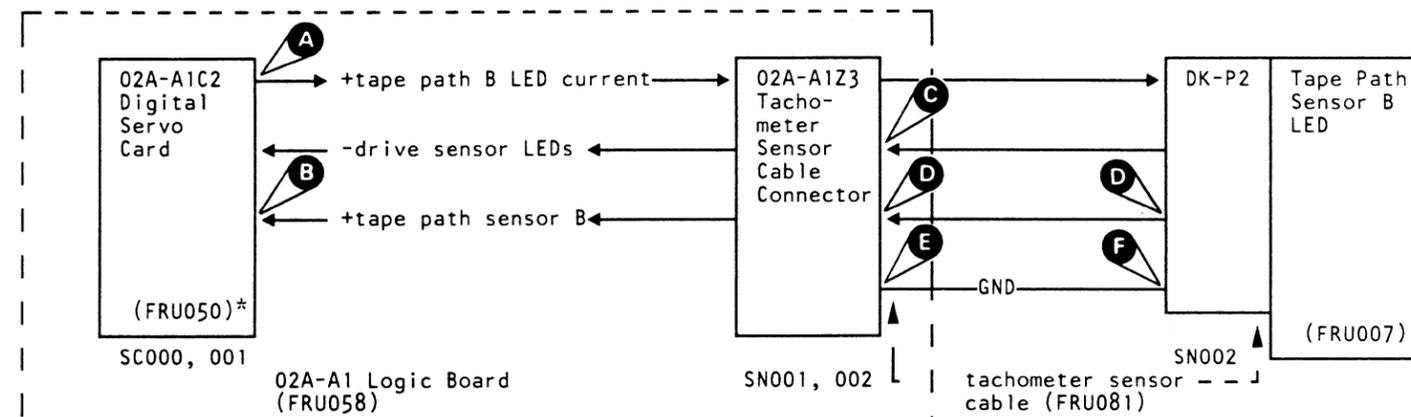
Error Diagram

Point-to-point wiring on a board is shown on the CU and/or DRV net wire lists.

NOTE: Point A Norm: +1.4 V to +2.2 V
Fail: +5.0 V
Point B Light: +0.4 V
Dark: +5.0 V

5. Check for a down logic level at point **B**. If point **B** is at an up logic level, check for an open circuit between points **B** and **D** or **E** and **F**. If point **B** is at a down logic level or if no open circuit can be found, the failure is in the area of FRU058 or FRU085*.

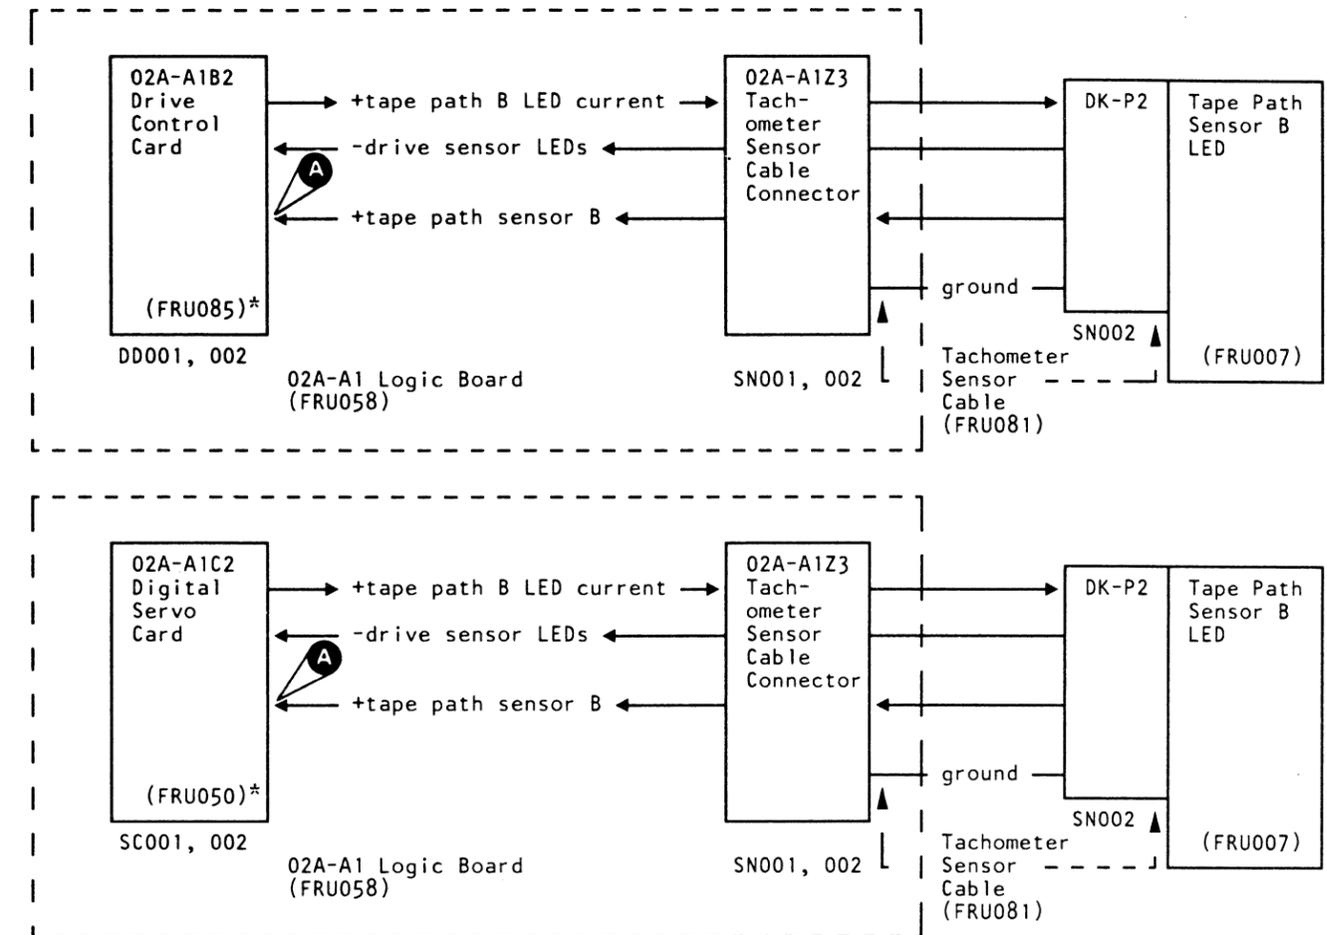
ERROR DIAGRAM

Point-to-point wiring on a board is shown on the CU and/or DRV net wire lists.

NOTE: Point A Light: +0.4 V
Dark: +5.0 V

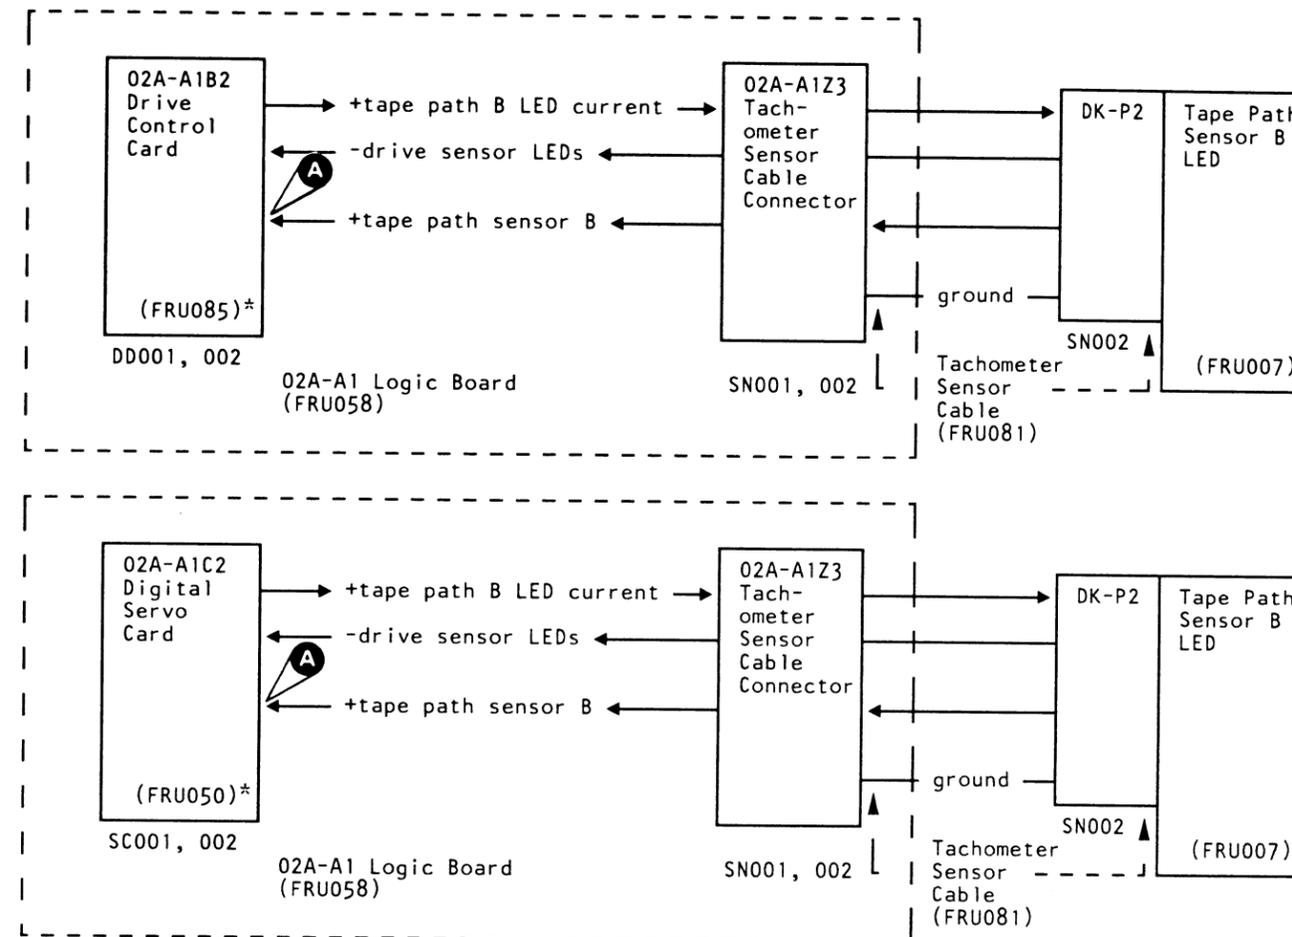
ERROR DIAGRAM

Point-to-point wiring on a board is shown on the CU and/or DRV net wire lists.

NOTE: Point A Light: +0.4 V
Dark: +5.0 V
