Collating List of Pages

This reference drawing contains the collating sequence, page side, and EC level of pages for *IBM 3480 Magnetic Tape Subsystem Maintenance Information Manual (MI) Volume A05, SY32-5061-13*.

PUBLICATIONS REFERENCE DRAWING

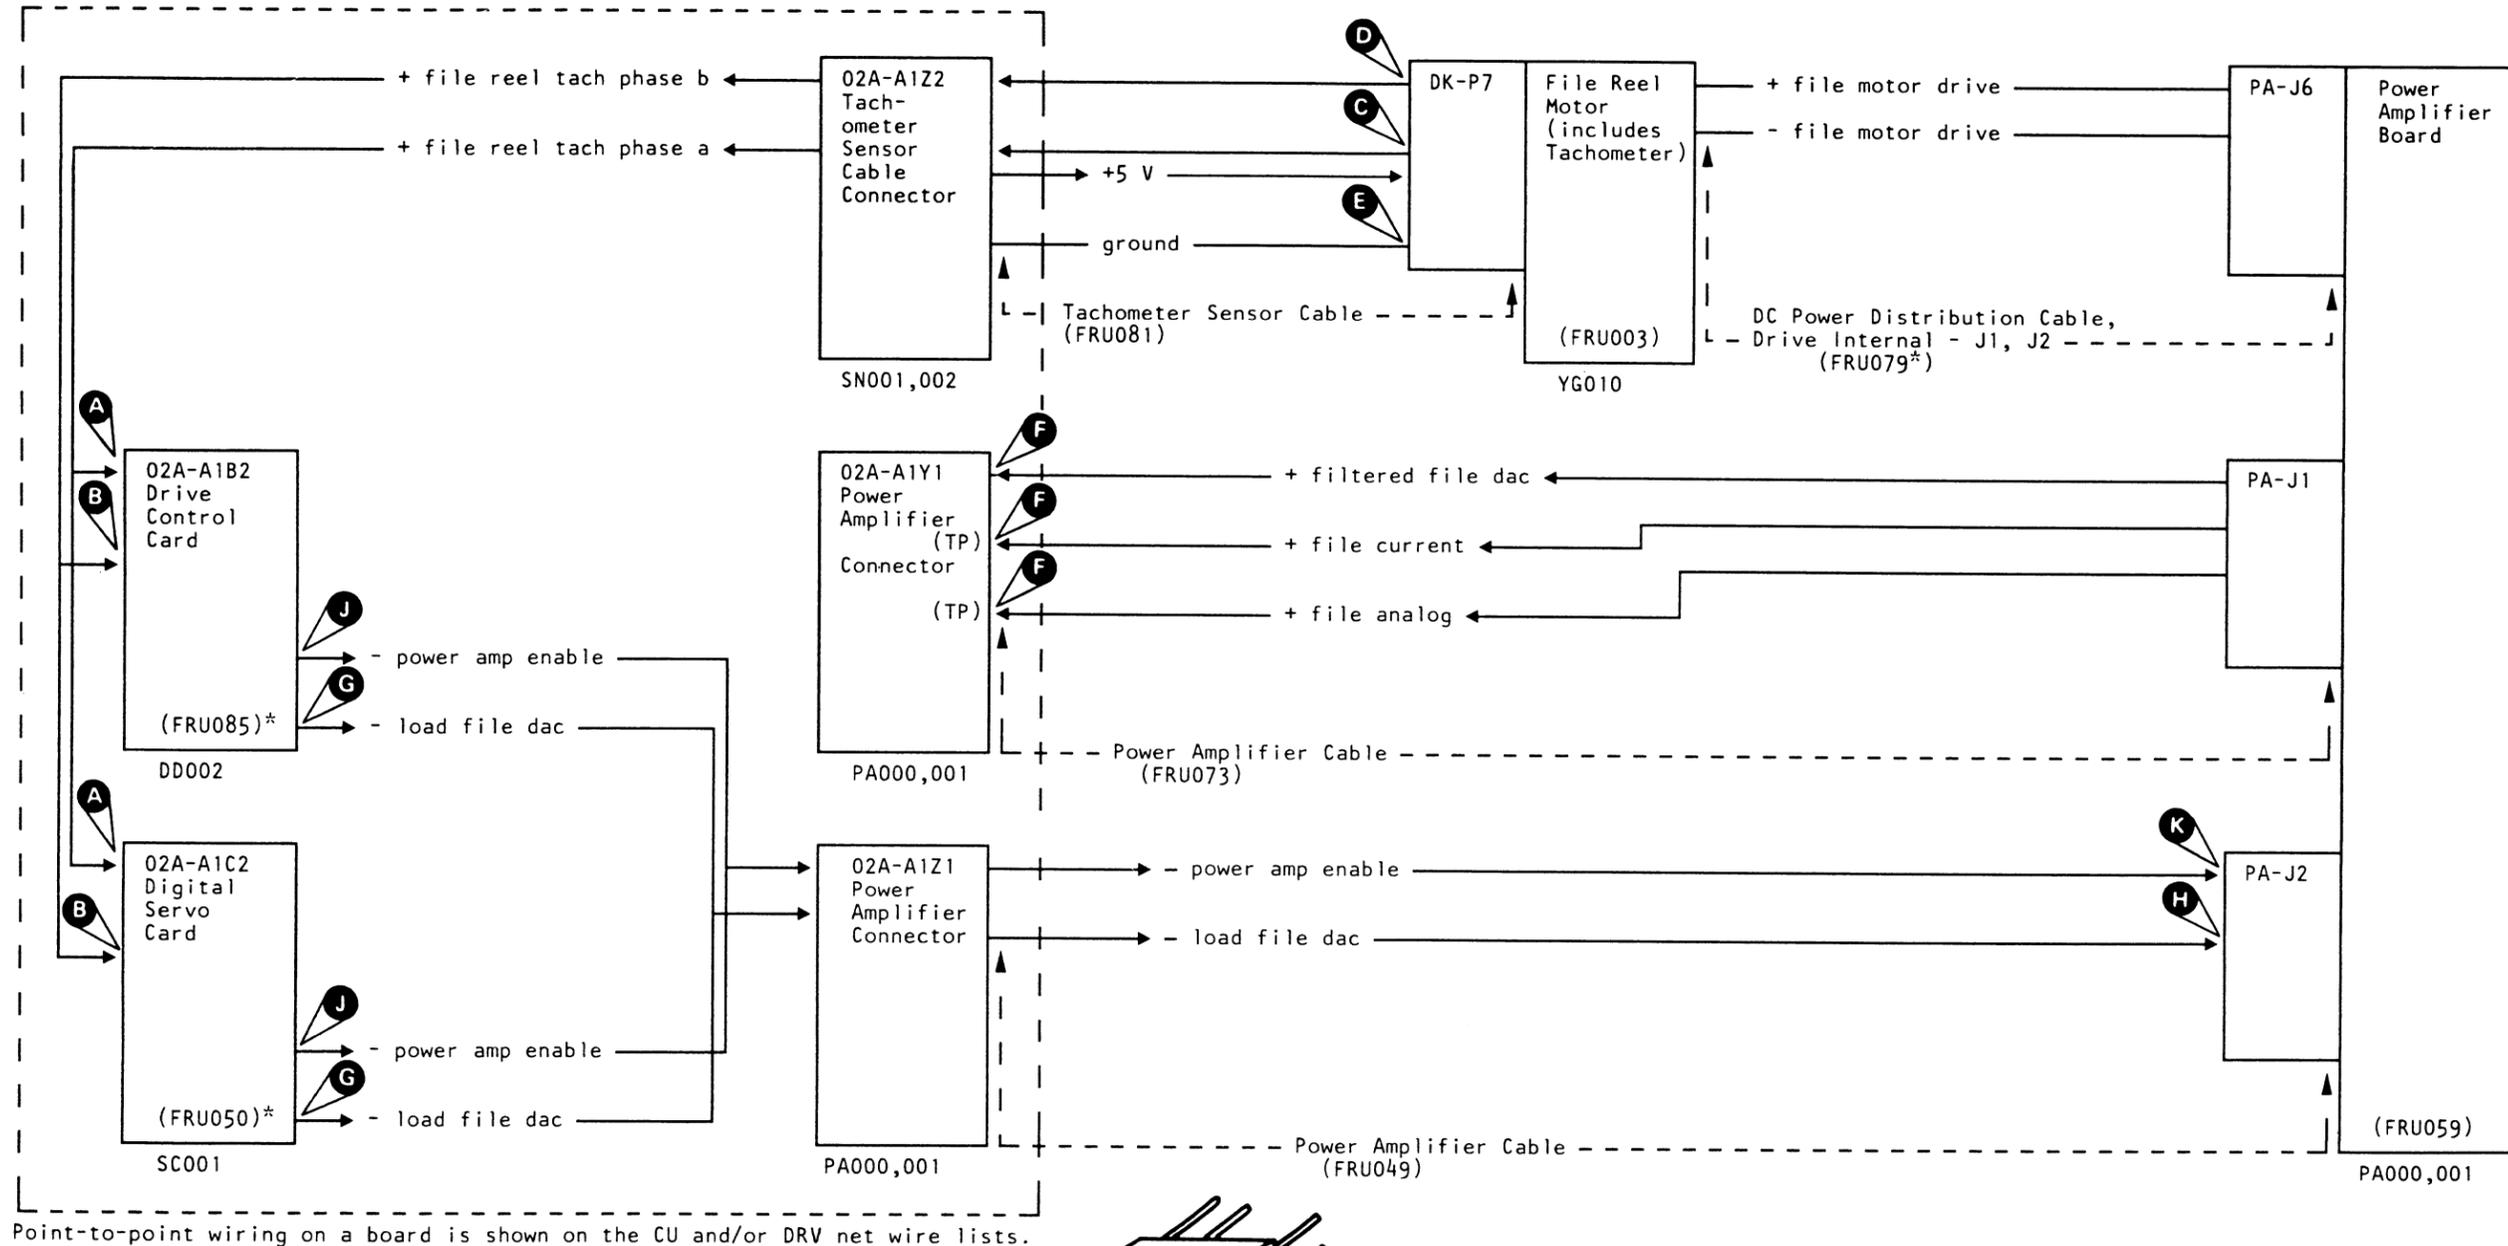
Error Diagram

Point-to-point wiring on a board is shown on the CU and/or DRV net wire lists.

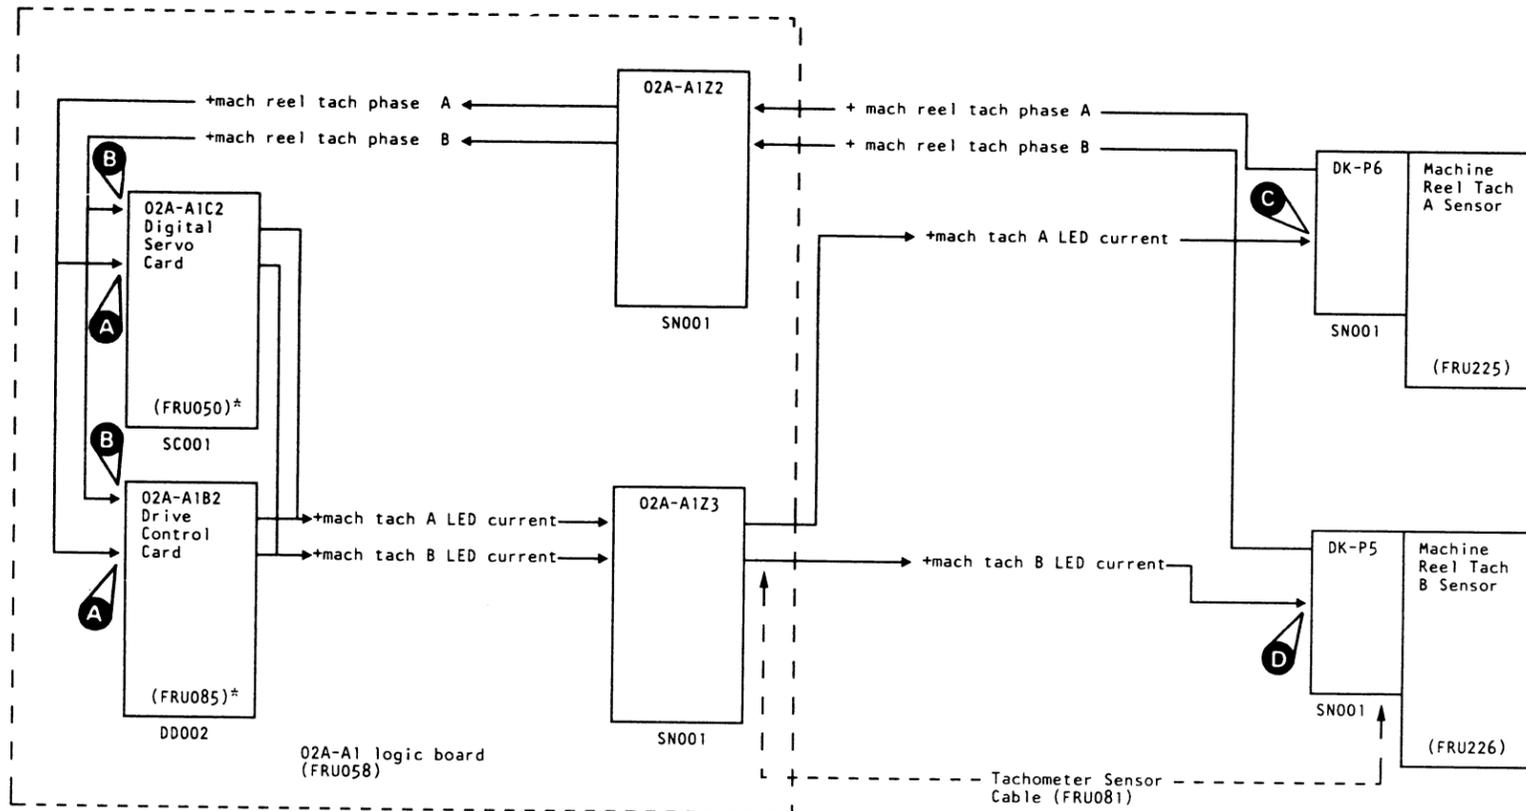
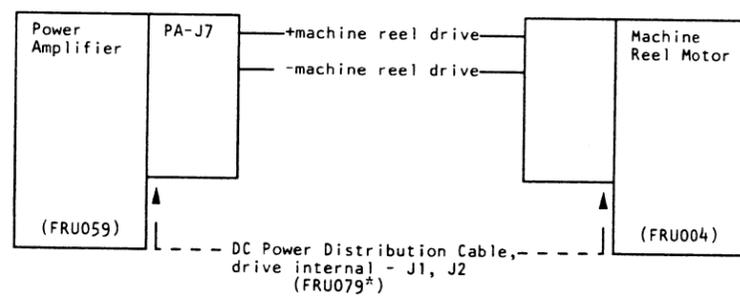
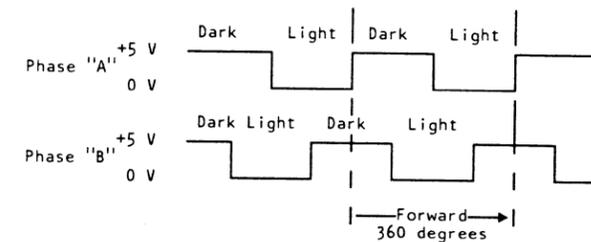
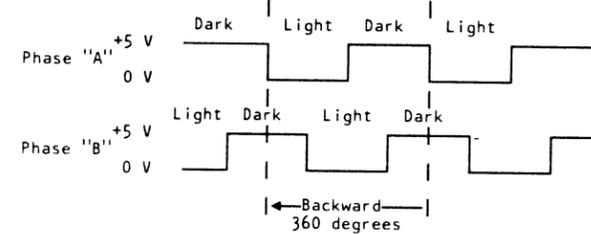
Error Diagram

Plug DK-P5 and P6 (Pin Side)

Point-to-point wiring on a board is shown on the CU and/or DRV net wire lists.

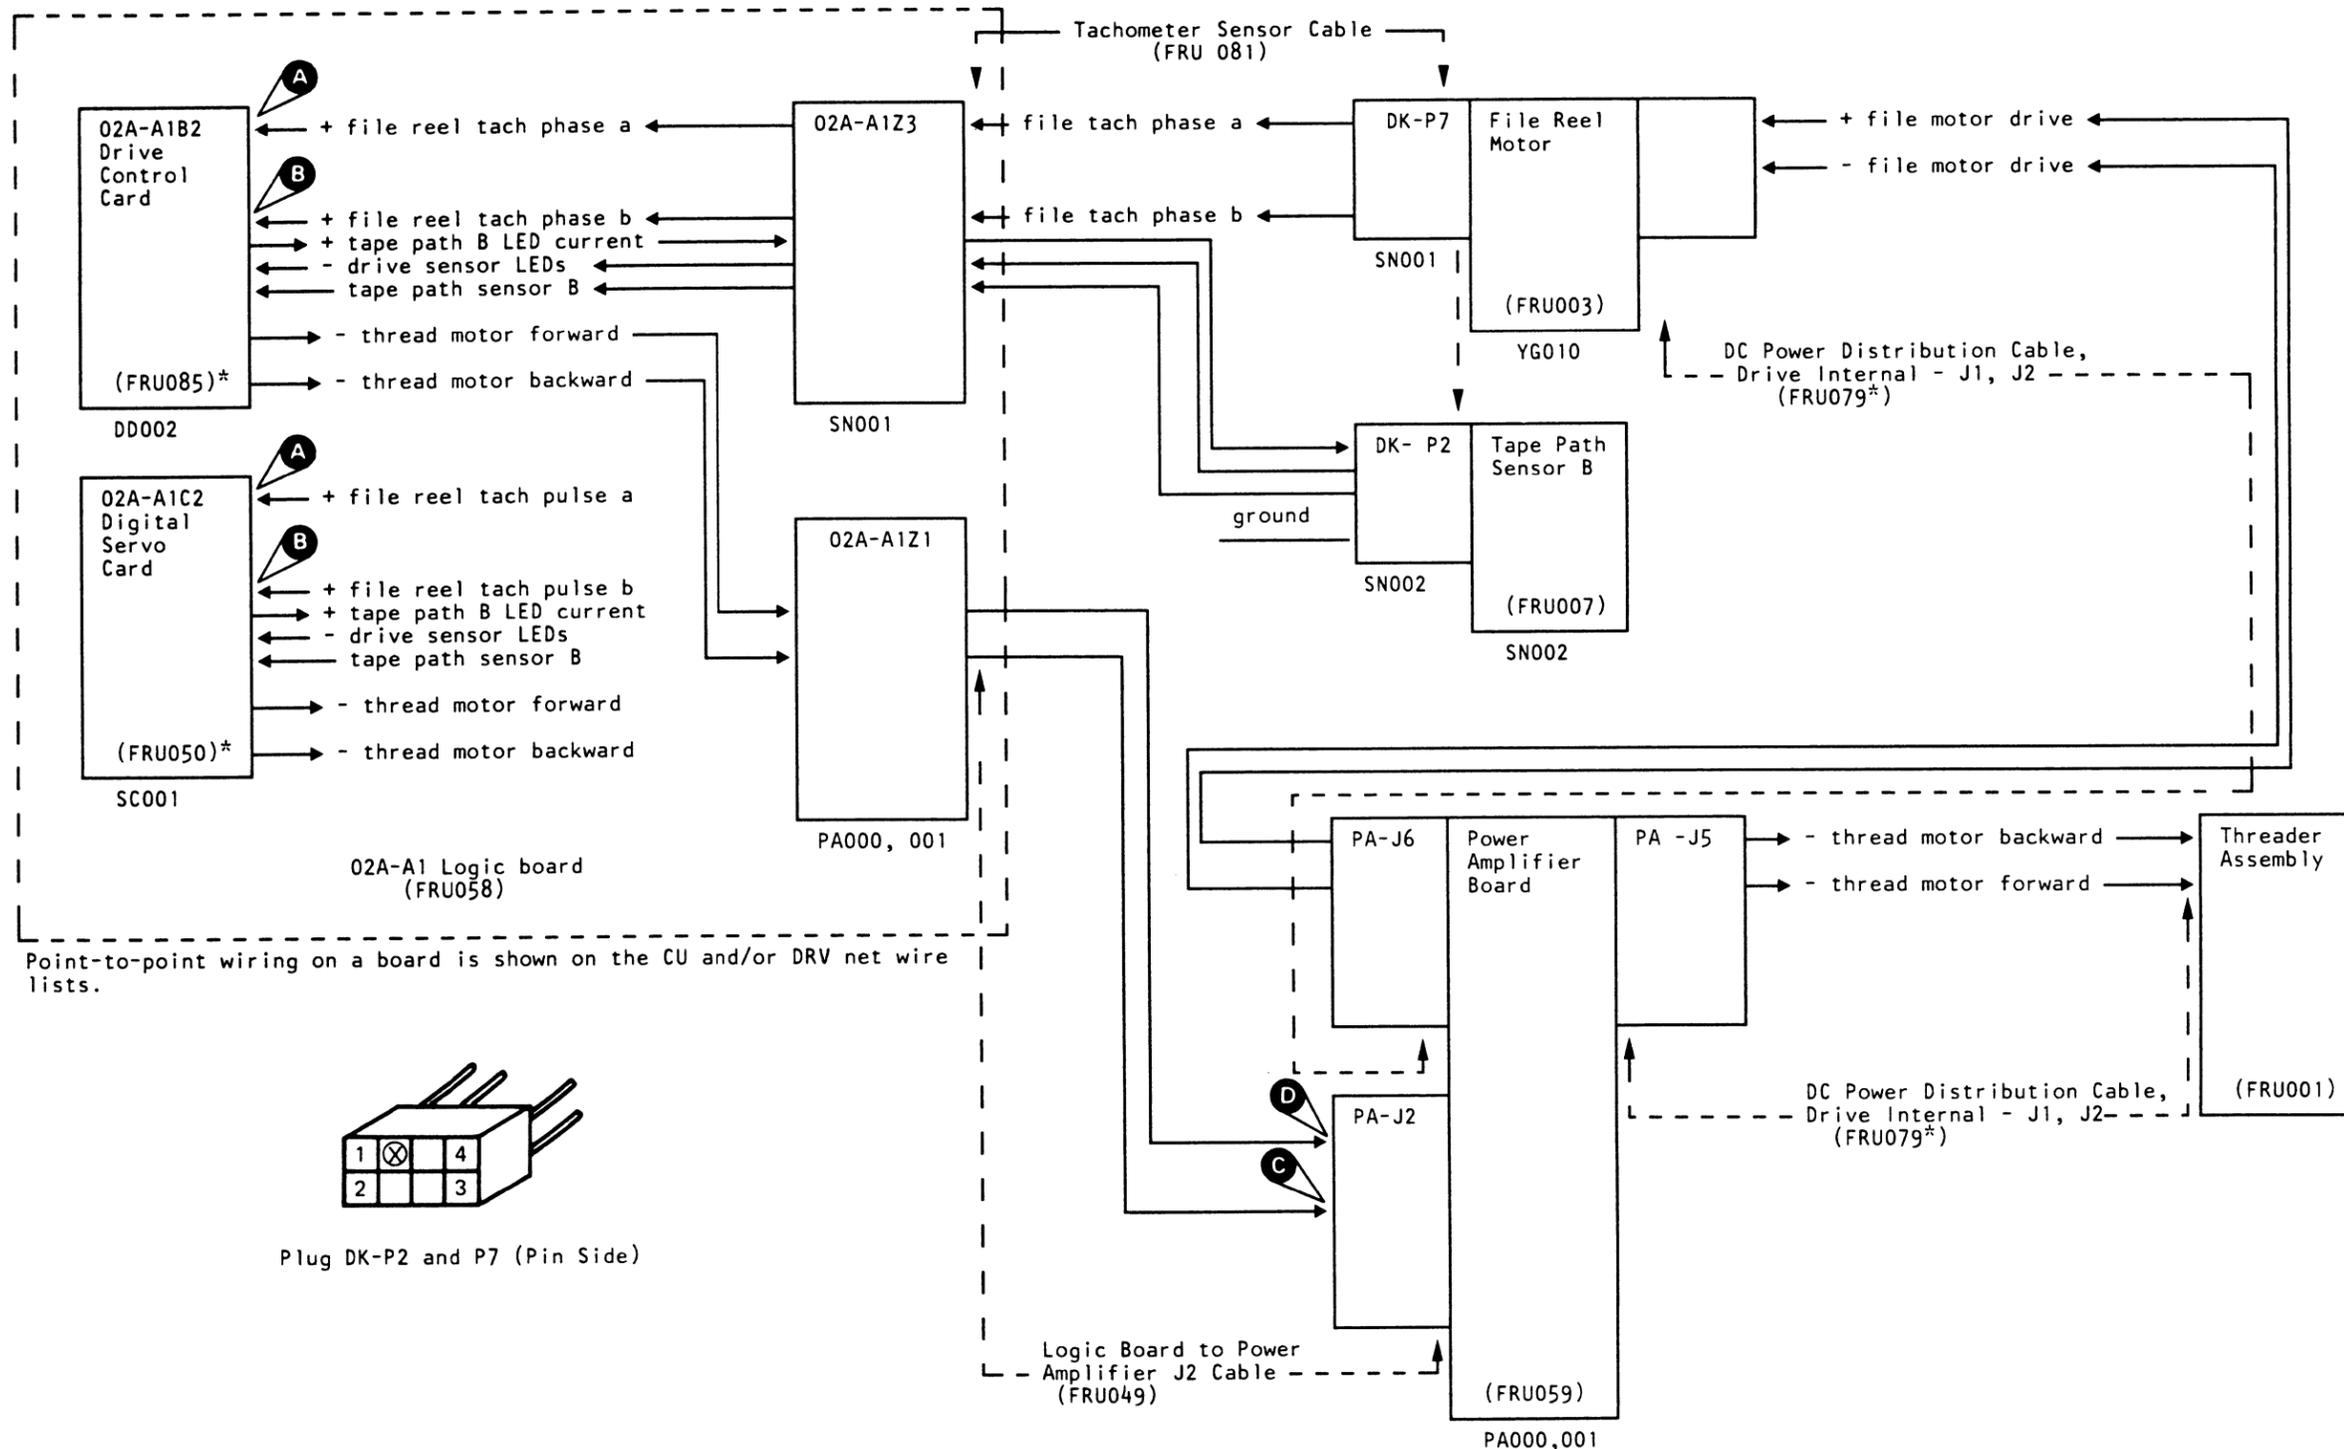
Error Diagram

Plug DK-P2 and P7 (Pin Side)

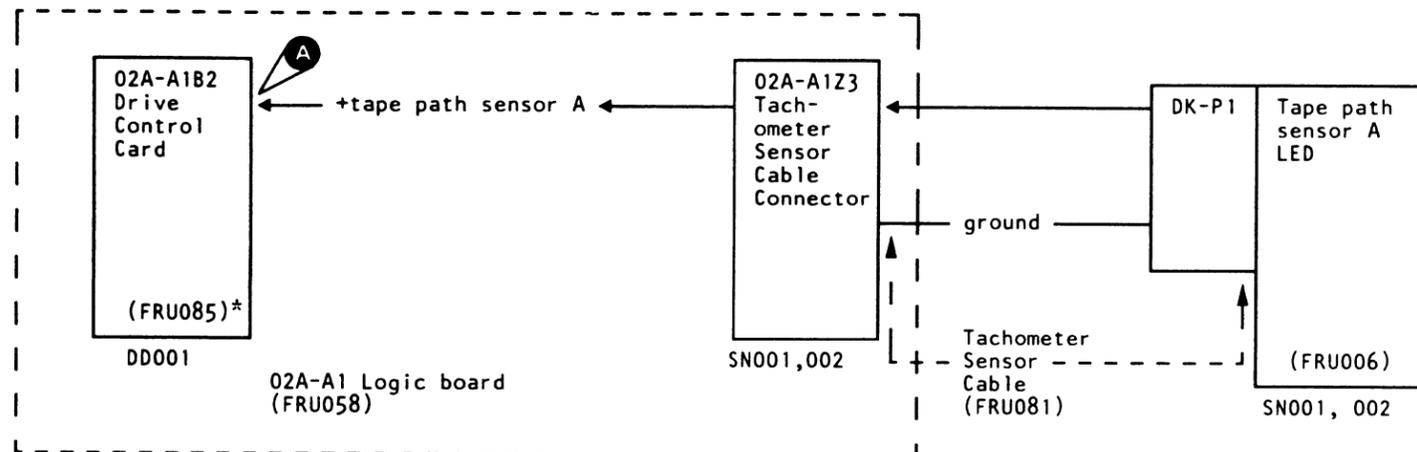
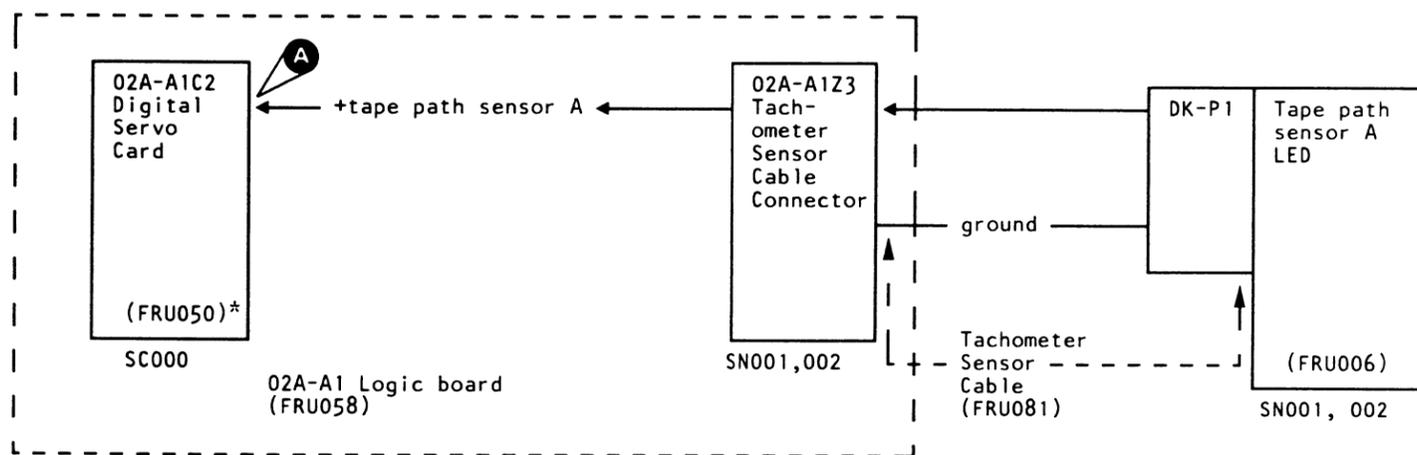
Error Diagram

Point-to-point wiring on a board is shown on the CU and/or DRV net wire lists.

NOTE: Point A Light: +0.4 V
Dark: +5.0 V

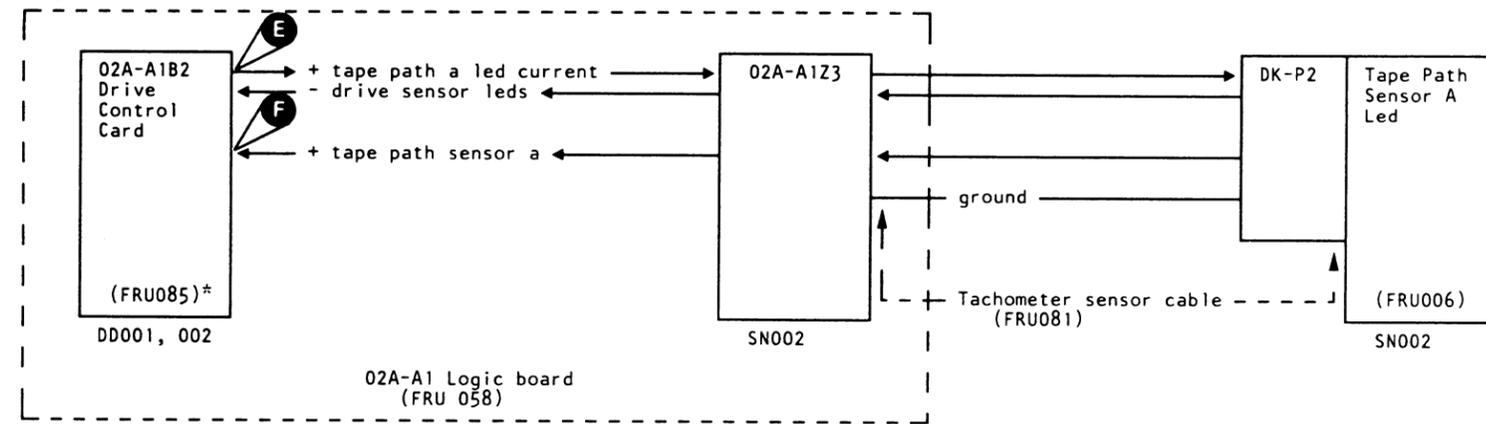
Diagram 3

Point-to-point on a board is shown on the CU and/or DRV net wire lists.

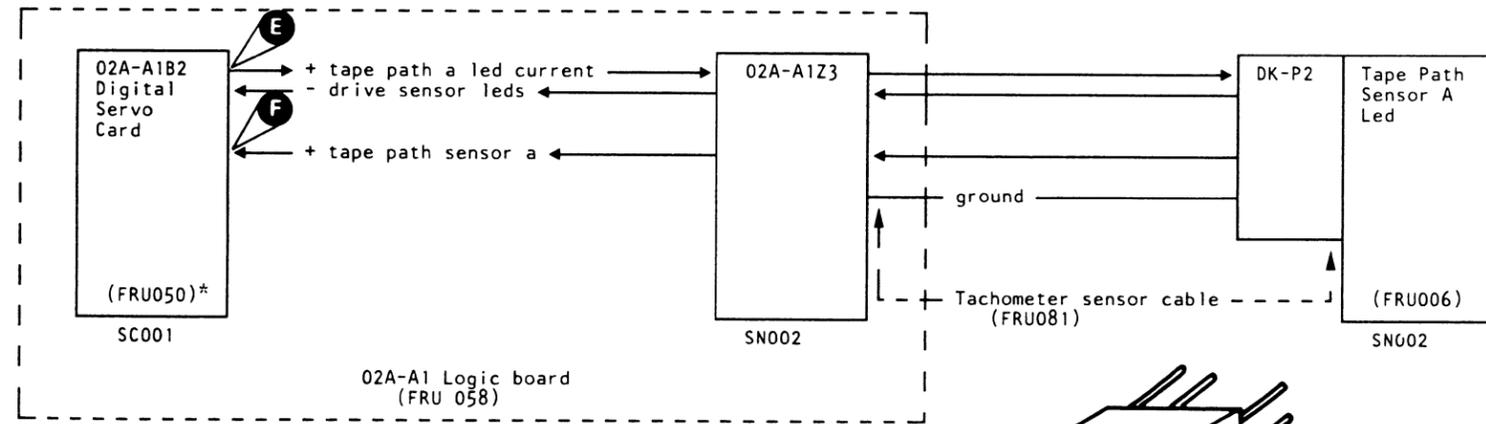
Diagram 3

Point-to-point on a board is shown on the CU and/or DRV net wire lists.

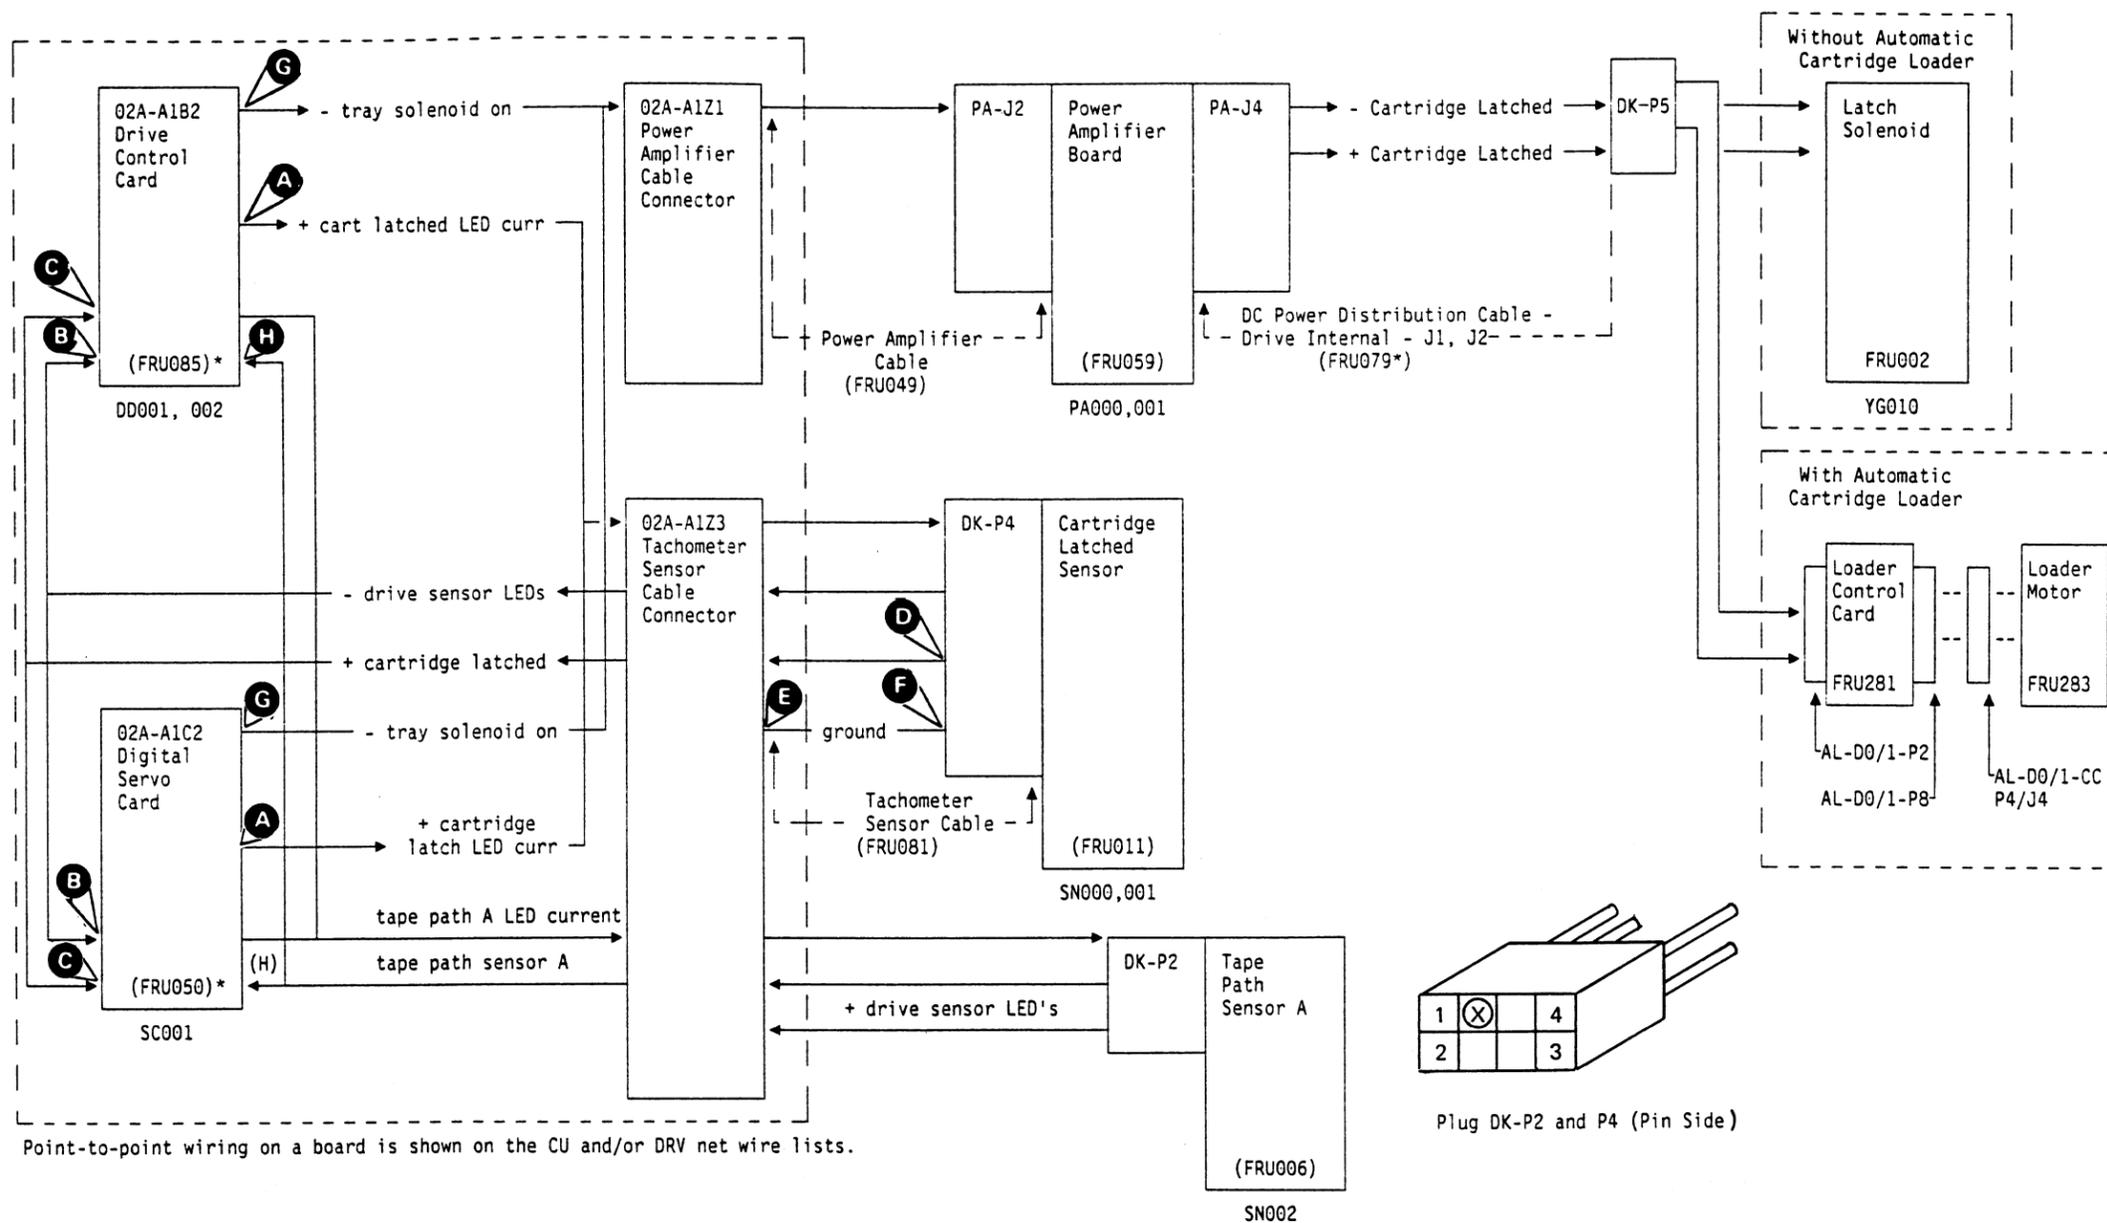
Error Diagram

Plug DK-P2 and P4 (Pin Side)

5. Check point **A** for +1.4 volts to +2.2 volts. If the voltage is correct, go to step 6. If the voltage is more than +2.2 volts, check for an open circuit between points **A** and **B**. (Note that there is a diode in the circuit. If the meter shows an open circuit, reverse the meter leads to verify that the circuit is really open.) If the voltage at **A** is less than +1.4 volts, check for a short circuit between **A** and ground. If no problem can be found, the failure is in the area of FRUs 058 or 085*.

6. With the cartridge unlatched on drives without the automatic cartridge loaders, or the load assembly in the up position on drives with the automatic cartridge loaders, check point **C** for a down logic level. If **C** is at an up logic level, check for an open circuit between points **C** and **D** or points **E** and **F**. If there is no open circuit, the failing area is FRU058 or FRU085*.

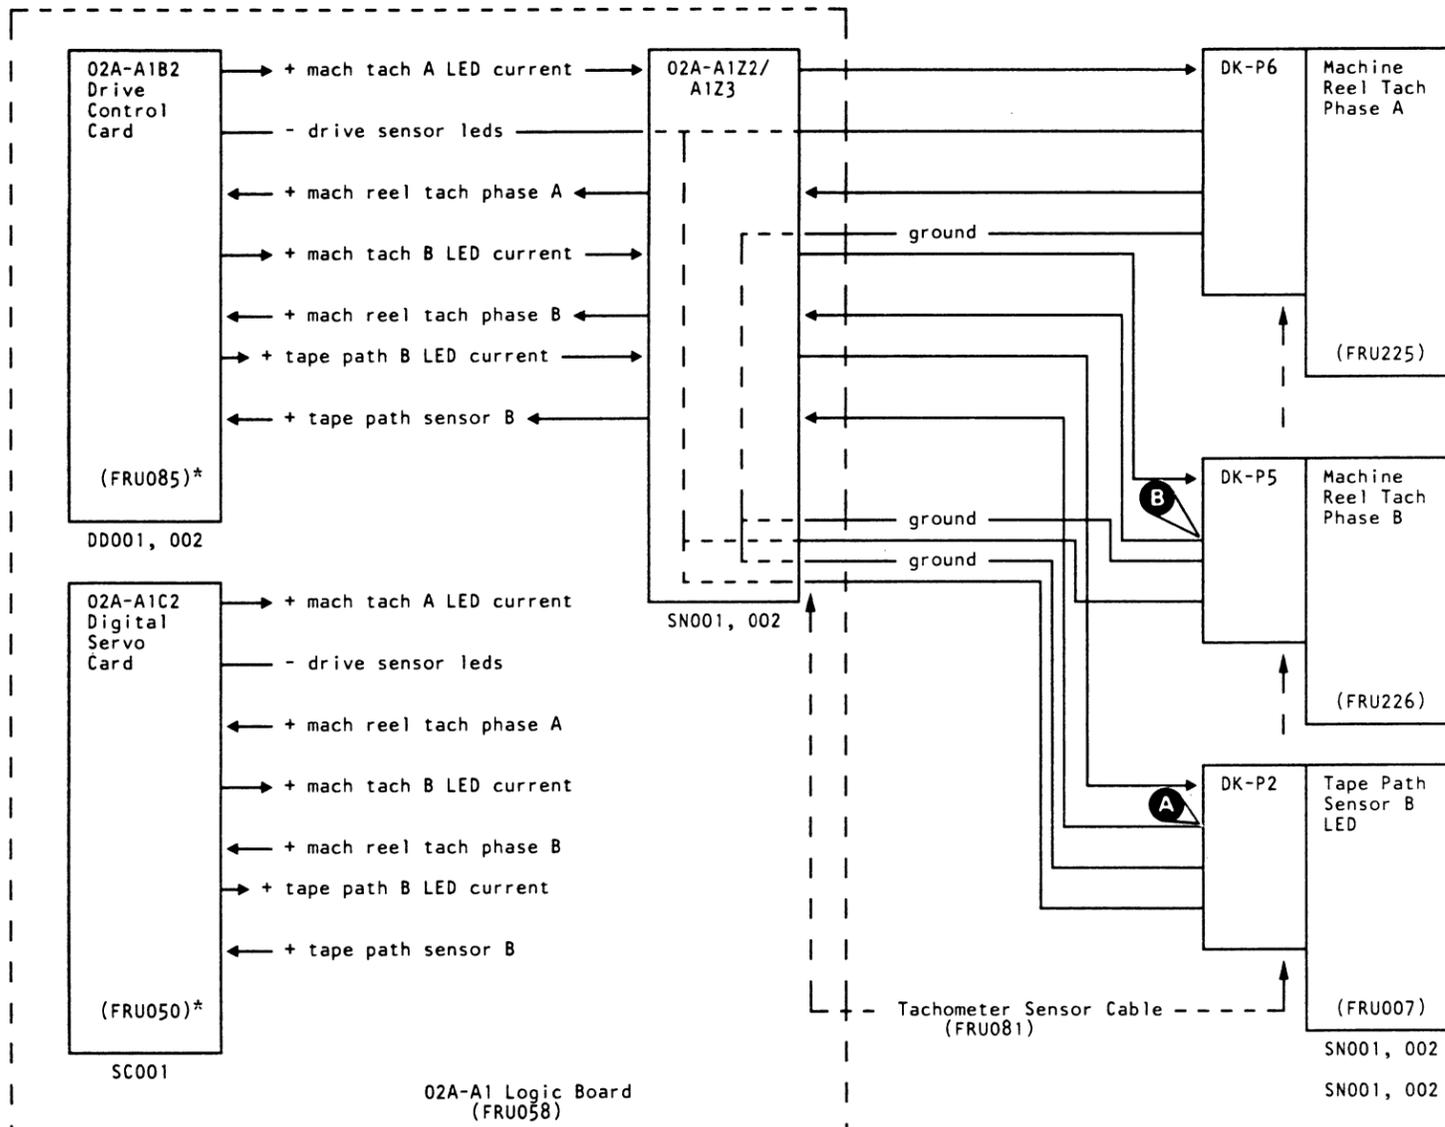
Error Diagram 1

DK-P2, P5, P6 (pin side)

If both lines fail to change to +0.4 volts, check for an open circuit in **E**. If either line fails to change to +5 volts, check that line for a short circuit to ground. If both phases are working, go to step 8.

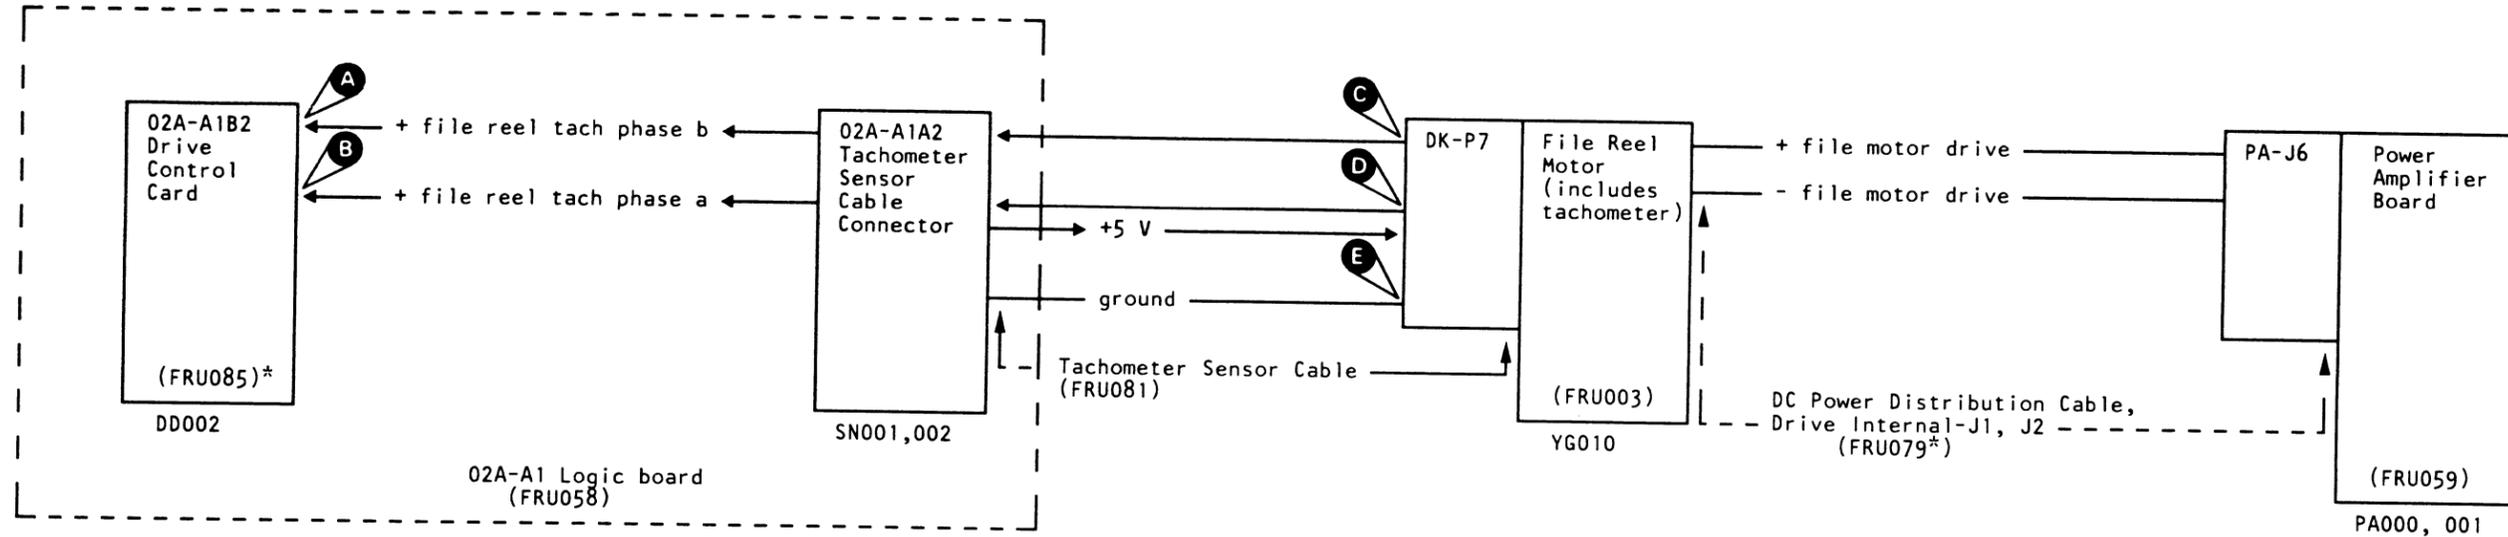
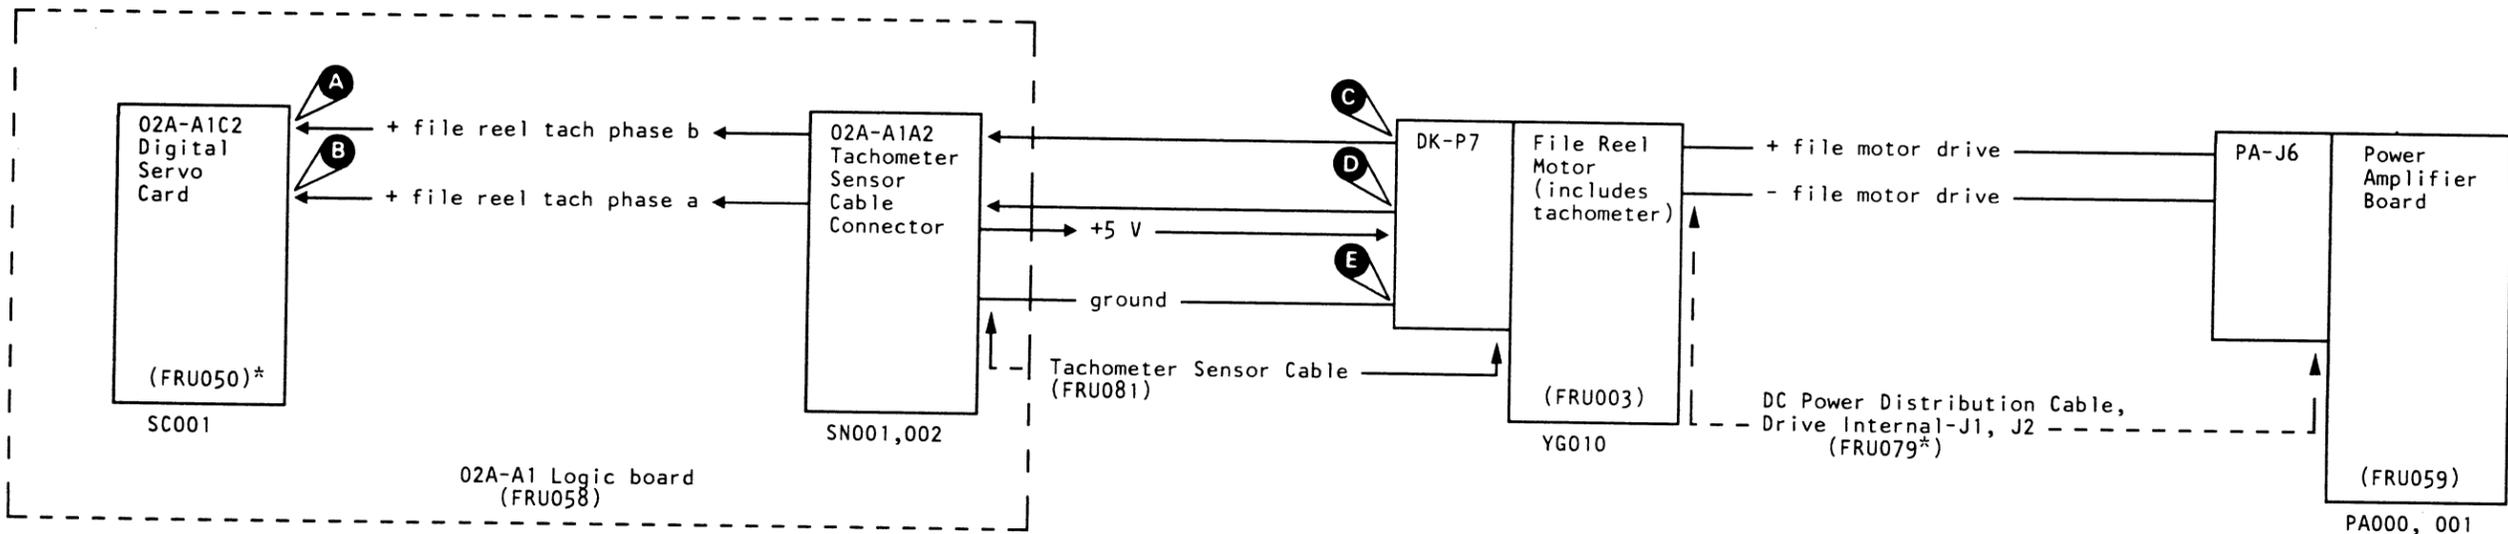
Error Diagram

Point-to-point wiring on a board is shown on the CU and/or DRV net wire lists.

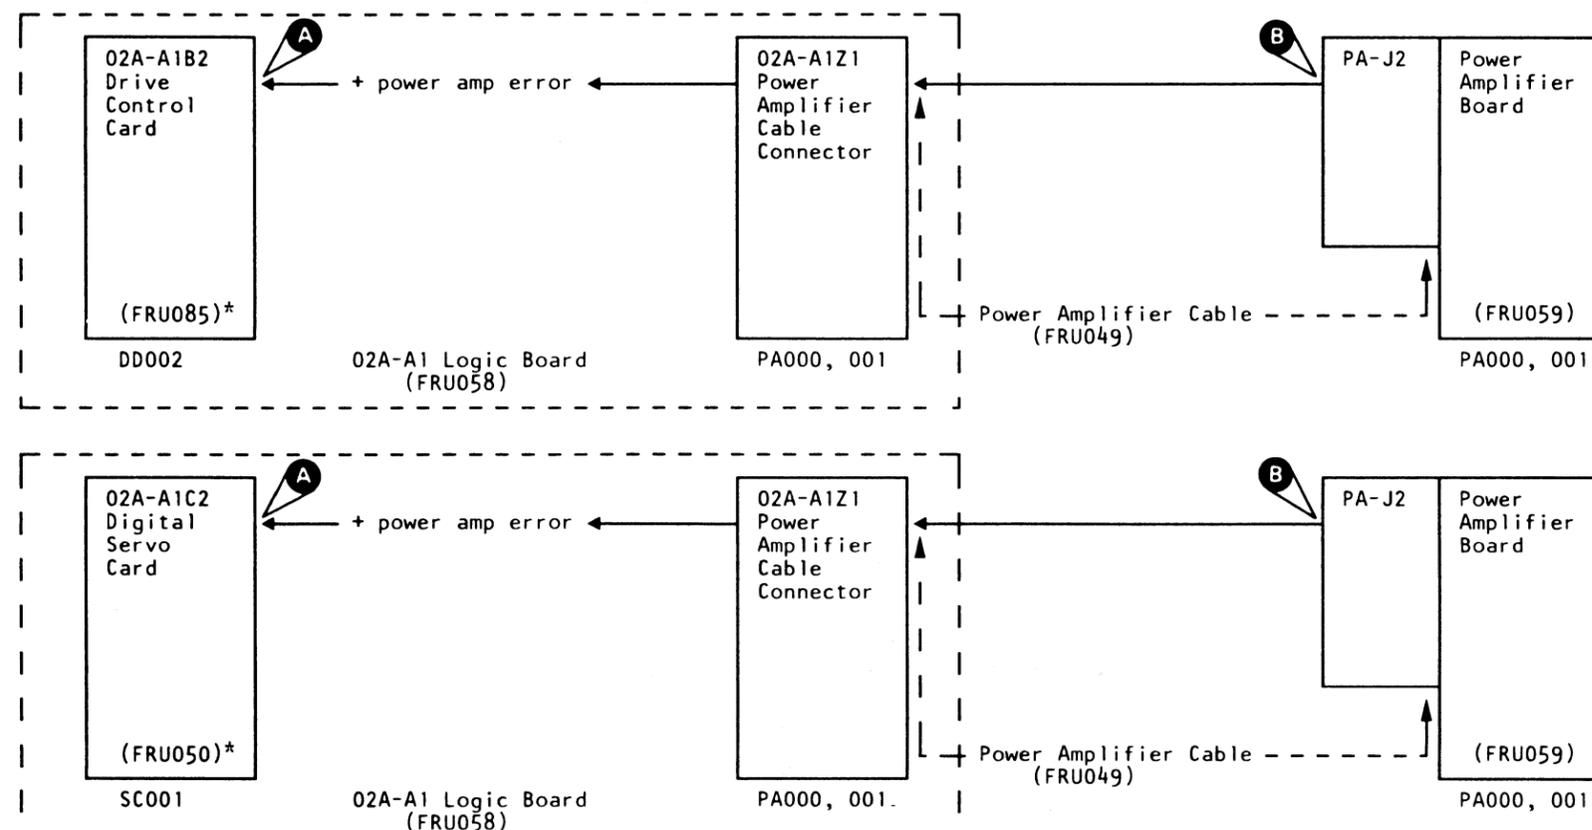
ERROR DIAGRAM

Point-to-point wiring on a board is shown on the CU and/or DRV net wire lists.

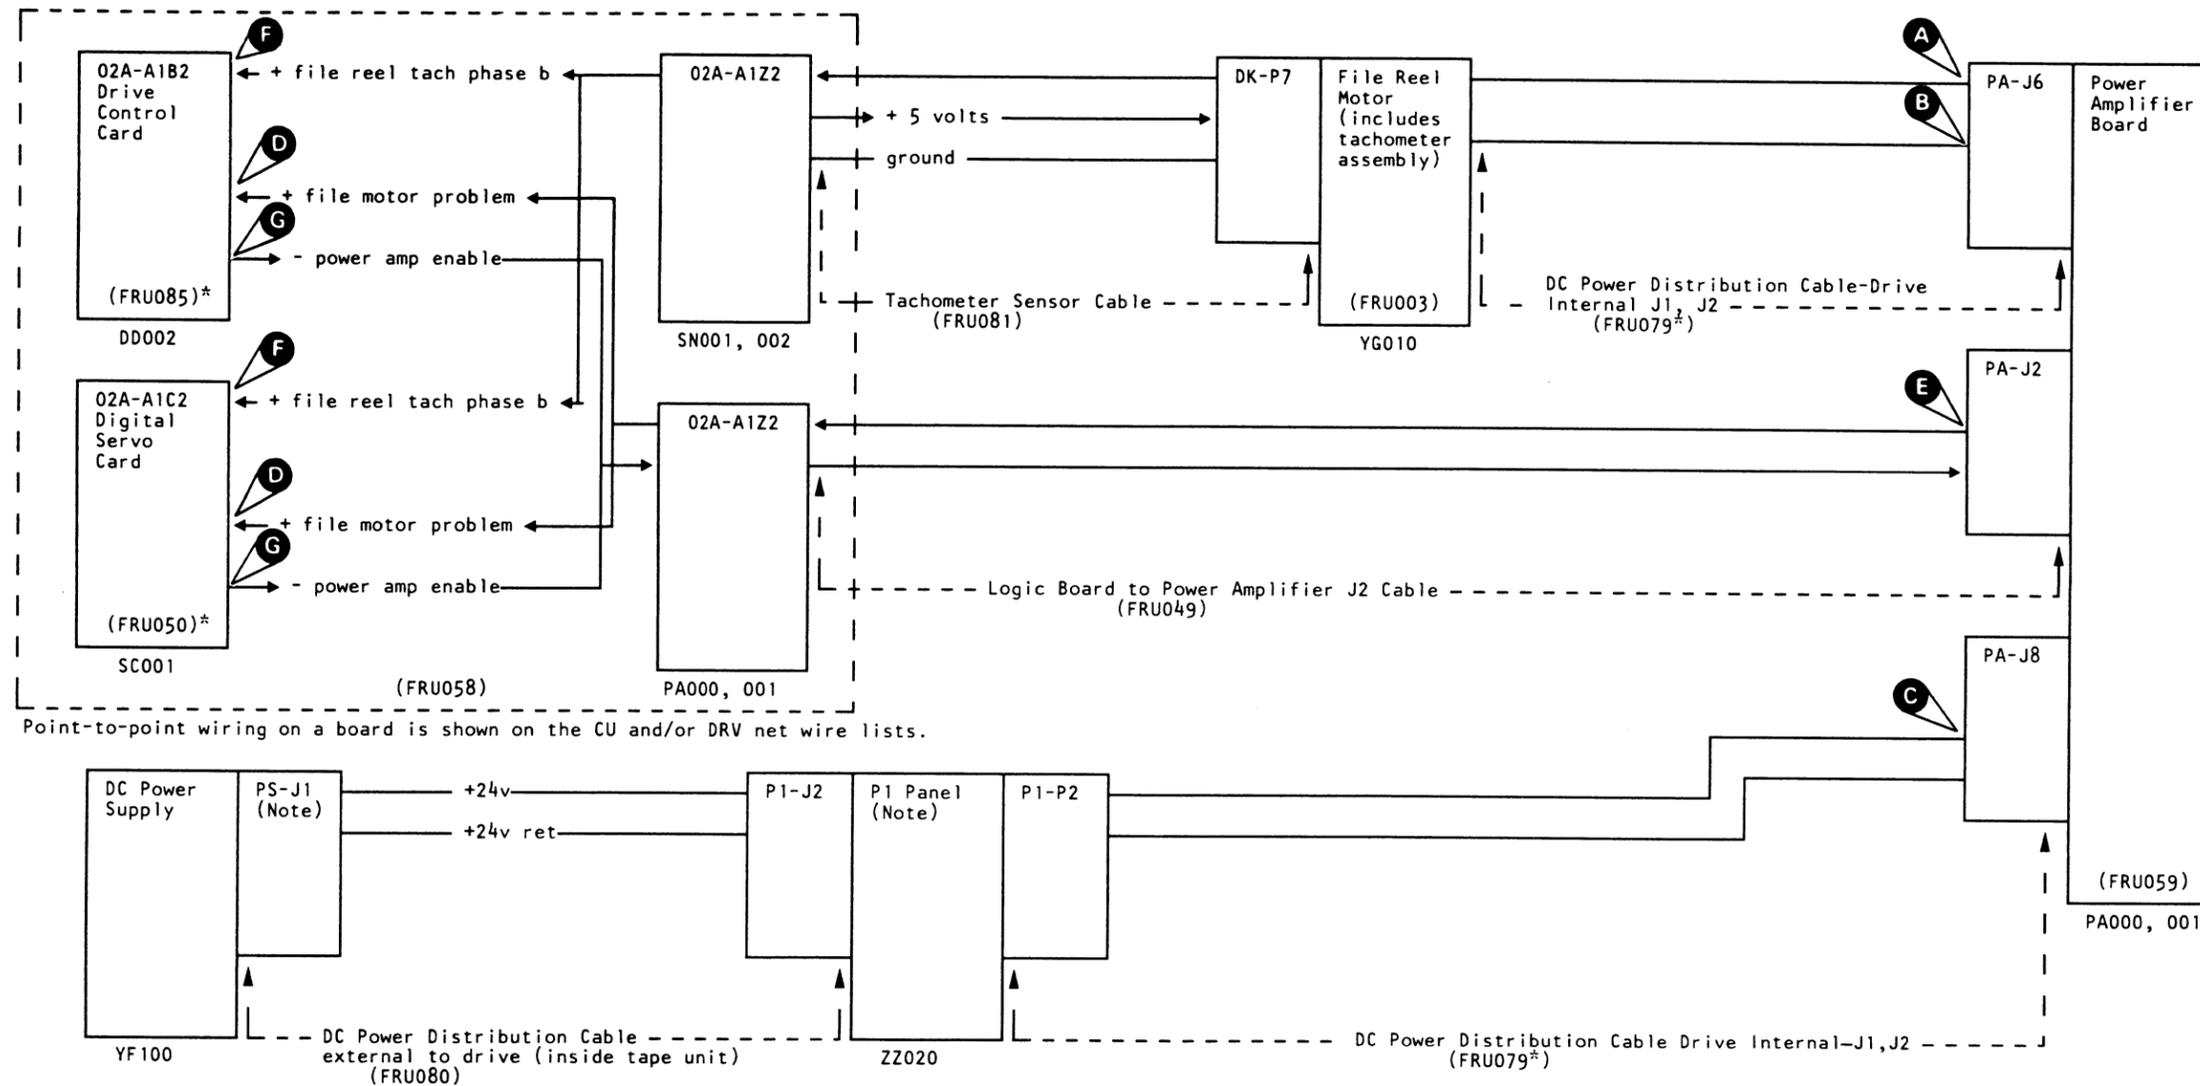
Error Diagram

Point-to-point wiring on a board is shown on the CU and/or DRV net wire lists.

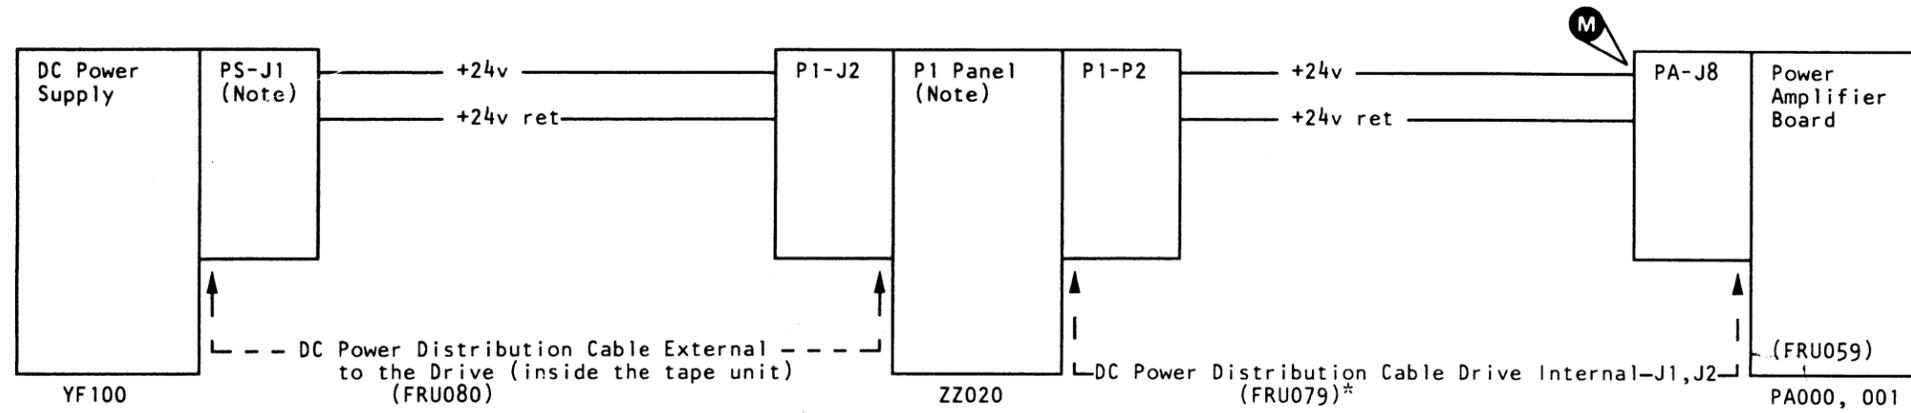
Error Diagram 2

Note: The logic reference shown is for drive 0. Use the correct lines for a drive 1 failure.
