Collating List of Pages

This reference drawing contains the collating sequence, page side, and EC level of pages for *IBM 3480 Magnetic Tape Subsystem Maintenance Information Manual (MI) Volume A05, SY32-5061-13*.

PUBLICATIONS REFERENCE DRAWING

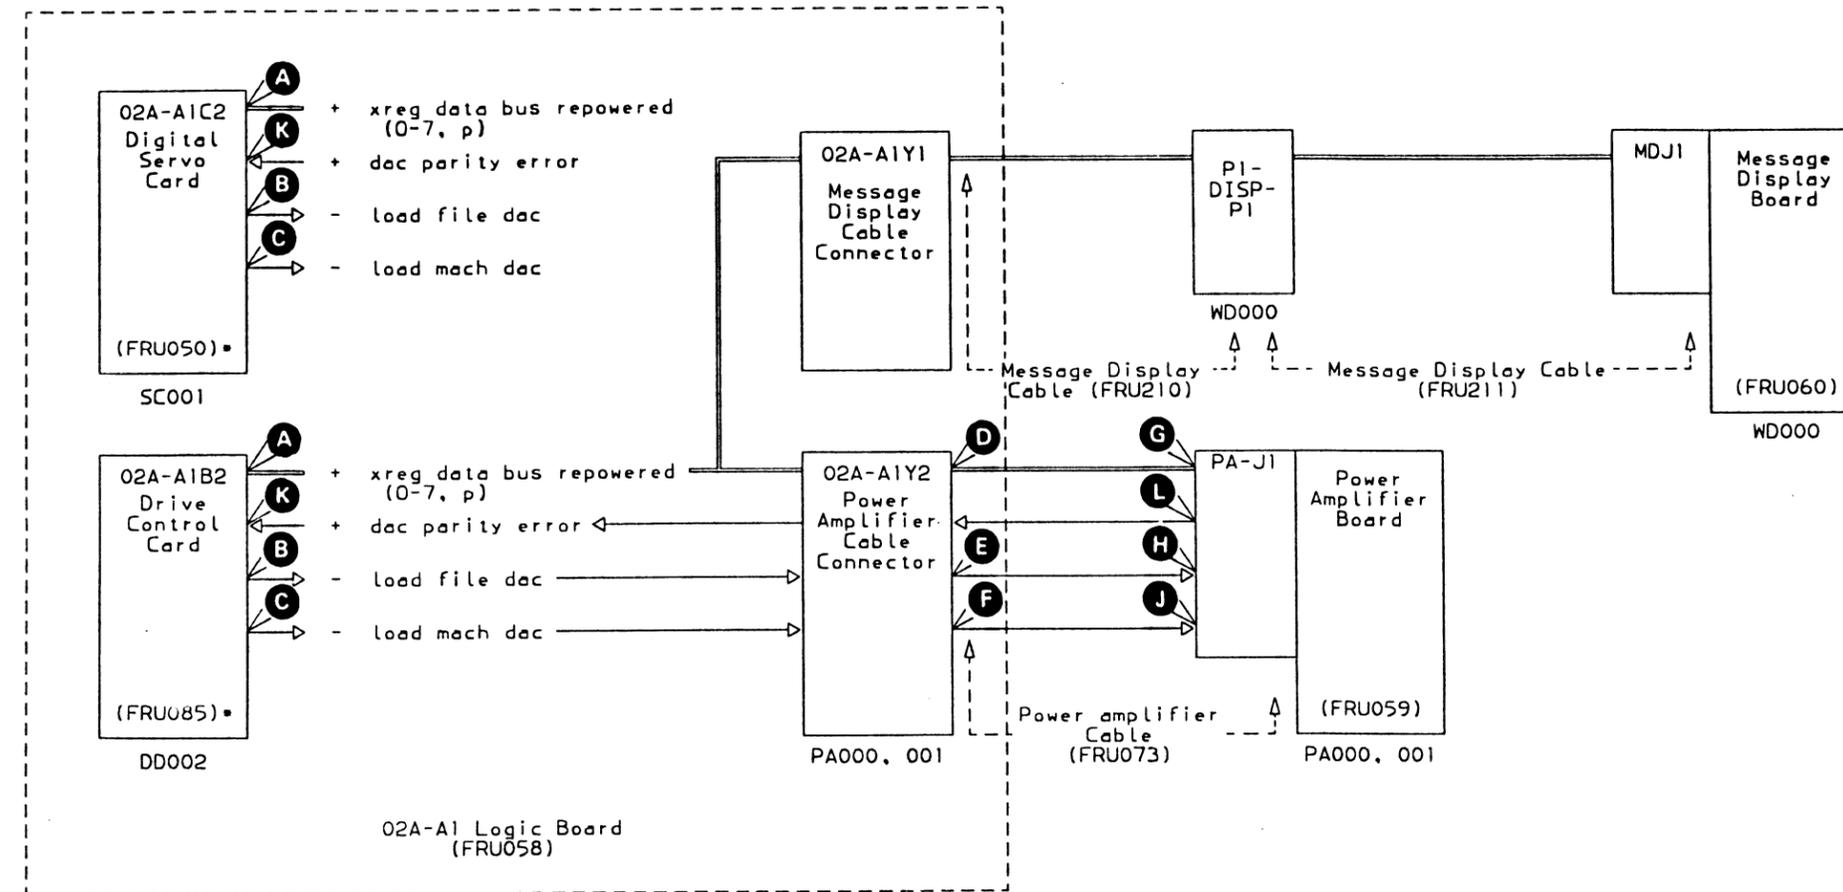
ERROR DIAGRAM

Point-to-point wiring on a board is shown on the CU and/or DRV net wire lists.

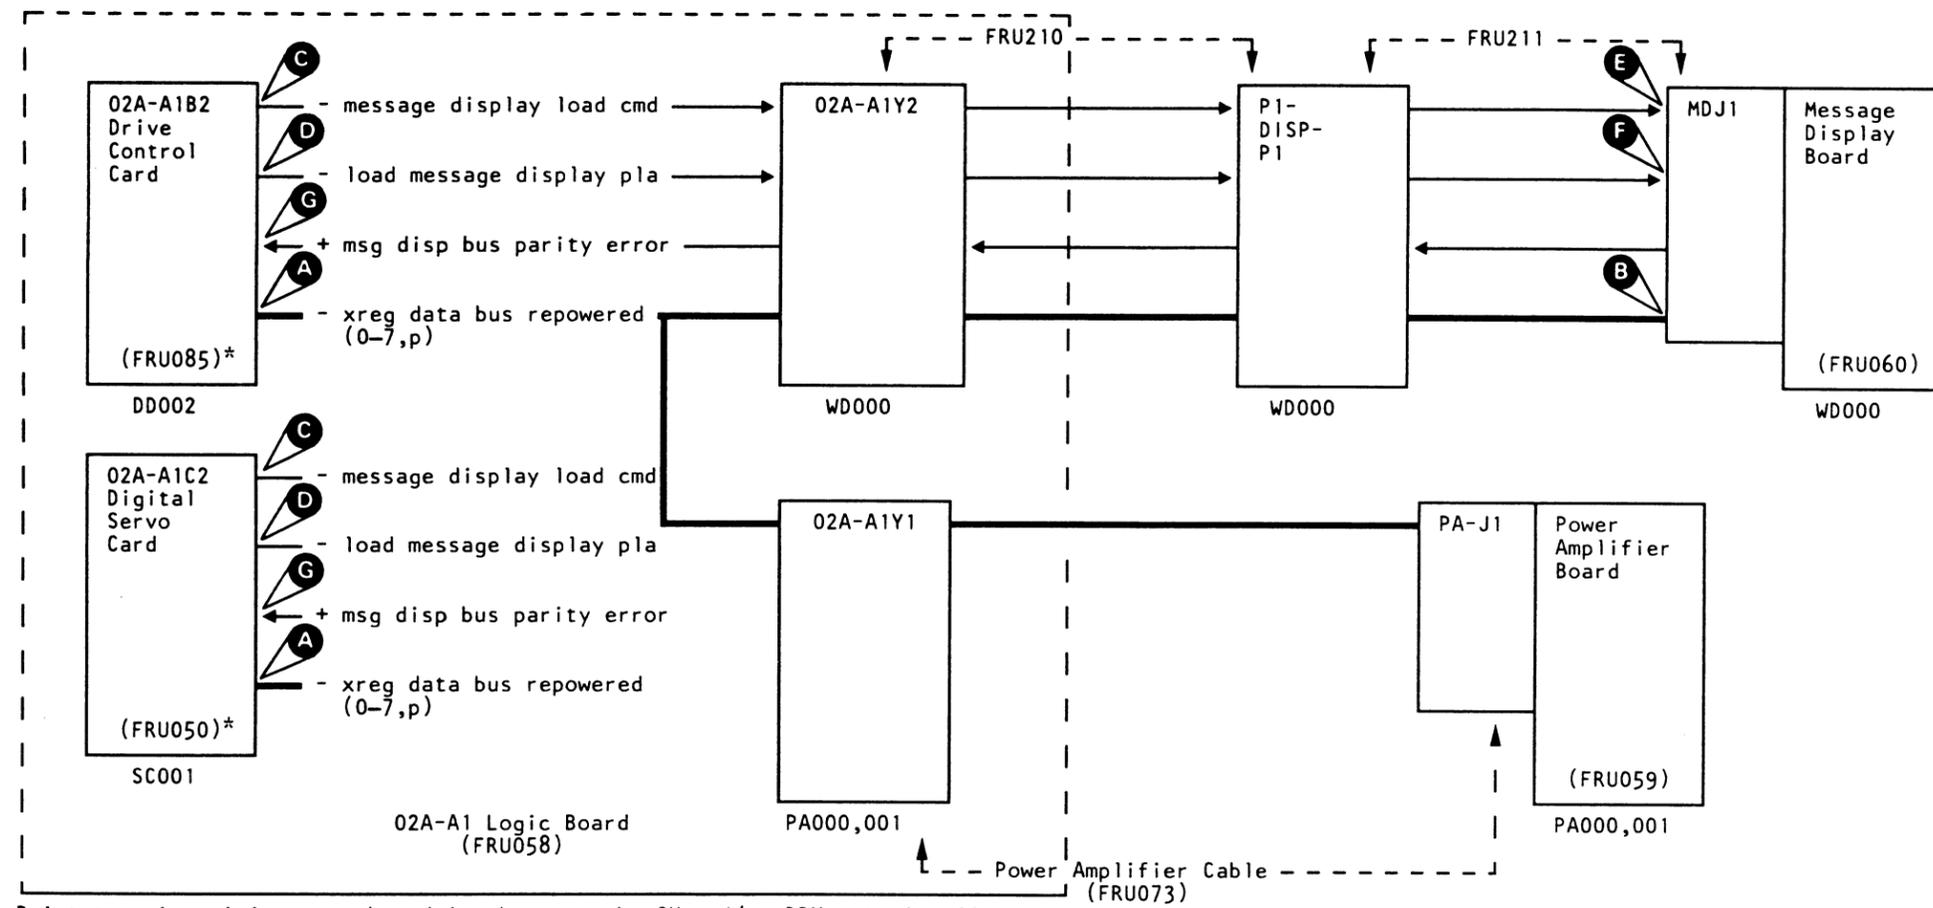
Error Diagram

Point-to-point wiring on a board is shown on the CU and/or DRV net wire lists.

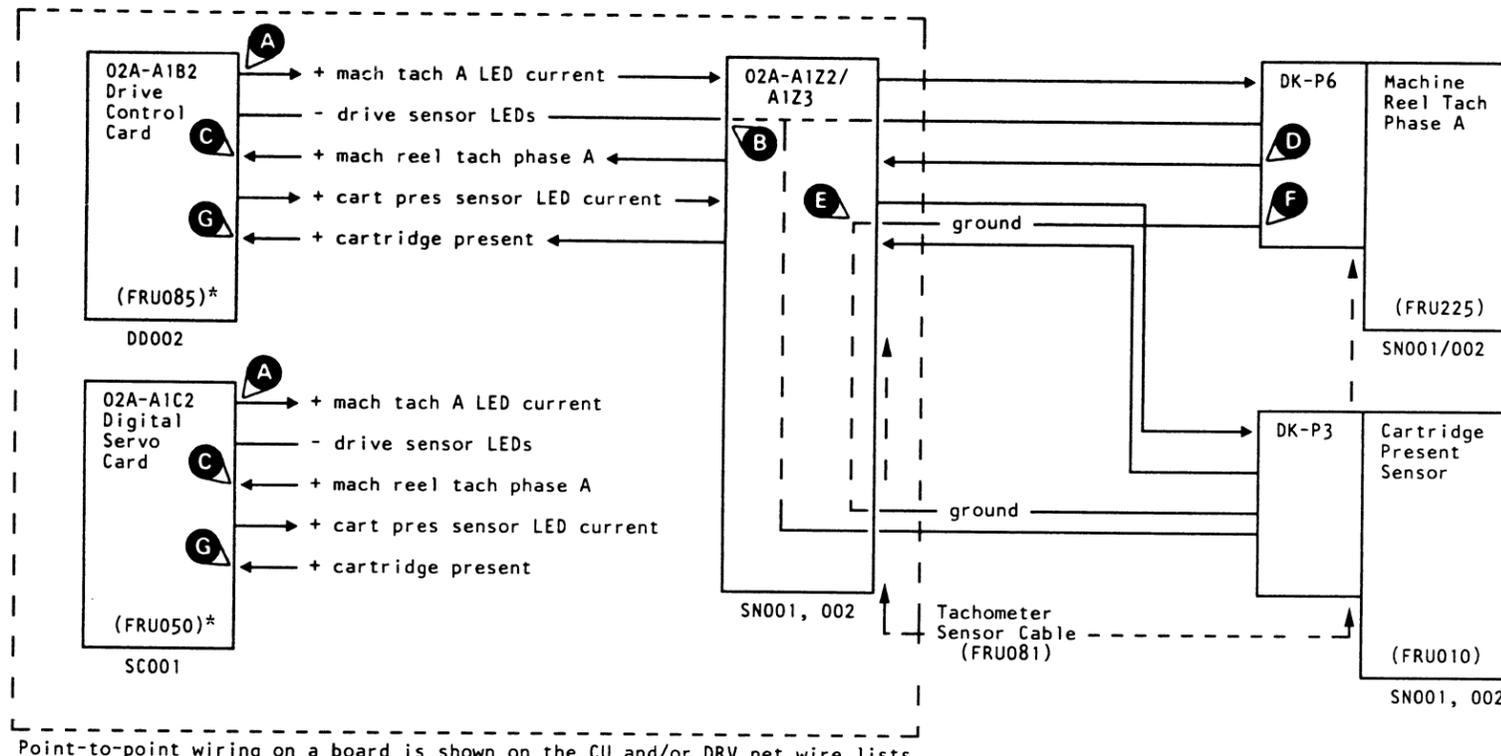
Error Diagram

Point-to-point wiring on a board is shown on the CU and/or DRV net wire lists.

Note: Point (A) Norm +1.4 volts to +2.2 volts
Fail +5.0 volts
Point (C) Light +0.4 volts
Dark +5.0 volts

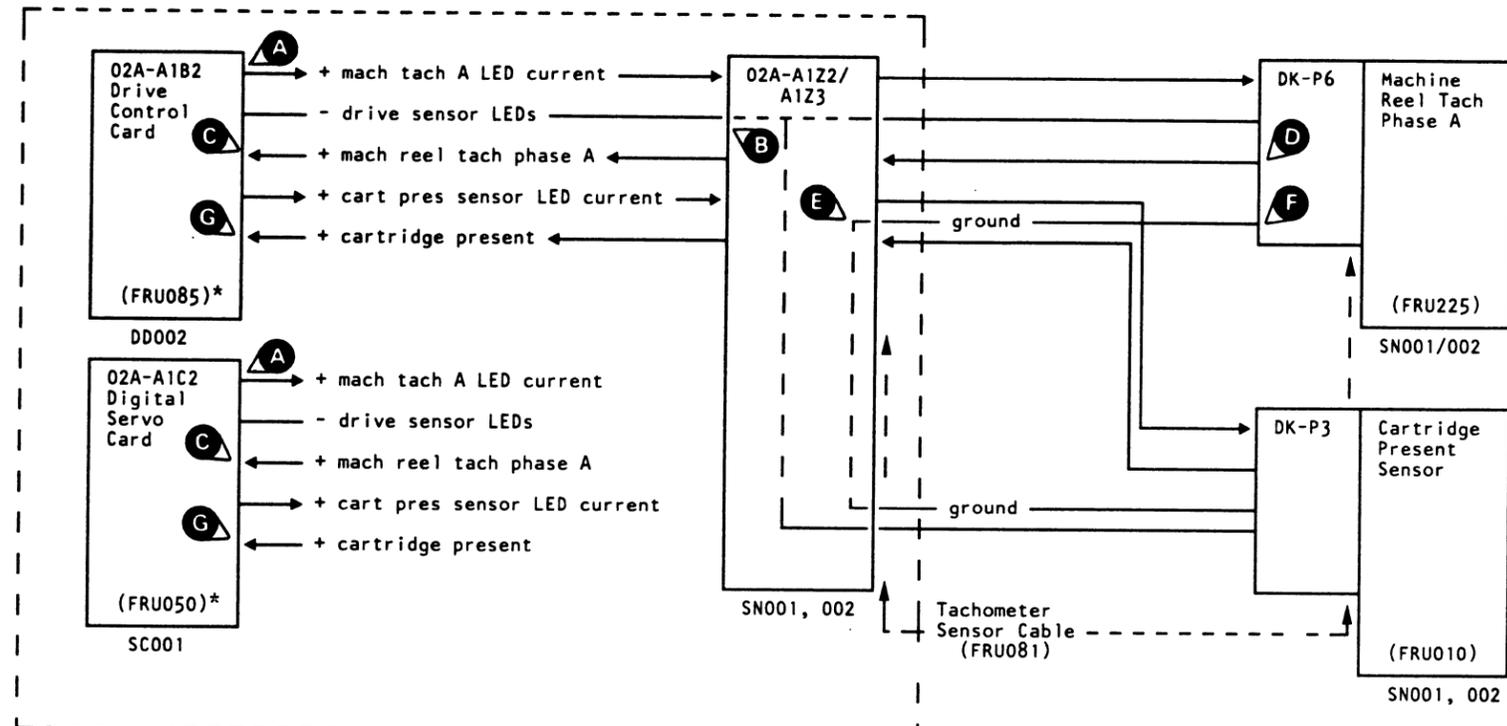
Error Diagram

Point-to-point wiring on a board is shown on the CU and/or DRV net wire lists.

Note: Point (A) Norm +1.4 volts to +2.2 volts
Fail +5.0 volts
Point (C) Light +0.4 volts
Dark +5.0 volts

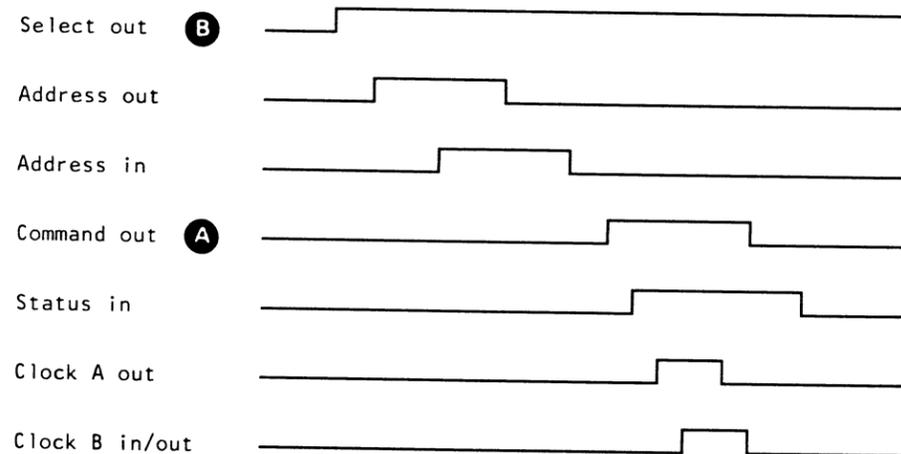
Error Diagram

See the control unit to drive cabling diagrams in the ALD volume of the maintenance information.

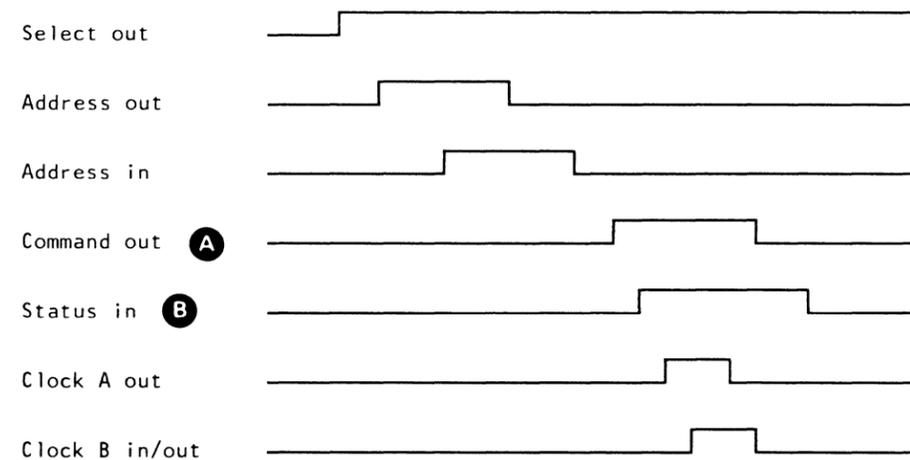
ERROR DIAGRAM

See the control unit to drive cabling diagrams in the ALD volume of the maintenance information.

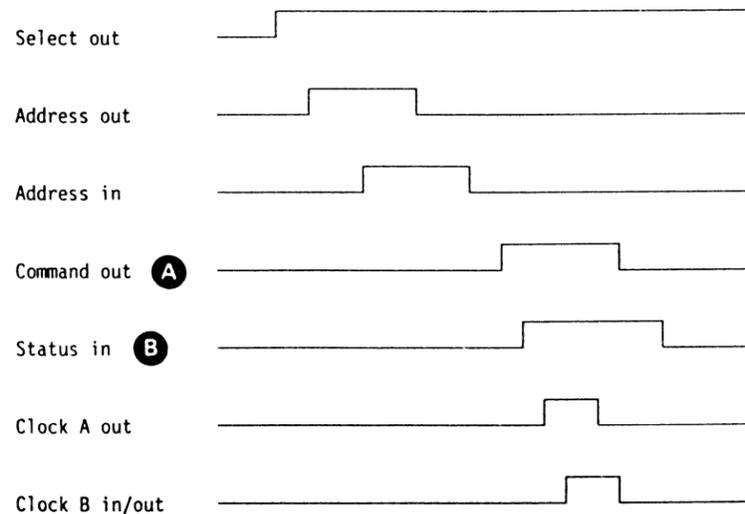
ERROR DIAGRAM

See the control unit to drive cabling diagrams in the ALD volume of the maintenance information.

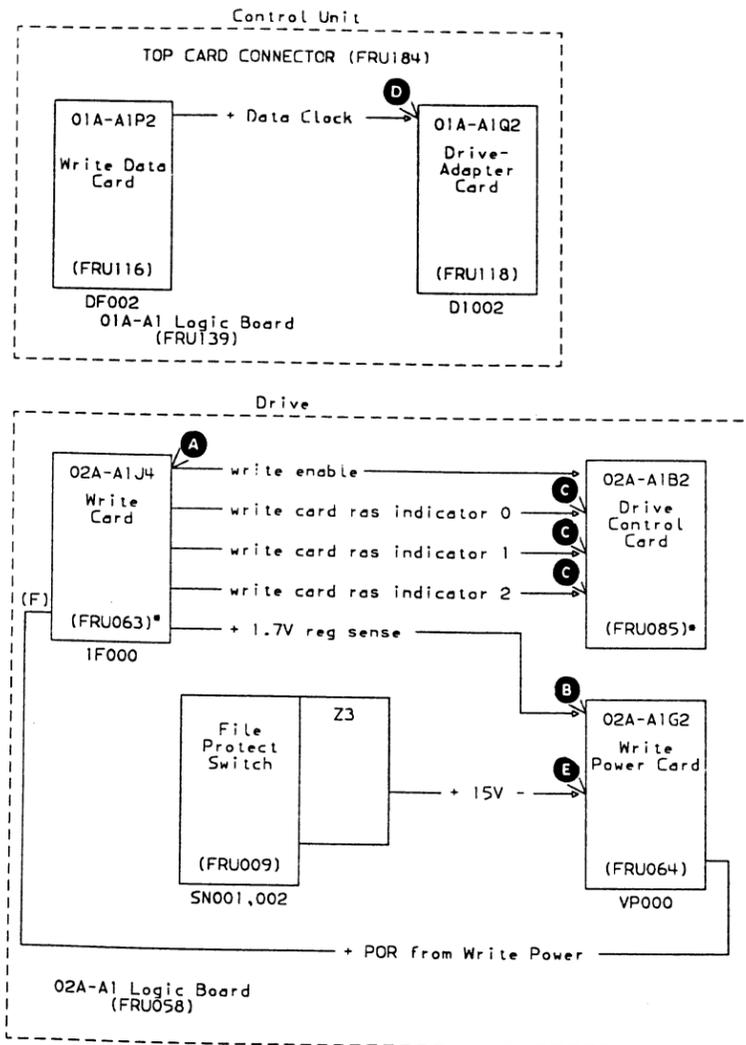
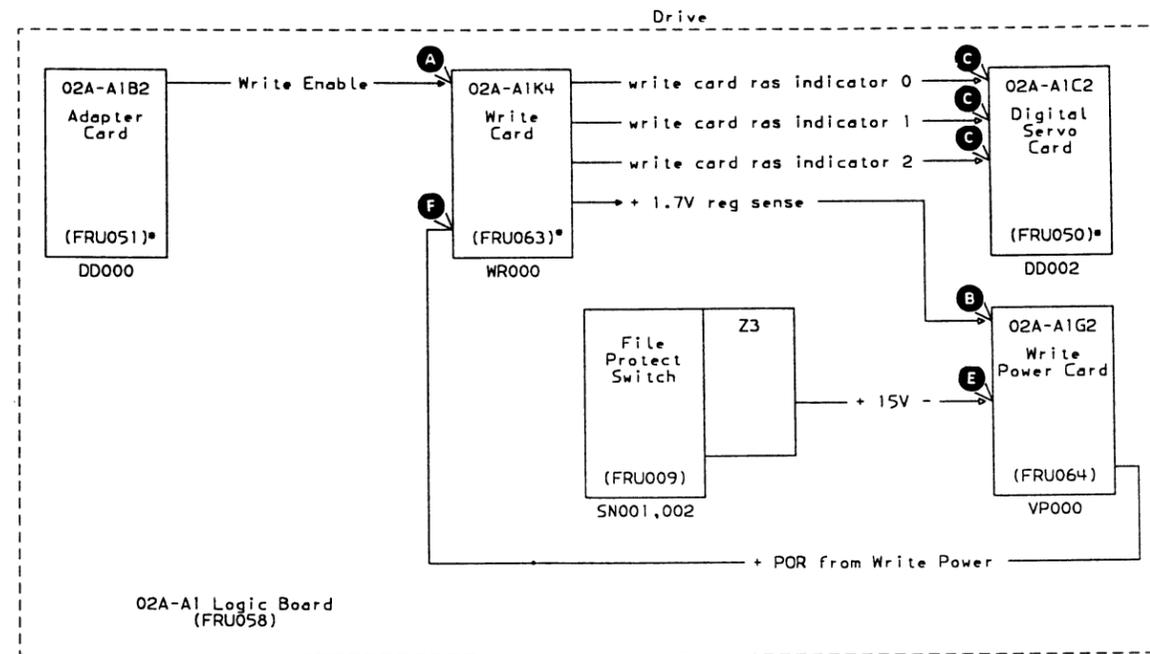
Error Diagram

WRITE CARD RAS INDICATOR	
BITS: 0,1,2	MEANING
111	Regulator Fault
110	Card Fault
101	Interconnection Fault
100	Open (Head/Cable) Fault
011	Phase Lock Loop Error
010	Parity Error
001	Write Valid
000	Default

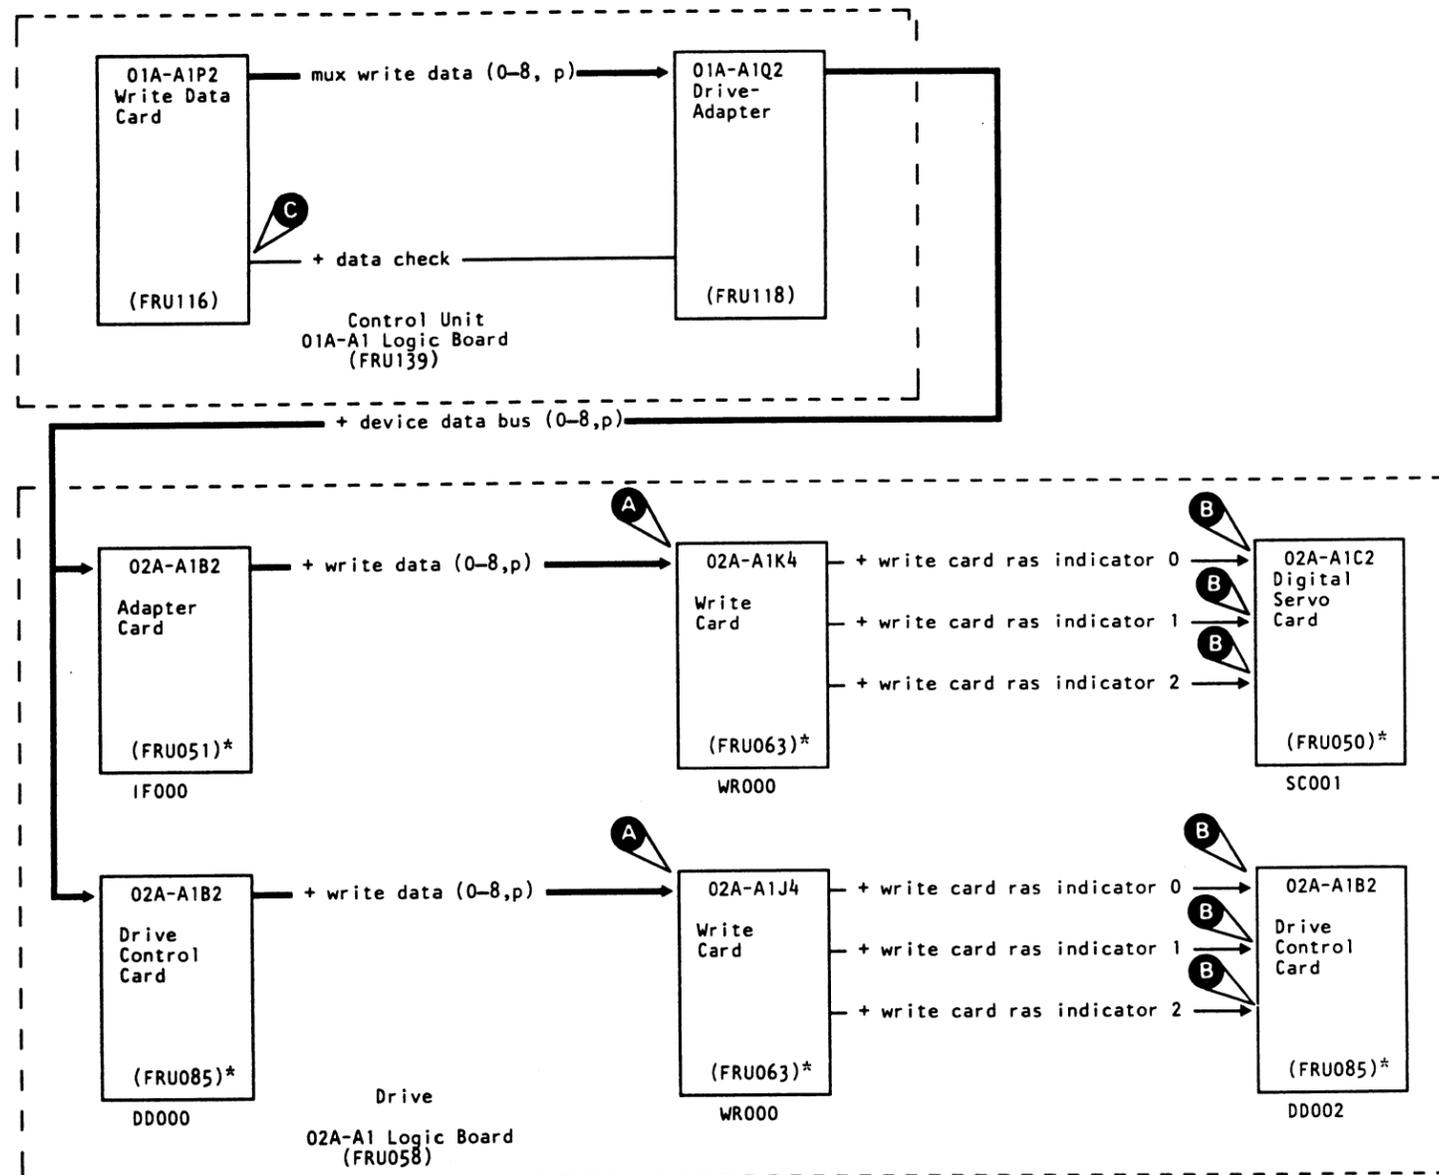
Error Diagram

Point-to-point wiring on a board is shown on the CU and/or DRV net wire lists.

WRITE CARD RAS INDICATOR	
BIT: 0,1,2	MEANING
000	Default
001	Write Valid
010	Parity Error
011	Phase Lock Loop Error
100	Open (Head/Cable) Fault
101	Interconnection Fault
110	Card Fault
111	Regulator Fault

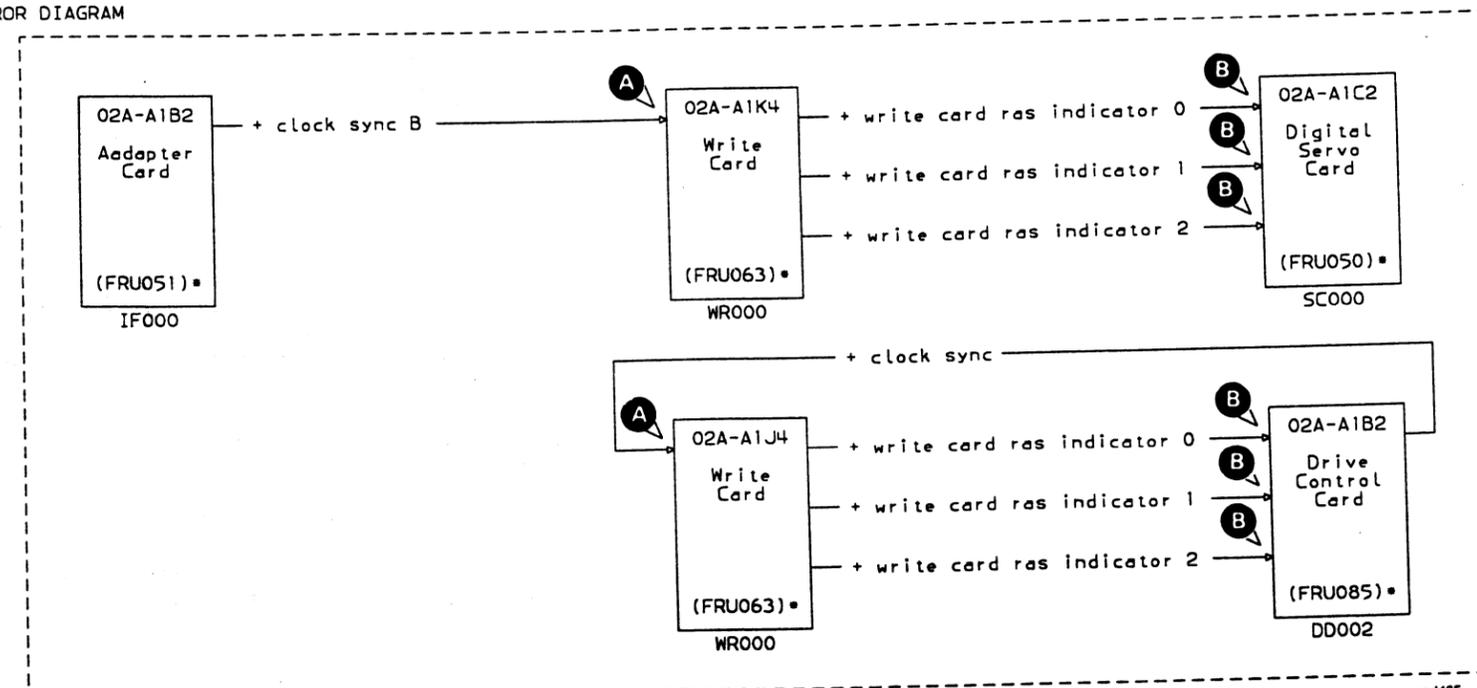
ERROR DIAGRAM

Point-to-point wiring on a board is shown on the CU and/or DRV net wire lists.

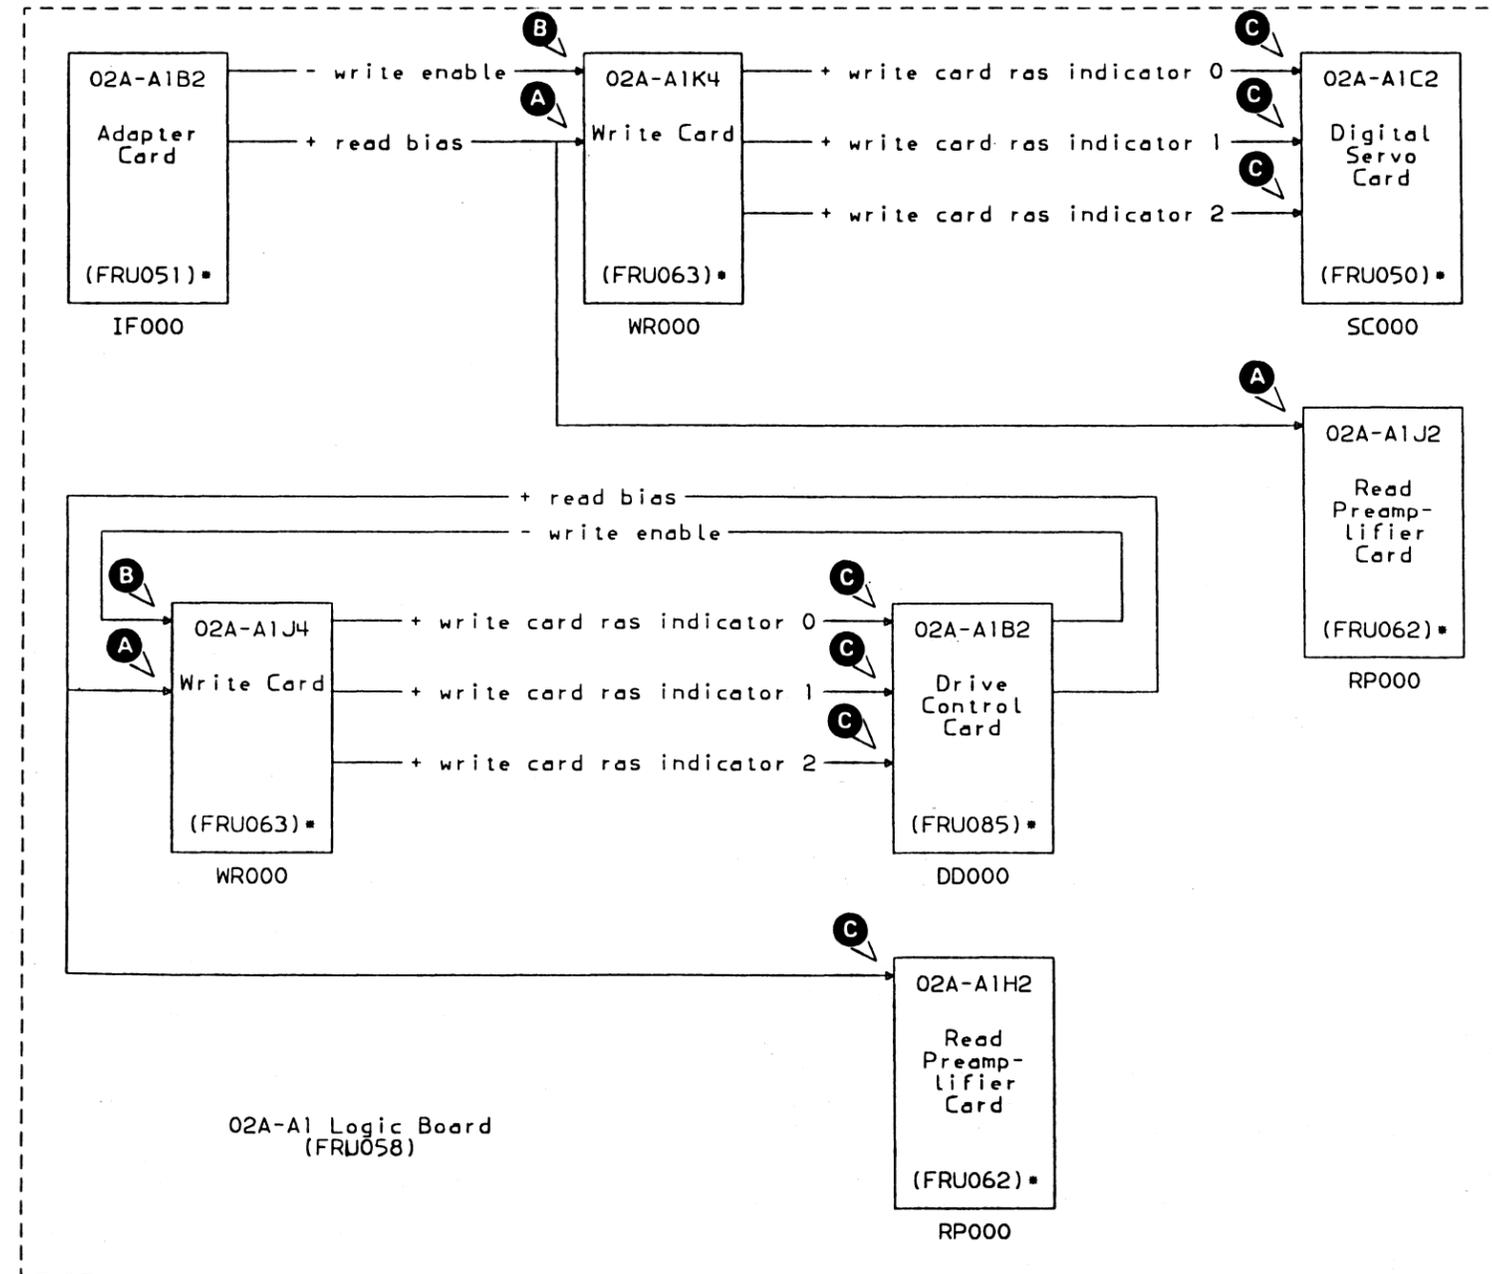
Error Diagram

Point to point wiring on a board is shown on the CU and/or DRV net wire lists.

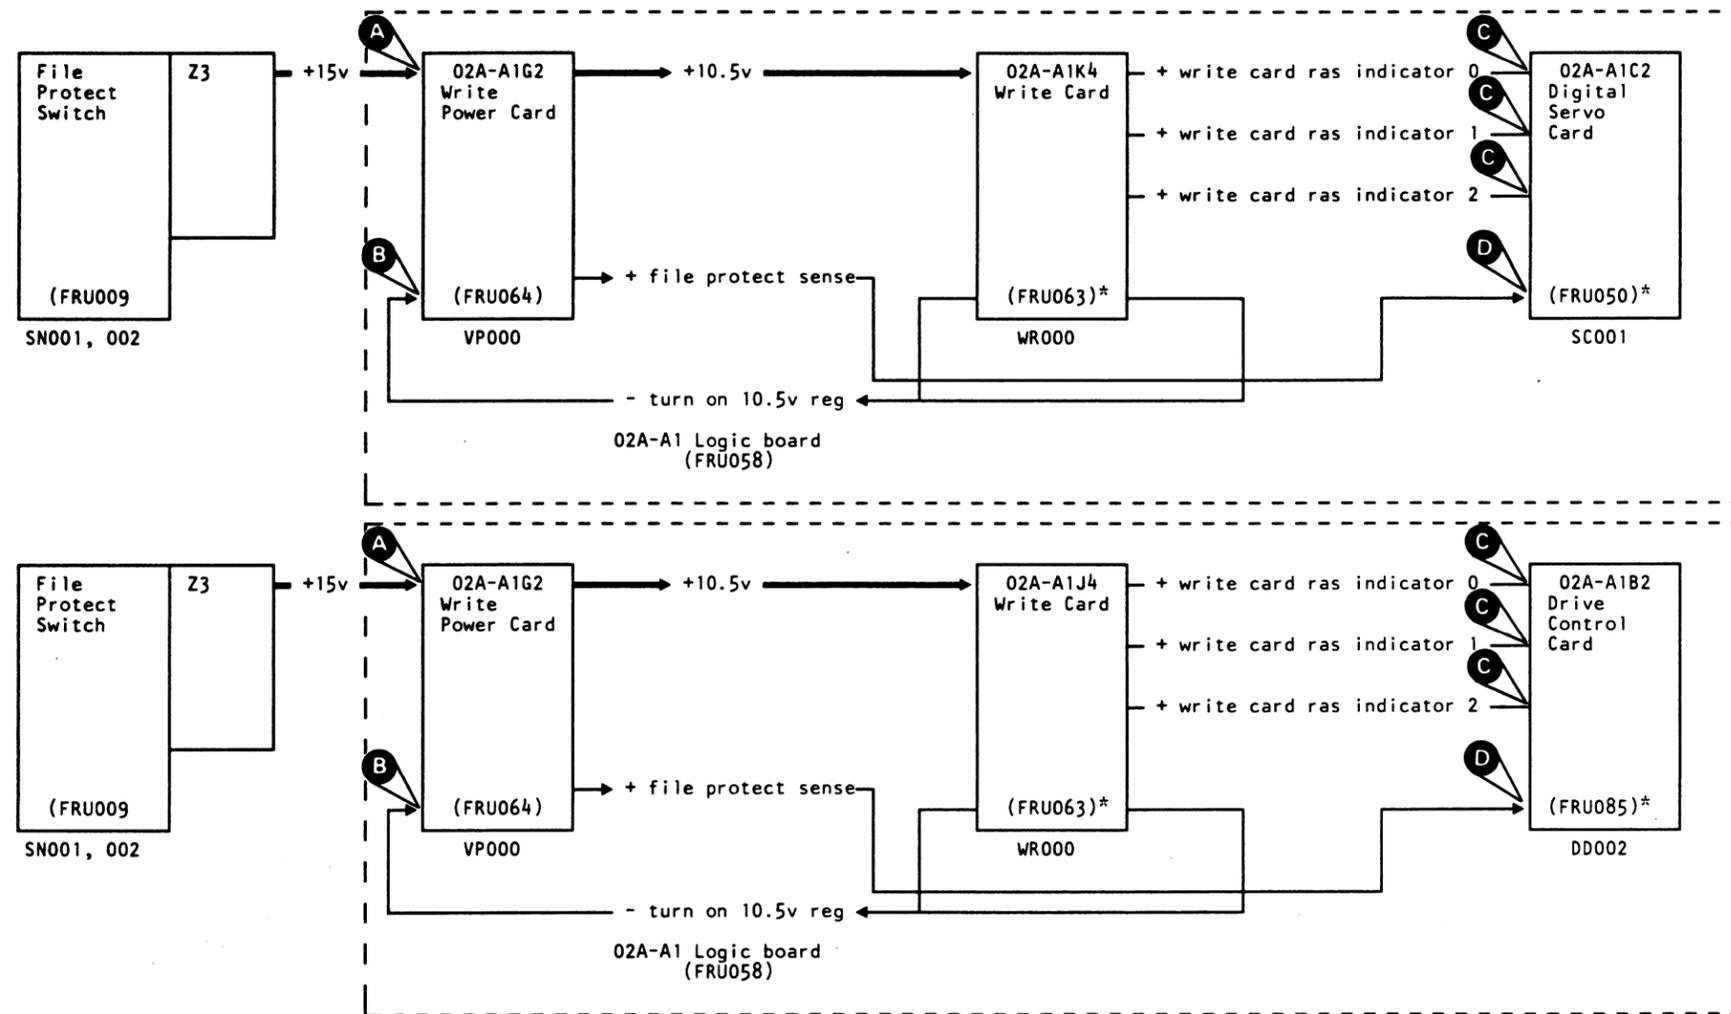
Error Diagram

WRITE CARD RAS INDICATOR	
BITS: 0,1,2	MEANING
000	Default
001	Write Valid
010	Parity Error
011	Phase Lock Loop Error
100	Open (Head/Cable) Fault
101	Interconnection Fault
110	Card Fault
111	Regulator Fault

Point-to-point wiring on a board is shown on the CU and/or DRV net wire lists.

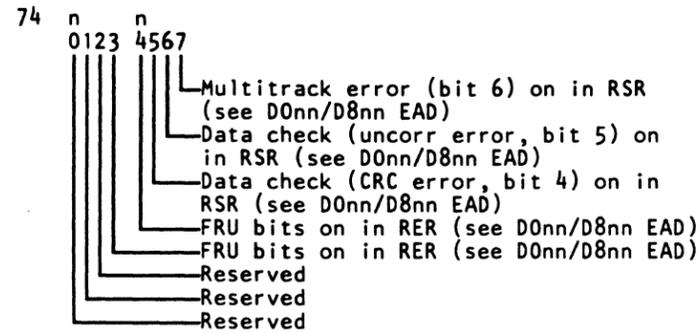
At the end of a write data record operation, the write data flow logic writes pad characters (if needed) to complete the 71 data frames and then writes two sync characters (end sync). The postamble is then written.

The read data flow cards detect the end sync pattern as an indication of the end of a data record. The read data flow is the same for detecting begin sync, resync, and end sync. A failure to detect end sync is most likely an indication that end sync was not written.

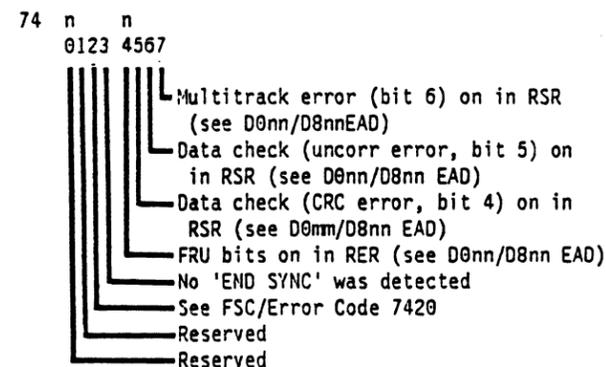
At the end of a write data record operation, the write data flow logic writes pad characters (if needed) to complete the 71 data frames and then writes two sync characters (end sync). The postamble is then written.

The read data flow cards detect the end sync pattern as an indication of the end of a data record. The read data flow is the same for detecting begin sync, resync, and end sync. A failure to detect end sync is most likely an indication that end sync was not written.

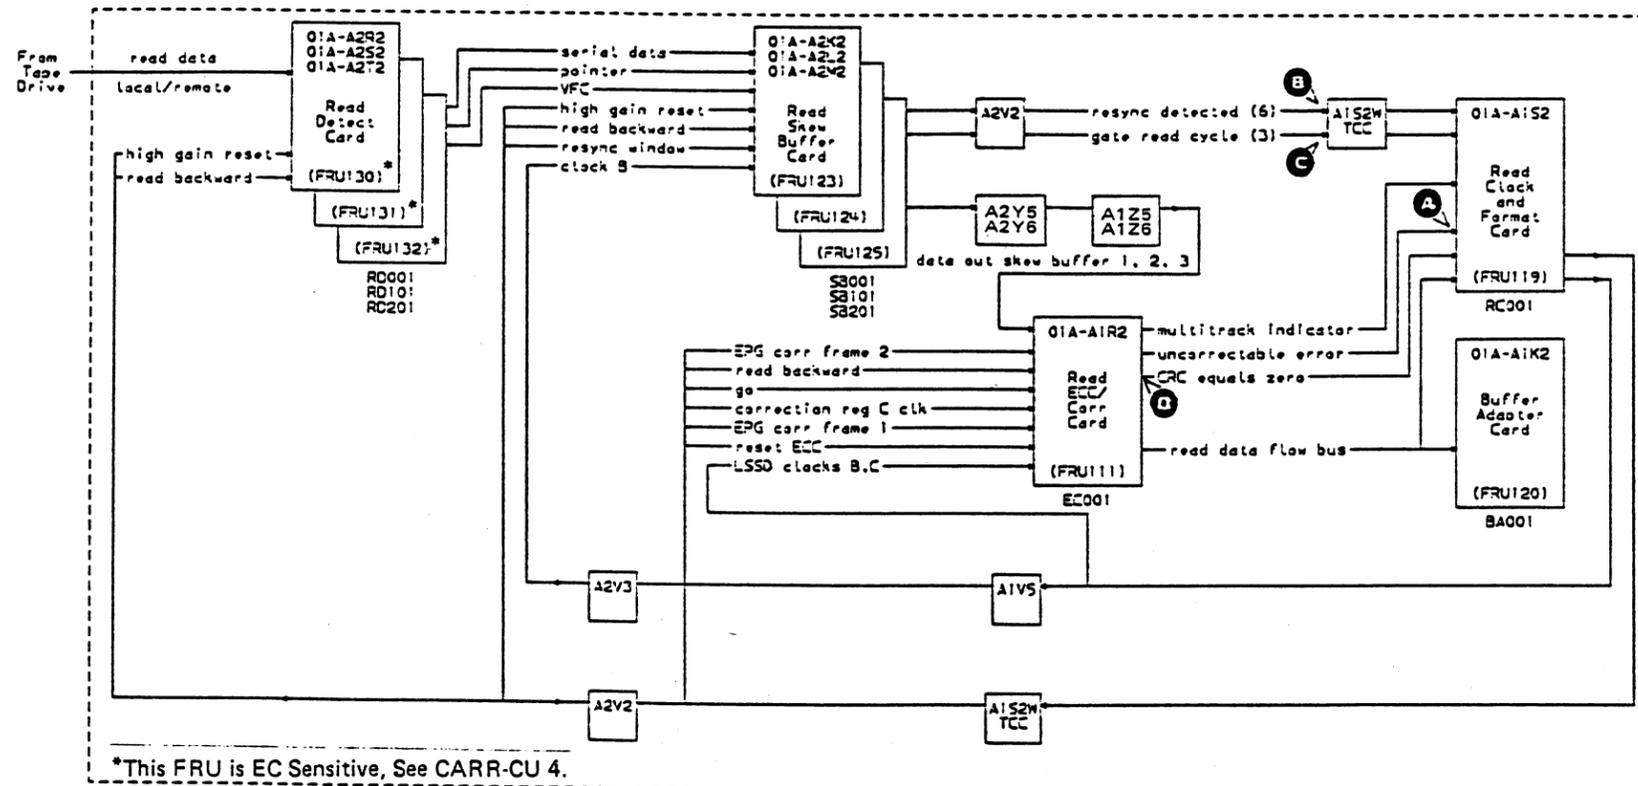
NET	LINE NAME	ERROR CODE	DIAGNOSTIC
\$ECRDFBUS (0-9,P)	+Read Data Flow Bus	D001	EEA0
\$RBUS1A1-9B	+/-Read Data Local/Remote	D005	EEA0
\$RDVFT01-T18	+VFC Trk 1A-9B	D001	EEA0
\$RSDAT01-T18	-Serial Data TRK 1A-9B	D001	EEA0
\$RDPNTR01-18	-Pointer Trk 1A-9B	D001	EEA0
\$CLK01TP-18TP	-Clock Test Point	D001	EEA0
\$VCO01TP-18TP	+Memory Voltage Test Point	D001	EEA0
\$SS01TP-18TP	+Single Shot Test Point	D001	EEA0
\$RCRSTECC	+Reset ECC	D007	EEA0, EE50
\$RCCREGCK	+Correction Reg C Clock	D001	EEA0, EE50
\$RCGO	+Go	D001	EEA0, EE50
\$ECCRCZRO	+CRC Equals Zero	D001	EEA0, EE50
\$RCEPGCF1	+EPG Completion Frame 1	D004	EEA0
\$RCEPGCF2	+EPG Completion Frame 2	D004	EEA0
\$RCBCCC00	+Backward Clock Control	D005	EEA0
\$RCRCKD00	-Read Backward	D007	EEA0, EE50
\$RCCLK00	-Demodulator Gate C	D003	EEA0, EE50
\$ECUNCERR	-Uncorrectable Error	D004	EEA0, EE50
\$ECMULTRK	-Multitrack Indicator	D002	EEA0, EE50
\$RCRSYW00	-Resync Window	D004	EEA0, EE50

See the control unit logic for pin numbering and detail net information.

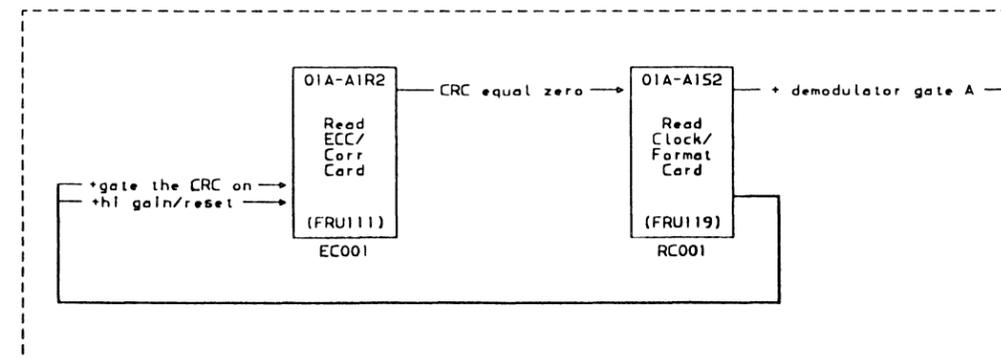
Error Diagram for RER Bit 4

See the control unit logic for pin numbering and detail net information.

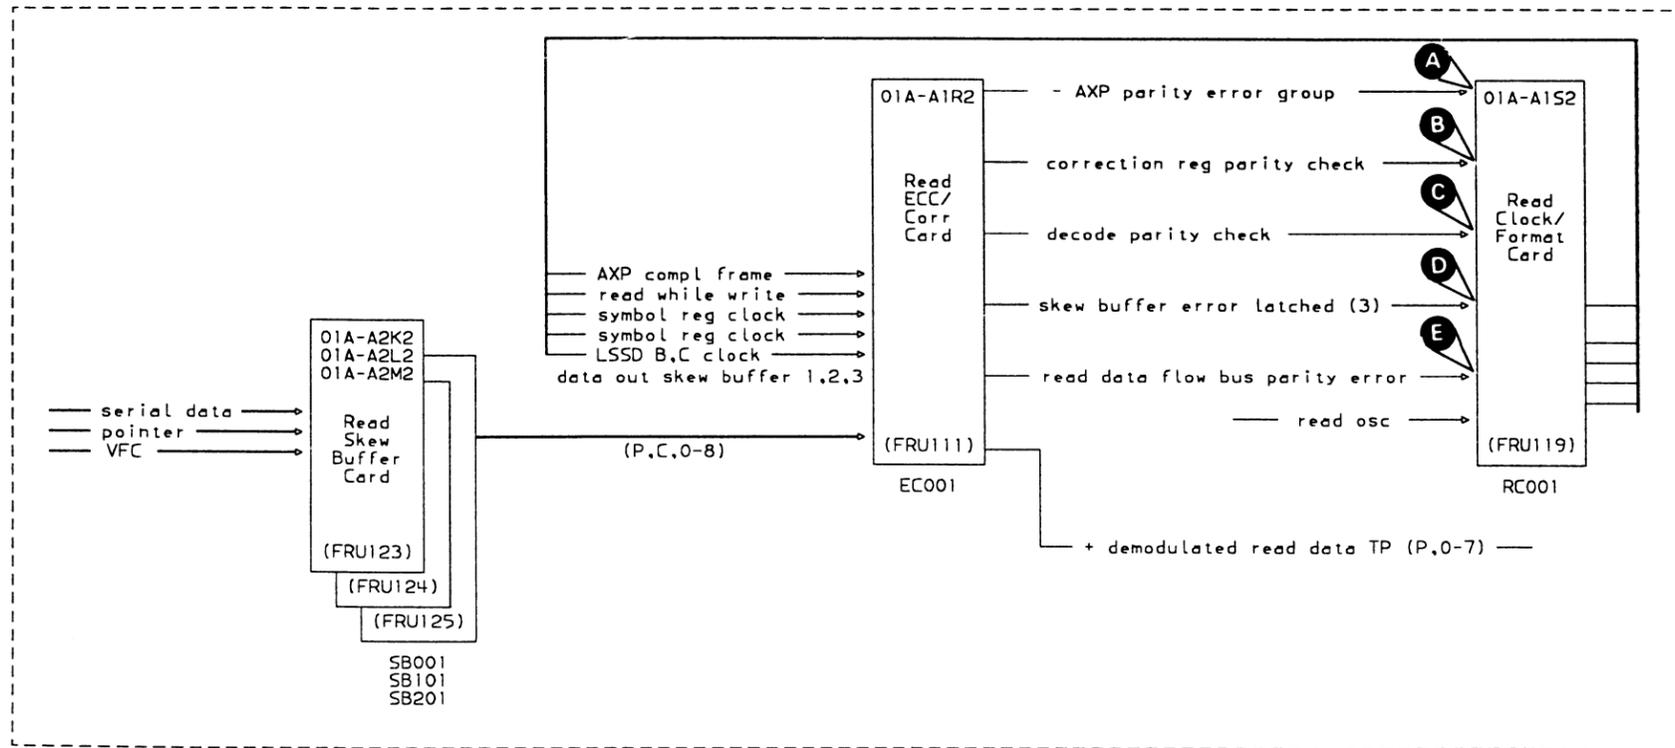
Error Diagram for RER Bit 5

See the control unit logic for pin numbering and detail net information.

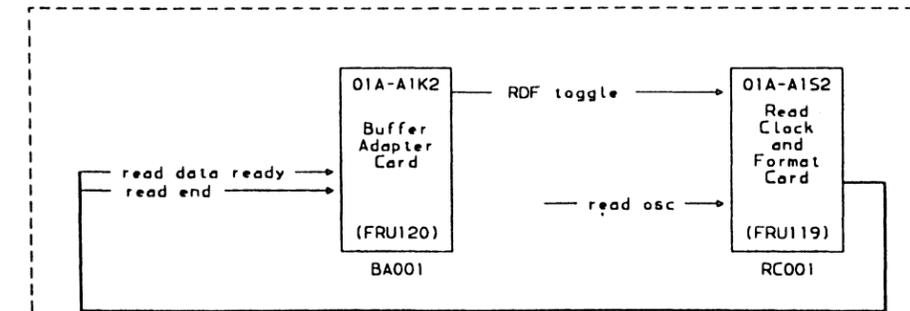
Error Diagram for RER Bit 6

See the control unit logic for pin numbering and detail net information.

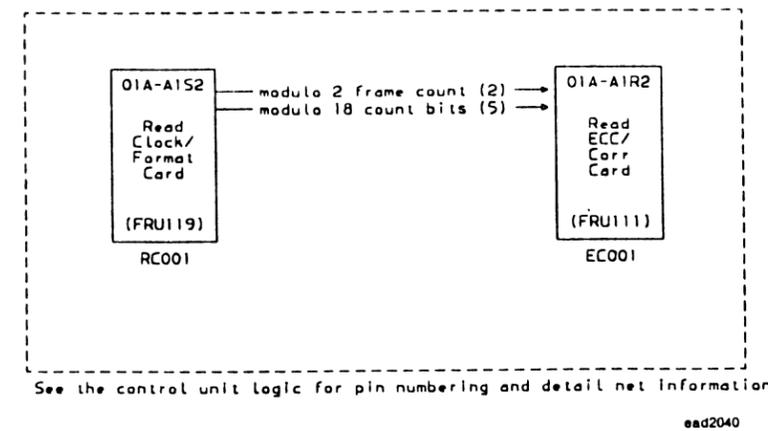
Error Diagram for RER Bit 7

Net List for RER Bit 7

EAD test points for hardware detected error code D801

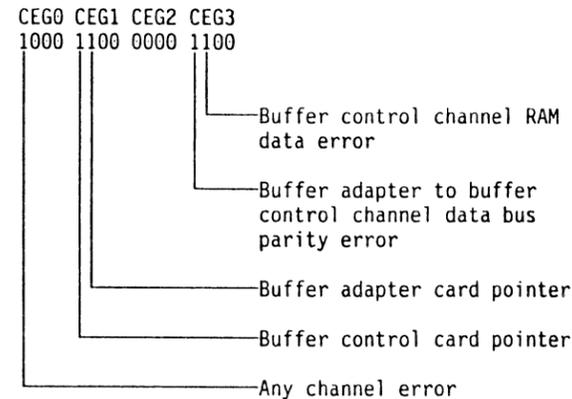
As an example, assume that we have CEG values 8C0C. The CEG bit values are:

- a. Start with bit 1 of CEG0. (Bit 0 of CEG0 should always be on. If it isn't, go to the troubleshooting procedure for CEG0 bit 0.)
- b. Take the bits in CEG0 in order from bit 1 to bit 3. Troubleshoot for the first bit that is a 1.
- c. If no bits (other than bit 0) in CEG0 are 1 or if troubleshooting the bits in CEG0 did not locate the trouble, go to CEG2. (CEG1 is a FRU pointer. Use the bits from CEG1 to determine which FRU to suspect.)

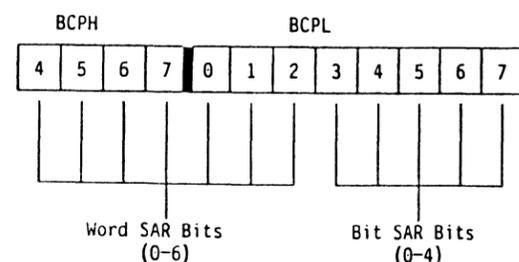
This bit indicates that a miss-compare occurred between the buffer storage address parity generated by the buffer control card and the address parity received by the buffer storage cards during a channel storage cycle. The parity of the buffer storage address received by the buffer storage cards is sent back to the buffer control card and compared there. Address parity is checked for channel storage data access cycles only. Address parity is generated from bits 4-7 of the buffer channel pointer high (BCPH) external register and bits 0-7 of the buffer channel pointer low (BCPL) external register as follows.

Word-SAR bits and bit-SAR bits are combined and parity is generated to give the address parity.

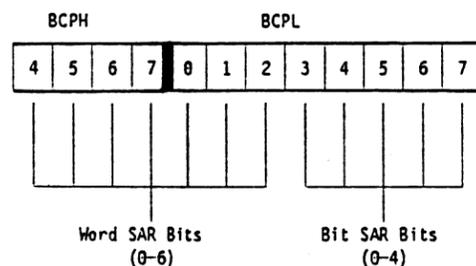
This bit indicates that a miss-compare occurred between the buffer storage address parity generated by the buffer control card and the address parity received by the buffer storage cards during a channel storage cycle. The parity of the buffer storage address received by the buffer storage cards is sent back to the buffer control card and compared there. Address parity is checked for channel storage data access cycles only. Address parity is generated from bits 4-7 of the buffer channel pointer high (BCPH) external register and bits 0-7 of the buffer channel pointer low (BCPL) external register as follows.

Word-SAR bits and bit-SAR bits are combined and parity is generated to give the address parity.

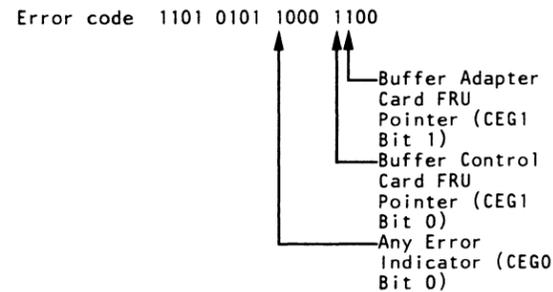
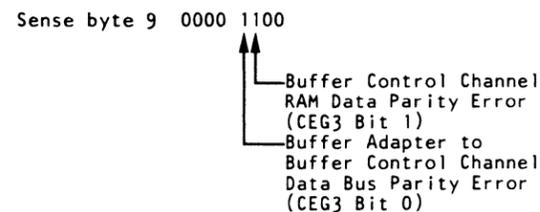
Example 1

Assume that the error code is D58C and sense byte 9 is 0C

This indicates that the buffer control card received data with bad parity from the buffer adapter card over the channel data bus. The incorrect data propagated through the buffer control card logic and was loaded into the RAM. The failure is either in the buffer adapter card, the channel data bus, the control lines from the buffer adapter card to the buffer control card, or the logic on the control card that precedes the checker for the buffer adapter to buffer control channel data bus parity error. Return to the error detection theory and troubleshooting guide for "CEG3 bit 0, Buffer Adapter to Buffer Control Channel Data Bus Parity Error."

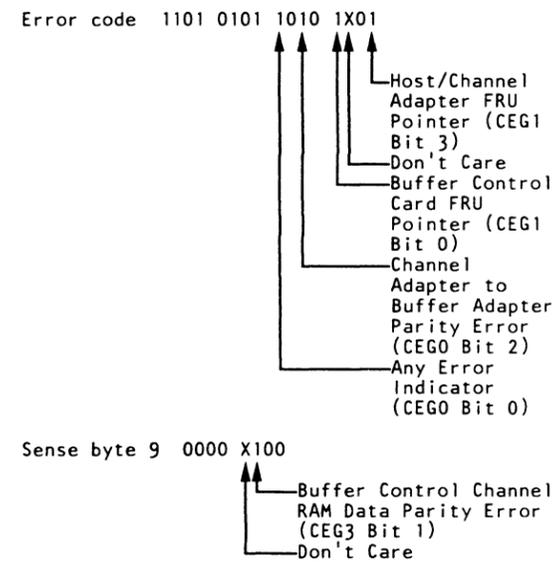
Example 2

Assume an error code of D5A9 or D5AD and sense byte 9 of 04 or 0C.

This indicates that the buffer adapter card received data with bad parity from the channel adapter over either the local or remote buffer data bus. The error data propagated through the buffer adapter card and the buffer control card logic and was loaded into the RAM. Return to the error detection theory and troubleshooting guide for "CEGO Bit 2, Channel Adapter to Buffer Adapter Parity Error."

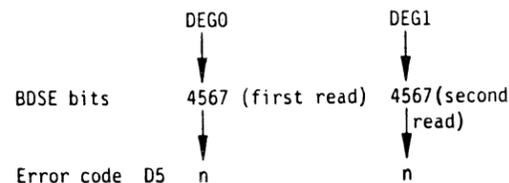
When an error is detected, the microcode reads the BDSE register which includes DEG0 in bits 4 through 7. Then the microcode sets bit 3 of the BDSE register to signal that the other DEG registers must be read. When BDSE bit 3 is on, each read of the BDSE advances a pointer to cause the next DEG to be read out. If bit 3 of the BDSE is not on, the DEG pointer does not advance, and DEG0 is read for each read of the BDSE. The data read out of the DEG registers is stored, and the microcode uses it to build sense data and the D6nn error code. DEG2 and DEG3 are stored in sense byte 9, and DEG0 and DEG1 are used to build the error code as follows.

DEG0 and DEG1 are also stored in sense byte 17.

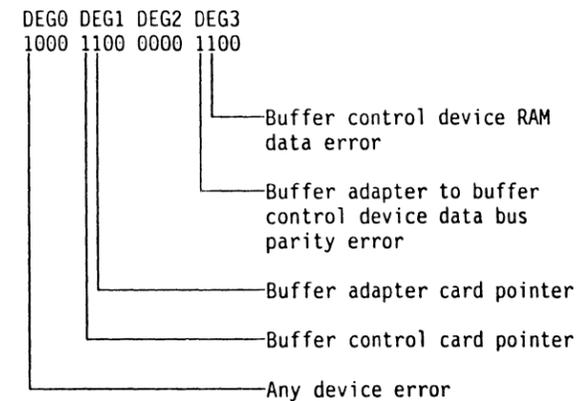
As an example, assume that we have DEG values 8C0C. The DEG bit values are:

- a. Start with bit 1 of DEG0. (Bit 0 of DEG0 should always be on. If it isn't, go to the troubleshooting procedure for DEG0 bit 0.)
- b. Take the bits in DEG0 in order from bit 1 to bit 3. Troubleshoot for the first bit that is a 1.

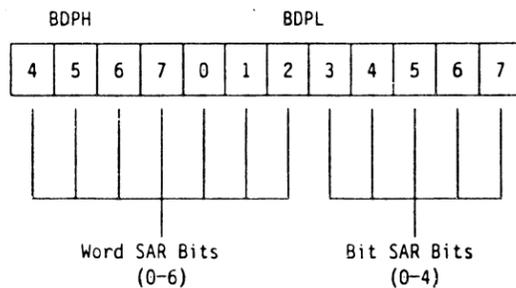
This bit indicates that a miscompare occurred between the buffer storage address parity generated by the buffer control card and the address parity received by the buffer storage cards during a device storage cycle. The parity of the buffer storage address received by the buffer storage cards is sent back to the buffer control card and compared there. Address parity is checked for device memory data access cycles only. Address parity is generated from bits 4–7 of the buffer device pointer high (BDPH) external register and bits 0–7 of the buffer device pointer low (BDPL) external register as follows.

word SAR bits and bit SAR bits are combined and parity is generated to give the address parity.
