Collating List of Pages

This reference drawing contains the collating sequence, page side, and EC level of pages for *IBM 3480 Magnetic Tape Subsystem Maintenance Information Manual (MI) Volume A05, SY32-5061-13*.

PUBLICATIONS REFERENCE DRAWING

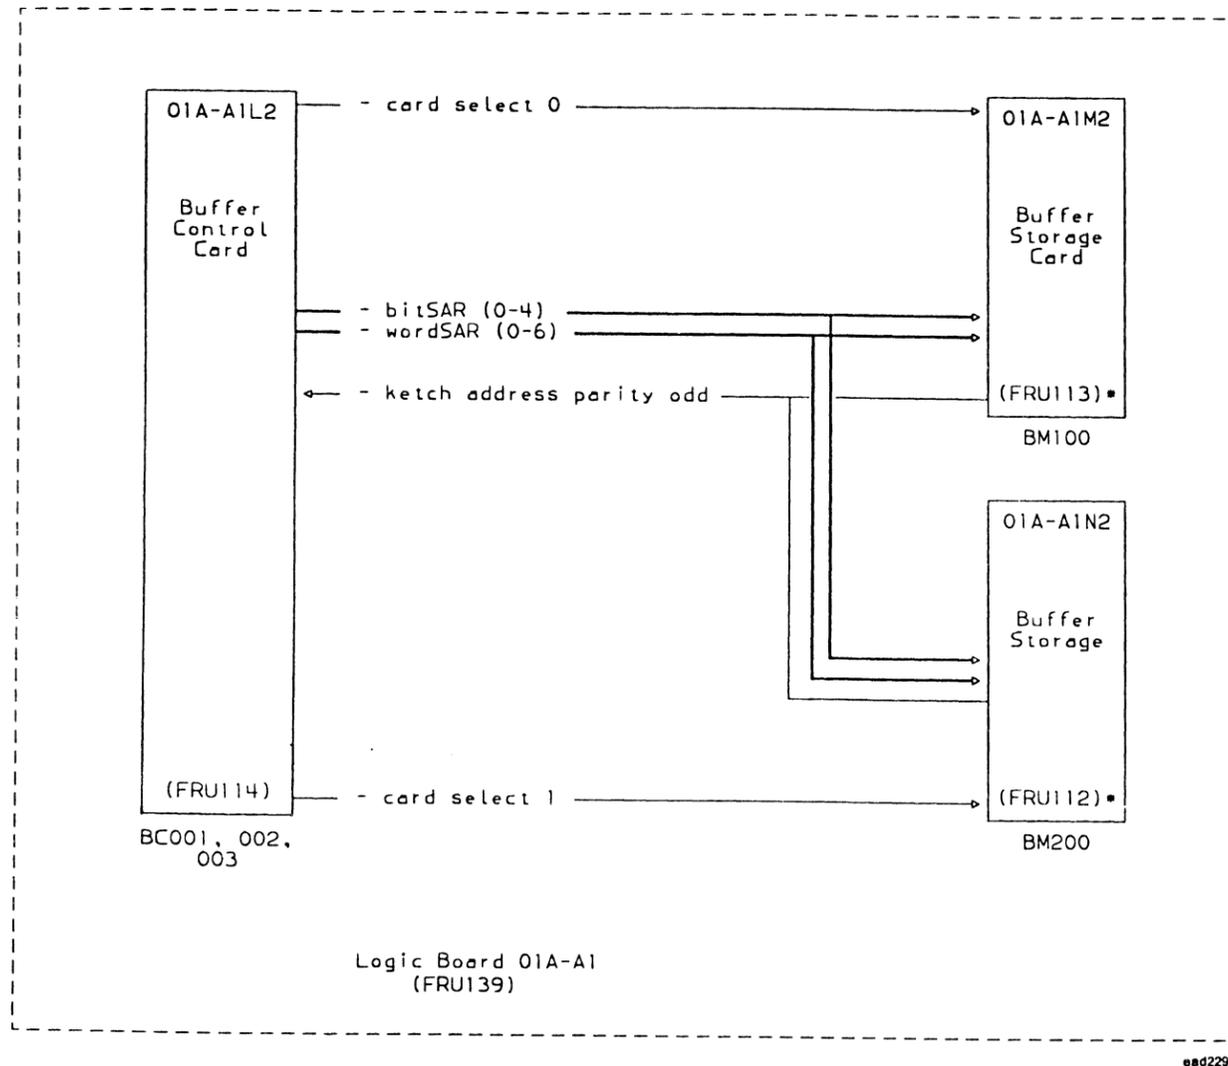
Error Diagram

Diagnostic	Net Name	Failure ID	BCSE	BDSE
EE32, E010	- Bitsar (0–4)			
EE32, E010	- Wordsar (0–6)			
EE32, E010	- Ketch address parity odd			
EE32, E010	- Card select 0			
EE32, E010	- Card select 1

* These FRUs are EC sensitive.
 FRU112 may not be present.
 See CARR-CU 7.

This bit indicates that a parity error was detected in the buffer device pointer high (BDPH) external register or buffer device pointer low (BDPL) external register in the buffer control card during a device storage cycle. These registers act as one counter and step each device storage cycle to provide the buffer storage addressing. A buffer wrap (BWRP) external register is used to determine the segment size buffer boundary. The BDPH and BDPL step up to the boundary set by the BWRP and go back to the beginning of the segment for the next storage cycle.

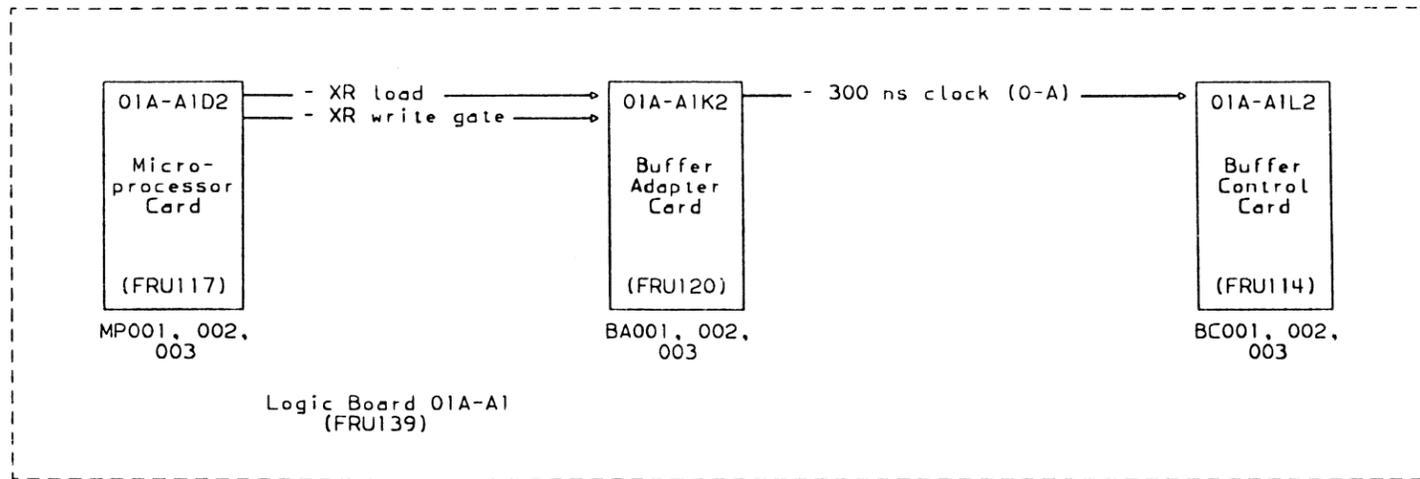
Error Diagram

Diagnostic	Net Name	Failure ID	BCSE	BDSE
EE32, E010	- XR load			
EE32, E010	- XR write gate			
EE32, E010	- 300 ns clock 0-A

DEG1 bits 0 and 2 are set to point to the buffer control card and buffer storage card as the probable failing FRUs.

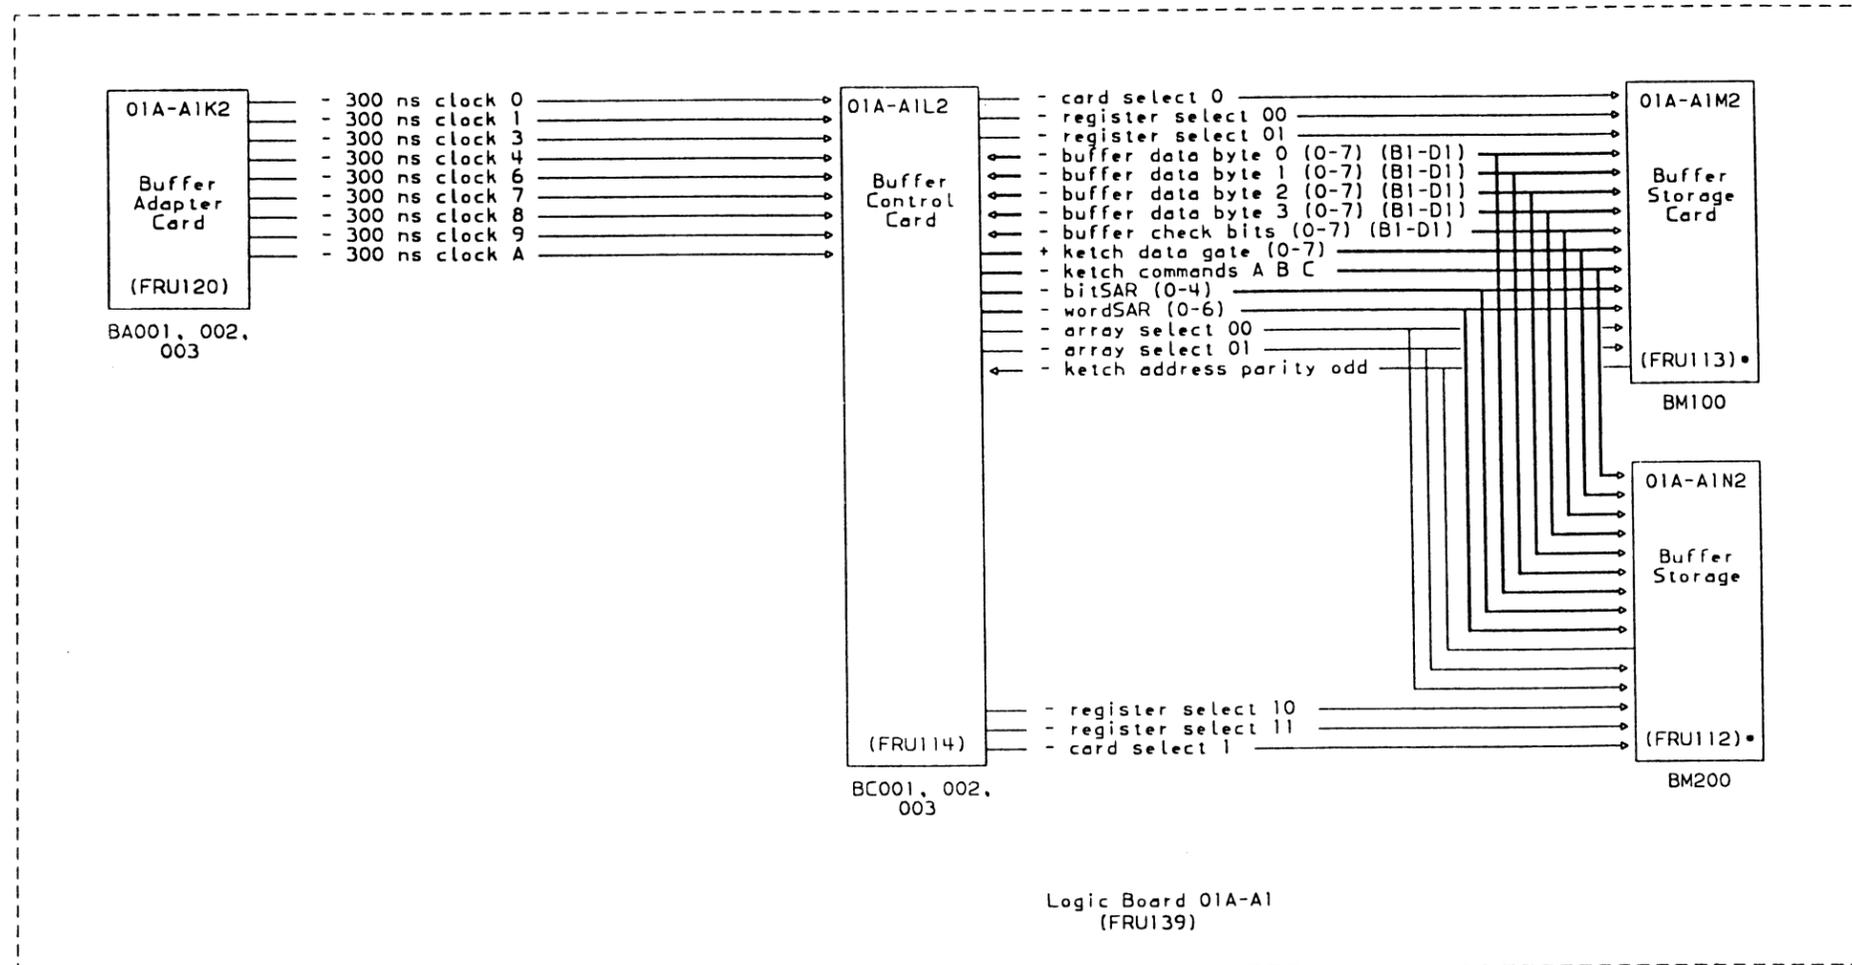
Error Diagram

Diagnostic	Net Name	Failure ID	BCSE	BDSE
EE32, E010	- Buffer check bits 0 – 7	BU2022	30000	98A10
EE33, E010	- 300 ns clock B	BU2024	30000	98A10
EE32, E010	- 300 ns clock A	BU2024	10000	1CA10
EE32, E010	- Buffer data byte 0 bits 0 – 7	BU2024	30000	98A10
EE32, E010	- Buffer data byte 1 bits 0 – 7	BU2024	30000	98A10
EE32, E010	- Buffer data byte 2 bits 0 – 7	BU2024	30000	98A10
EE32, E010	- Buffer data byte 3 bits 0 – 7	BU2024	30000	98A10
EE33, E010	+ Ketch data gate (0 – 7)	BU2024	30000	18A10
EE32, E010	- Ketch command C	BU2024	30000	18A10
EE32, E010	- Ketch command A	BU2024	30000	18A10
EE32, E010	- Register select 10	BU2024	30000	18A10
EE32, E010	- Register select 11	BU2024	30000	18A10
EE32, E010	- Array select 00	BU2024	30000	18A10
EE32, E010	- Register select 00	BU2049	10000	98A10
EE32, E010	- Array select 01	BU2049	10000	98A10
EE32, E010	- Register select 01	BU2049	10000	98A10
EE33, E010	- 300 ns clock 0	BU3022	10000	98A10

* These FRUs are EC sensitive.
FRU112 may not be present.
See CARR-CU 7.

This bit indicates that the buffer control card received data with even parity from the buffer adapter card during a read-data-flow-to-buffer data transfer. DEG1 bit 1 is set to point to the buffer adapter card as the probable failing FRU.

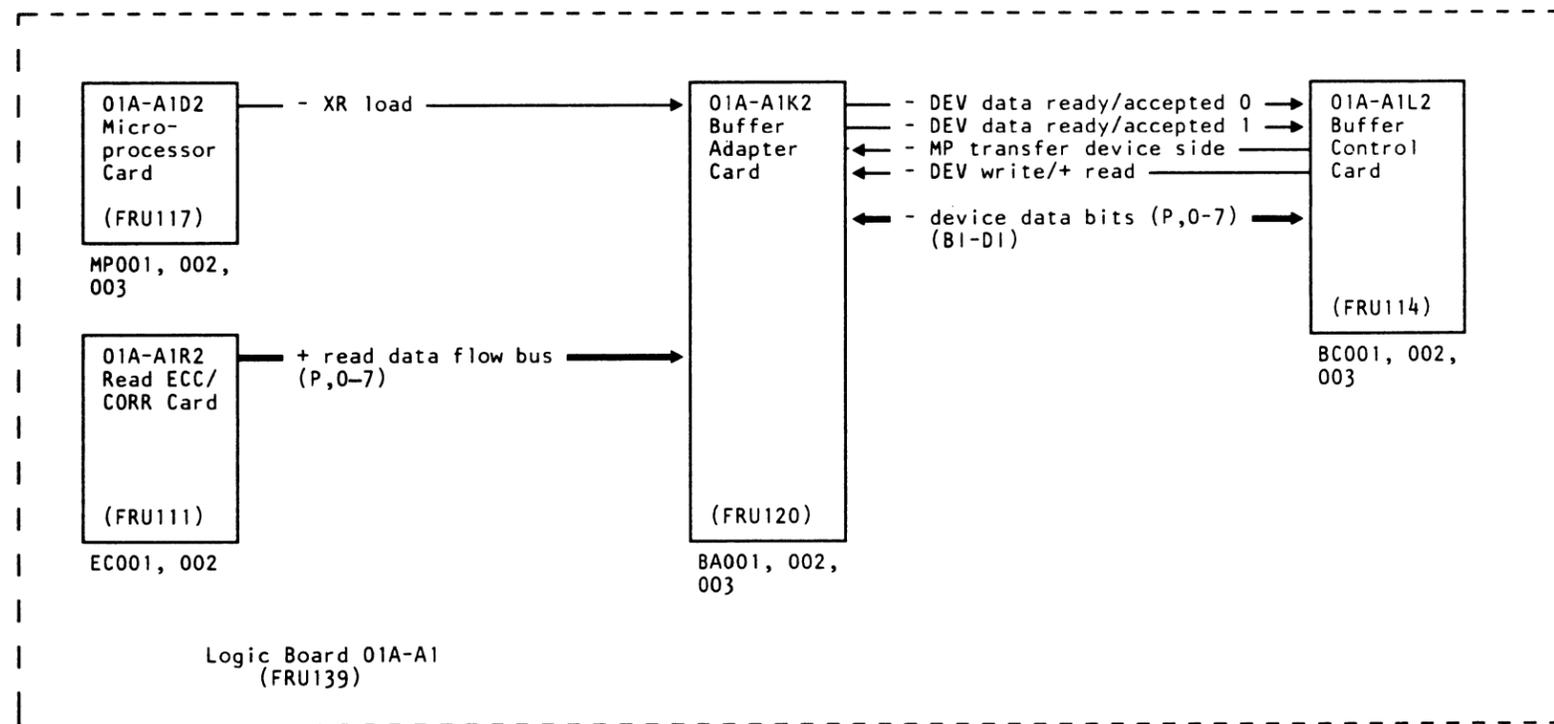
Error Diagram

Diagnostic	Net Name	Failure ID	BCSE	BDSE
EE32, E010	- DEV data read/accepted 0			
EE32, E010	+ Read data flow bus (0 – 7)			
EE32, E010	- DEV write/+ read			
EE32, E010	- XR load			
EE32, E010	- MP transfer device side			
EE32, E010	- Device data bits (P,0 – 7)

This bit indicates that a parity error was detected on the output of the buffer control device RAM on the buffer control card during a buffer-memory-device-store cycle while performing a read-data-flow-to-buffer data transfer. This is an internal parity check of data stored temporarily in the device RAMs before it is sent to the buffer storage card. All data written or read from the buffer storage cards must pass through the buffer control device RAM on the buffer control card.

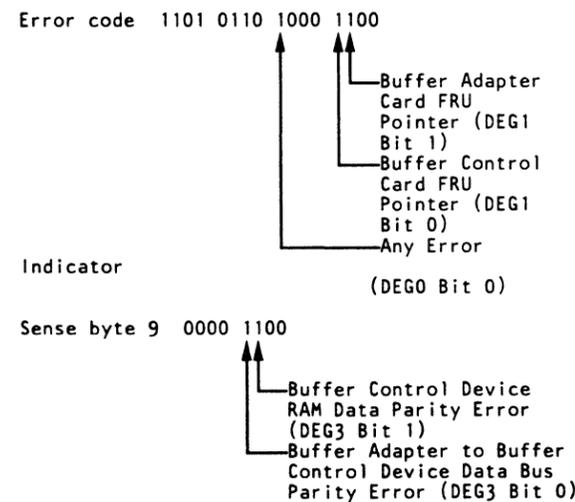
Example 1

Assume that the error code is D68C and sense byte 9 is 0C

This indicates that the buffer adapter card received data with bad parity from the buffer adapter card over the device data bus. The incorrect data propagated through the buffer control card logic and was loaded into the RAM. The failure is either in the buffer adapter card, the device data bus, the control lines from the buffer adapter card to the buffer control card, or the logic on the control card that precedes the checker for the buffer adapter to buffer control device data bus parity error. Return to the error detection theory and troubleshooting guide for "DEG3 bit 0, Buffer Adapter to Buffer Control Device Data Bus Parity Error."

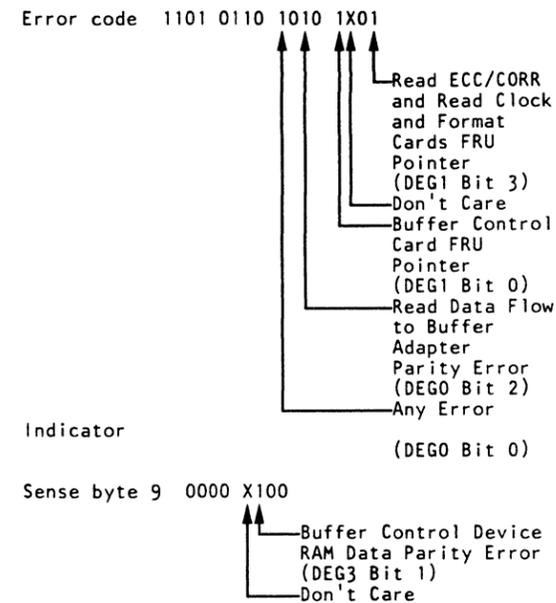
Example 2

Assume an error code of D6A9 or D6AD and sense byte 9 of 04 or 0C.

This indicates that the buffer adapter card received data with bad parity from the read data flow over the read data flow bus. The error data propagated through the buffer adapter card and the buffer control card logic and was loaded into the RAM. Return to the error detection theory and troubleshooting guide for "DEGO Bit 2, Read Data Flow to Buffer Adapter Parity Error."

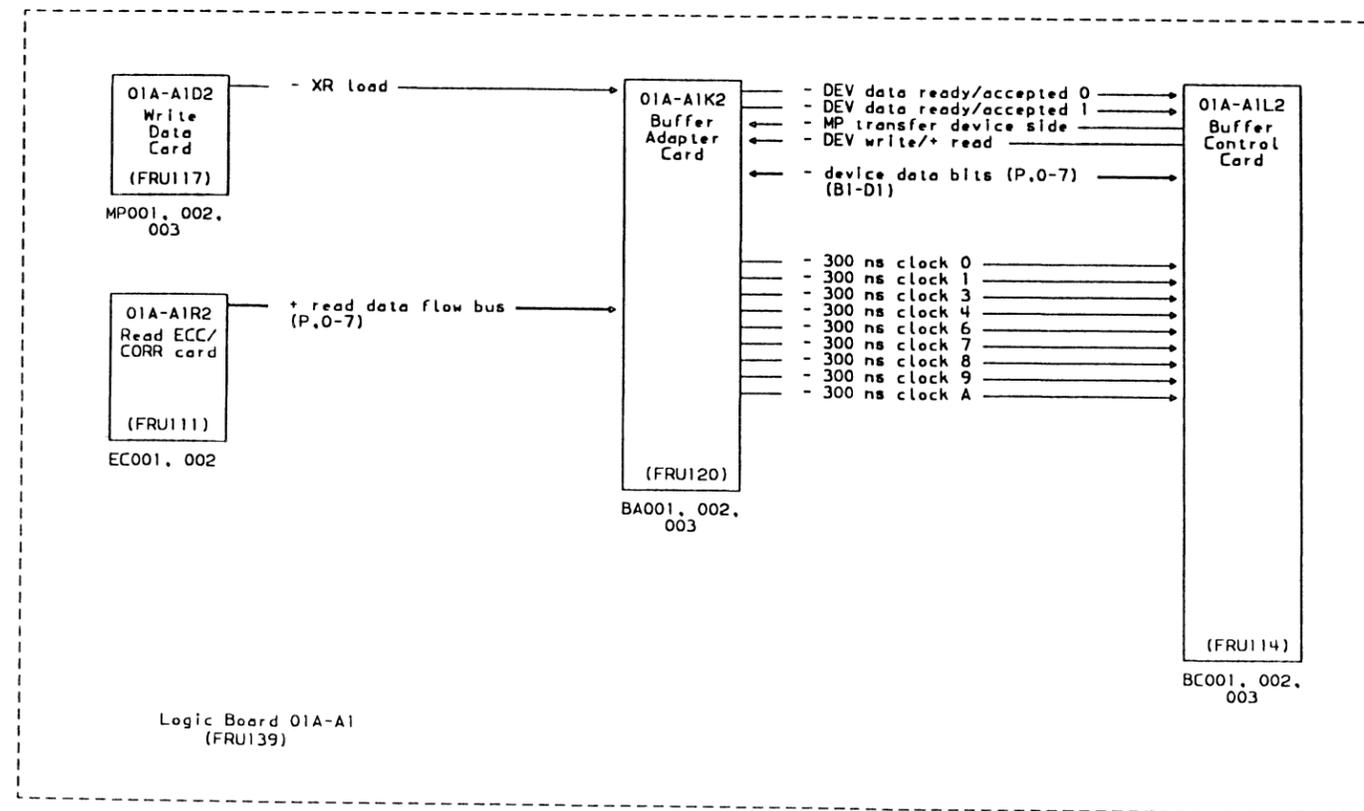
Error Diagram

Diagnostic	Net Name	Failure ID	BCSE	BDSE
EE32, E010	- 300 ns clock 0 - A			
EE32, E010	- DEV data read/accepted 0			
EE32, E010	- DEV data ready/accepted 1			
EE32, E010	+ Read data flow bus (0 - 7)			
EE32, E010	- DEV write/+ read			
EE32, E010	- XR load			
EE32, E010	- MP transfer device side			
EE32, E010	- Device data bits (P,0 - 7)

- * These FRUs are EC sensitive.
FRU112 may not be present.
See CARR-CU 7.

When the device reads the record, the record is read from the buffer storage cards by the device-side circuits of the buffer control card. As each byte is sent to the device, the device-side circuits of the buffer control card clock the byte through a CRC generator. After the last byte has been sent to the device, the CRC that was stored behind the record is clocked through the CRC generator. The CRC generated by the channel-side circuits should cause the device-side CRC generator to go to zero. If the device-side CRC does not go to zero, device CRC error is detected. This CRC check ensures data integrity from the channel through the buffer storage cards to the buffer control card output to the buffer adapter card.

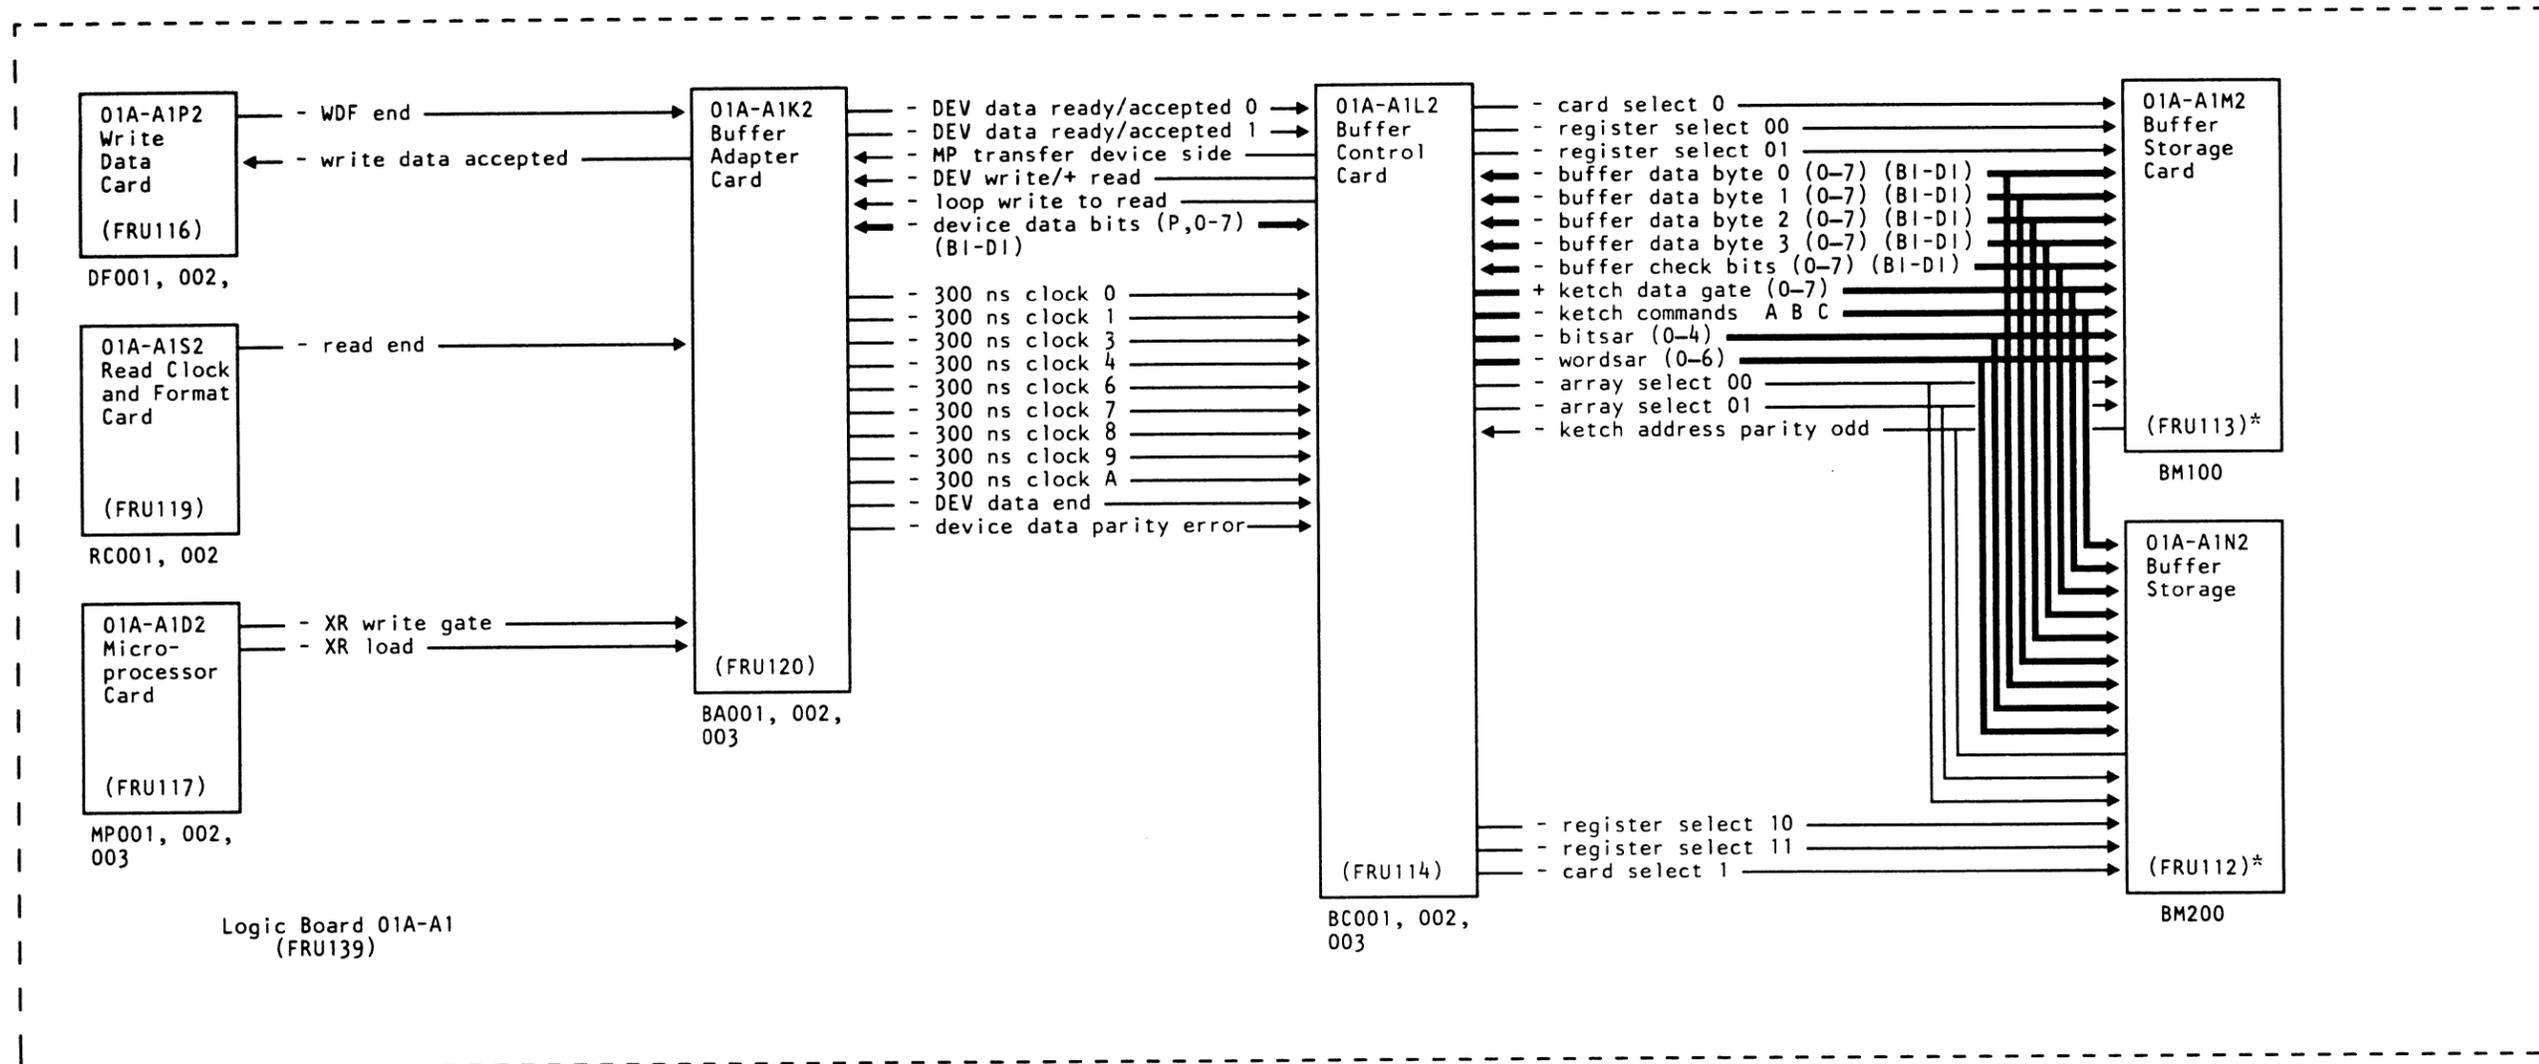
Error Diagram

* These FRUs are EC sensitive.
FRU112 may not be present.
See CARR-CU 7.

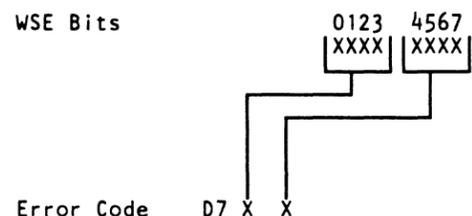
The Write Status/error register is contained in the Write Data Card. The Write Data Flow Card is used to communicate between the Buffer Functional Area and the drive Adapter Functional Area. The Write Data Card changes the 8 bit Write Data Flow Bus coming from the Buffer Adapter Card to the Multiplexed Data Bus going to the drive adapter Card. The Multiplexed data is a mixture of data and check bits. During the process of handling the write data and inserting the check bits, various checks are made and detected errors are recorded in the WSE register.

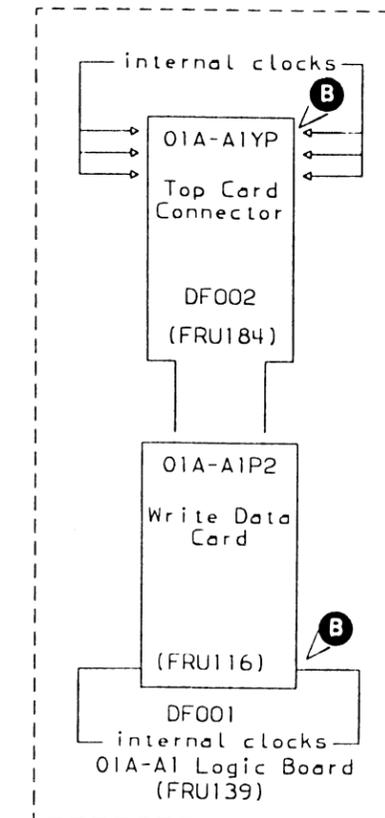
Error Diagram

Point-to-point wiring on a board is shown on the CU and/or DRV net wire list.

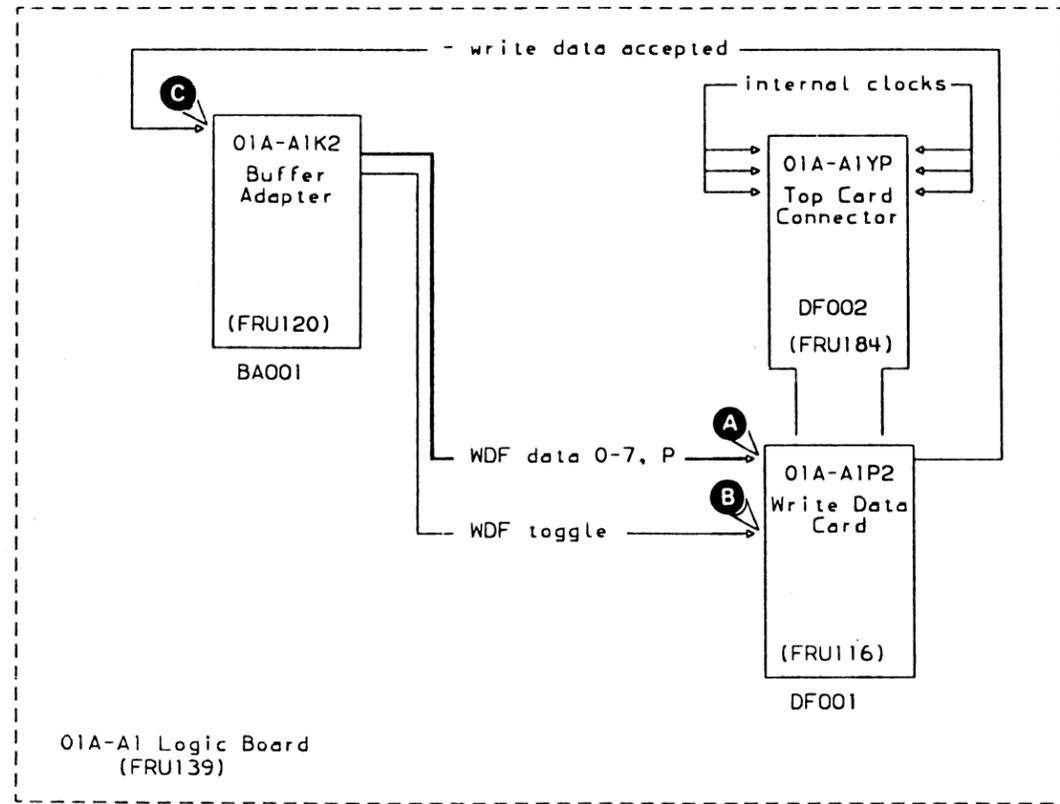
Error Diagram for WSE Bit 4 On

Point-to-point wiring on a board is shown on the CU and/or DRV net wire lists

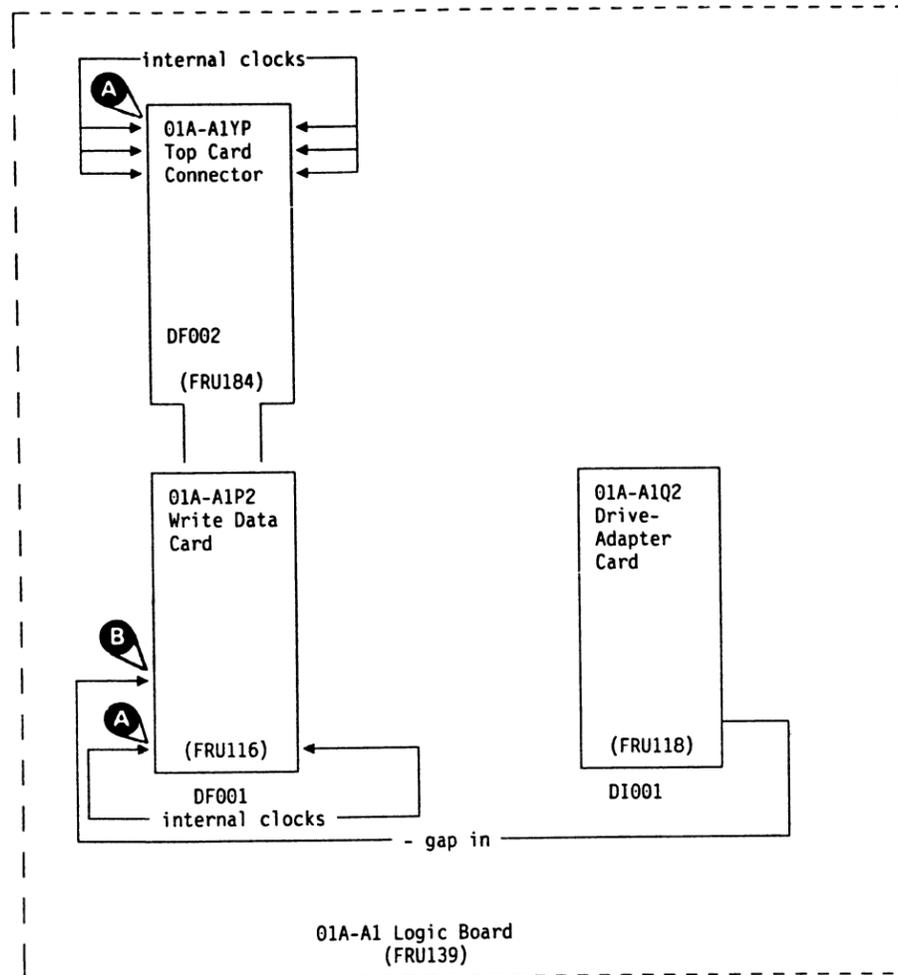
Error Diagram

Point-to-point wiring on a board is shown on the CU and/or DRV net wire lists.

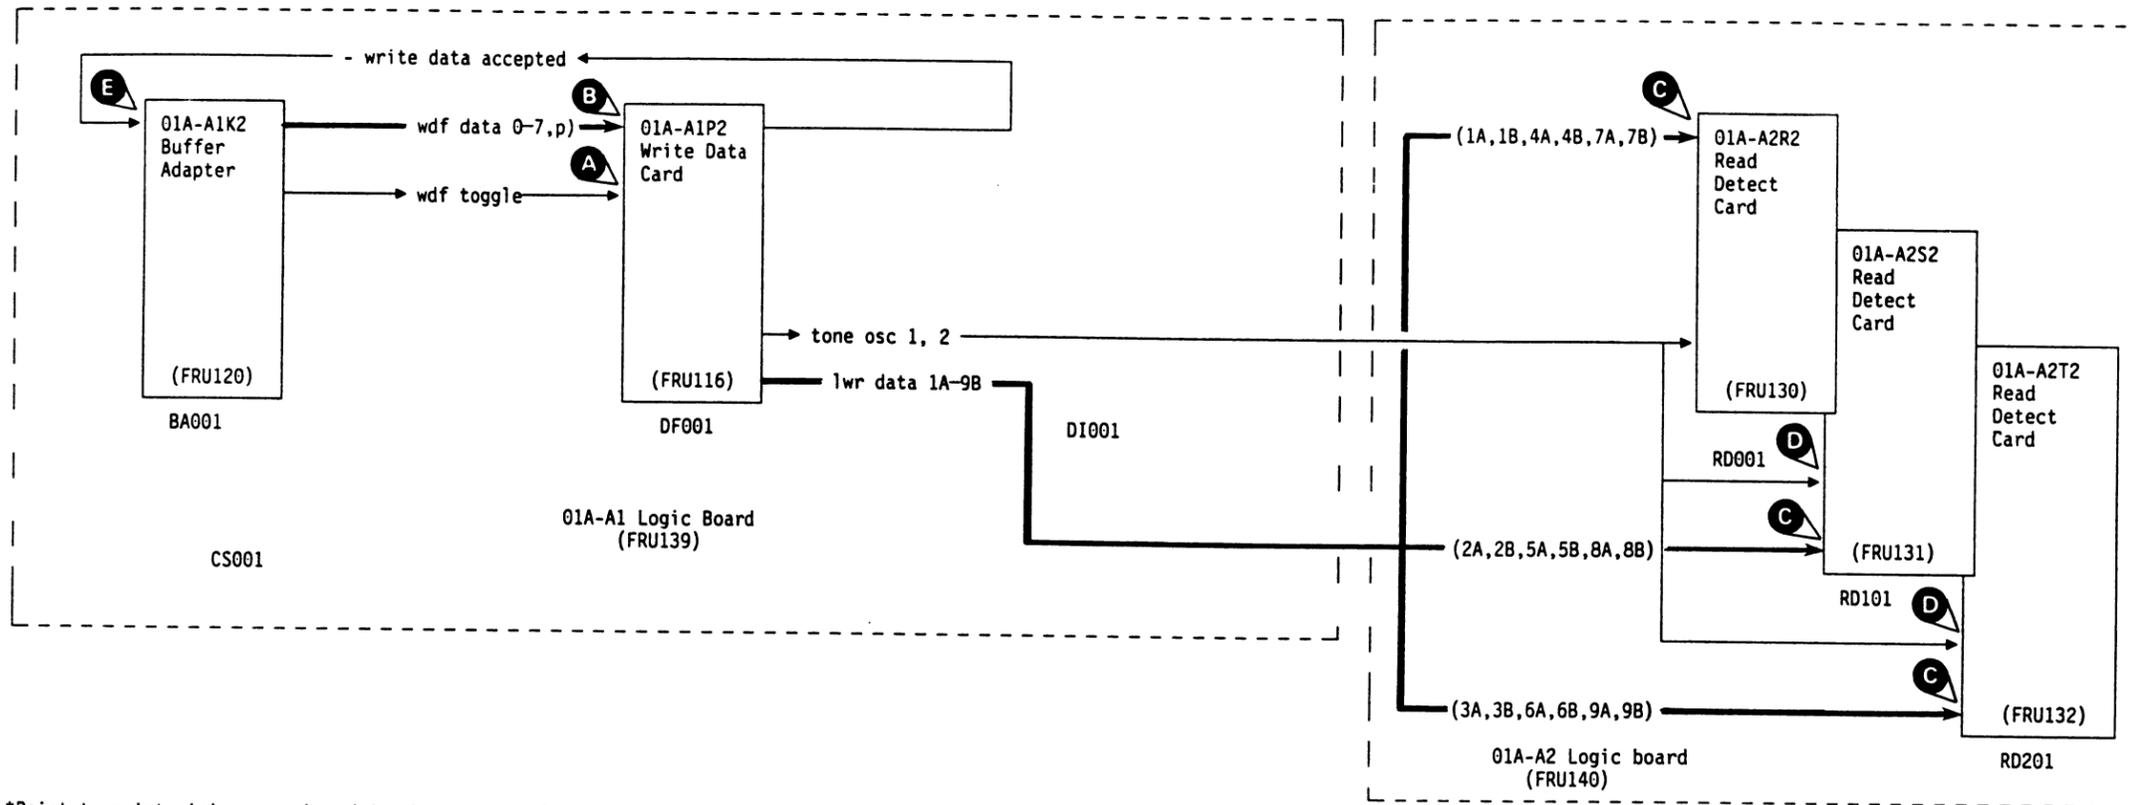
WSE Bit 6 Error Diagram

*Point-to-point wiring on a board is shown on the CU and/or DRV net wire lists.

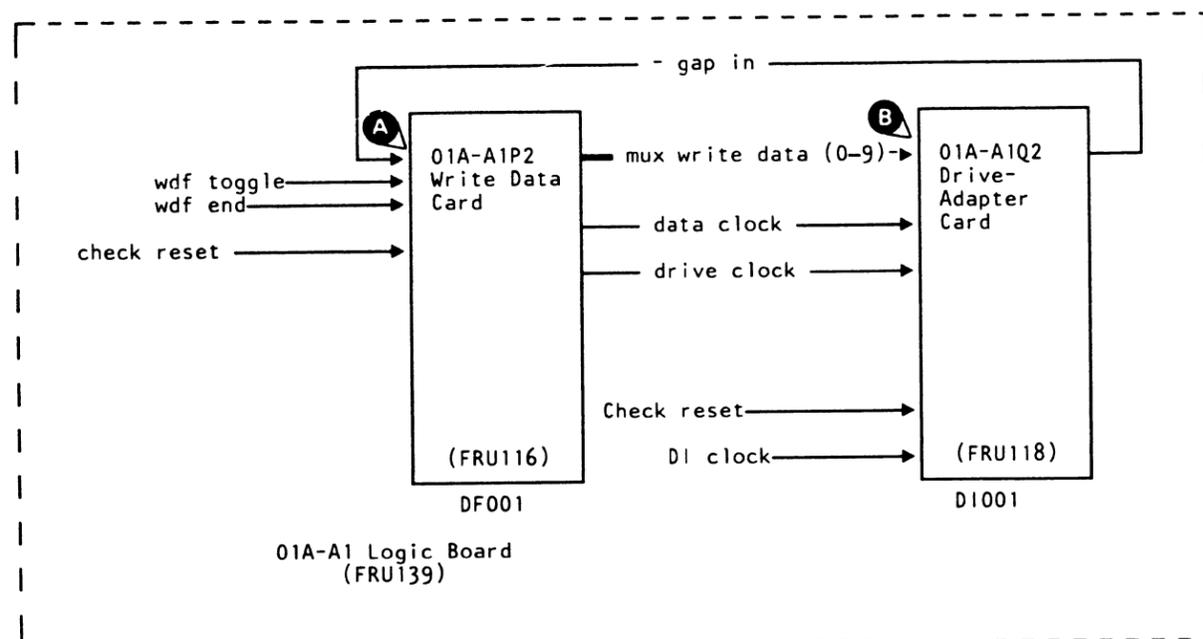
Error Diagram

*Point-to-point wiring on a board is shown on the CU and/or DRV net wire lists.

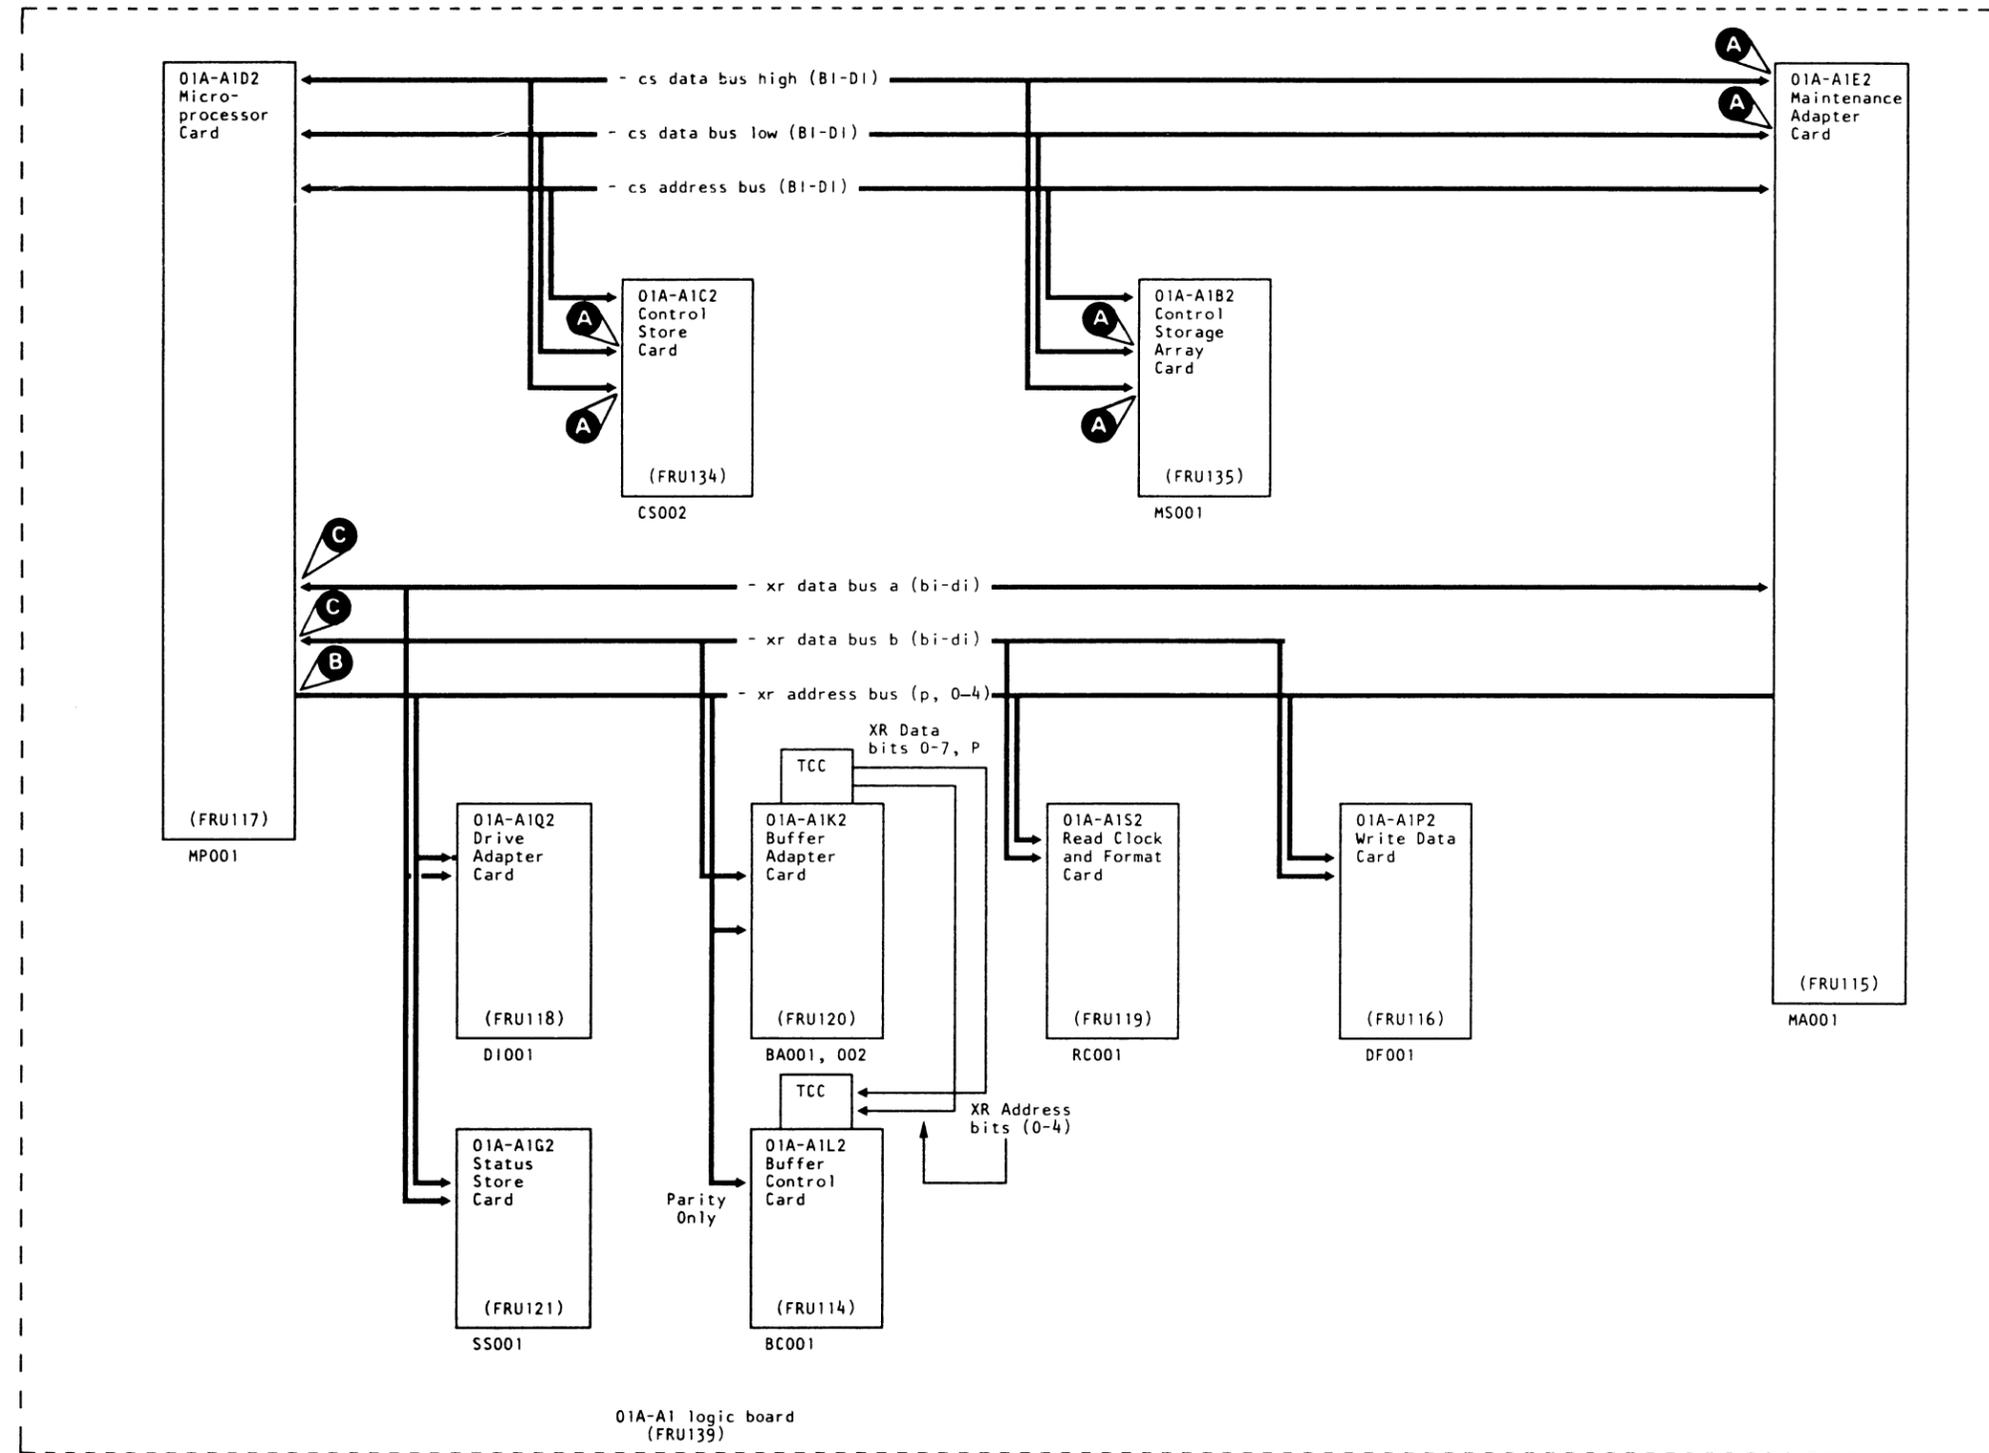
Error Diagram for ERA Bits 0 - 2 and 6 or ERB Bit 0 On

Point-to-point wiring on a board is shown on the CU and/or DRV net wire lists.

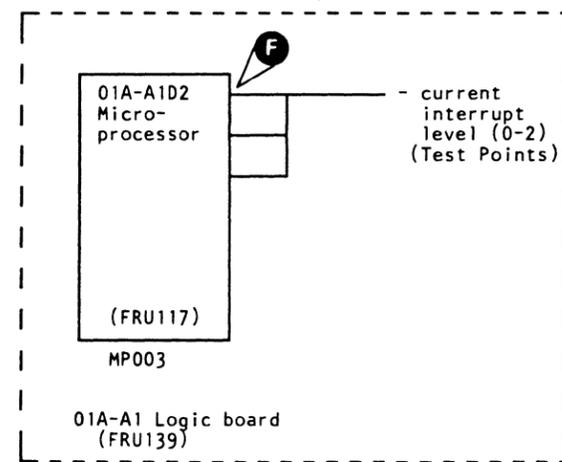
ERROR DIAGRAM for ERA Bit 3 On

Point-to-point wiring on a board is shown on the CU and/or DRV net wire lists.

1. Scope the 'current interrupt level' output **F** (see diagram on this page). These pins are scope points only and have no board nets. If any of these pins have logic level that is not correct and the card has been exchanged, the failure can only be a short circuit to that pin.
2. **If you have performed a repair action**, verify correct operation by running the program that detected the failure and select one of the following:
 - If no errors are detected, go to SPROC 1 "End of Call Actions."
 - If the program detects an error, continue in this EAD with the next action.
3. **If no repair action has been performed** and no additional actions are listed in this EAD or in the FSI, **Call your next level of support** and then go to SPROC 1 "End of Call Actions."

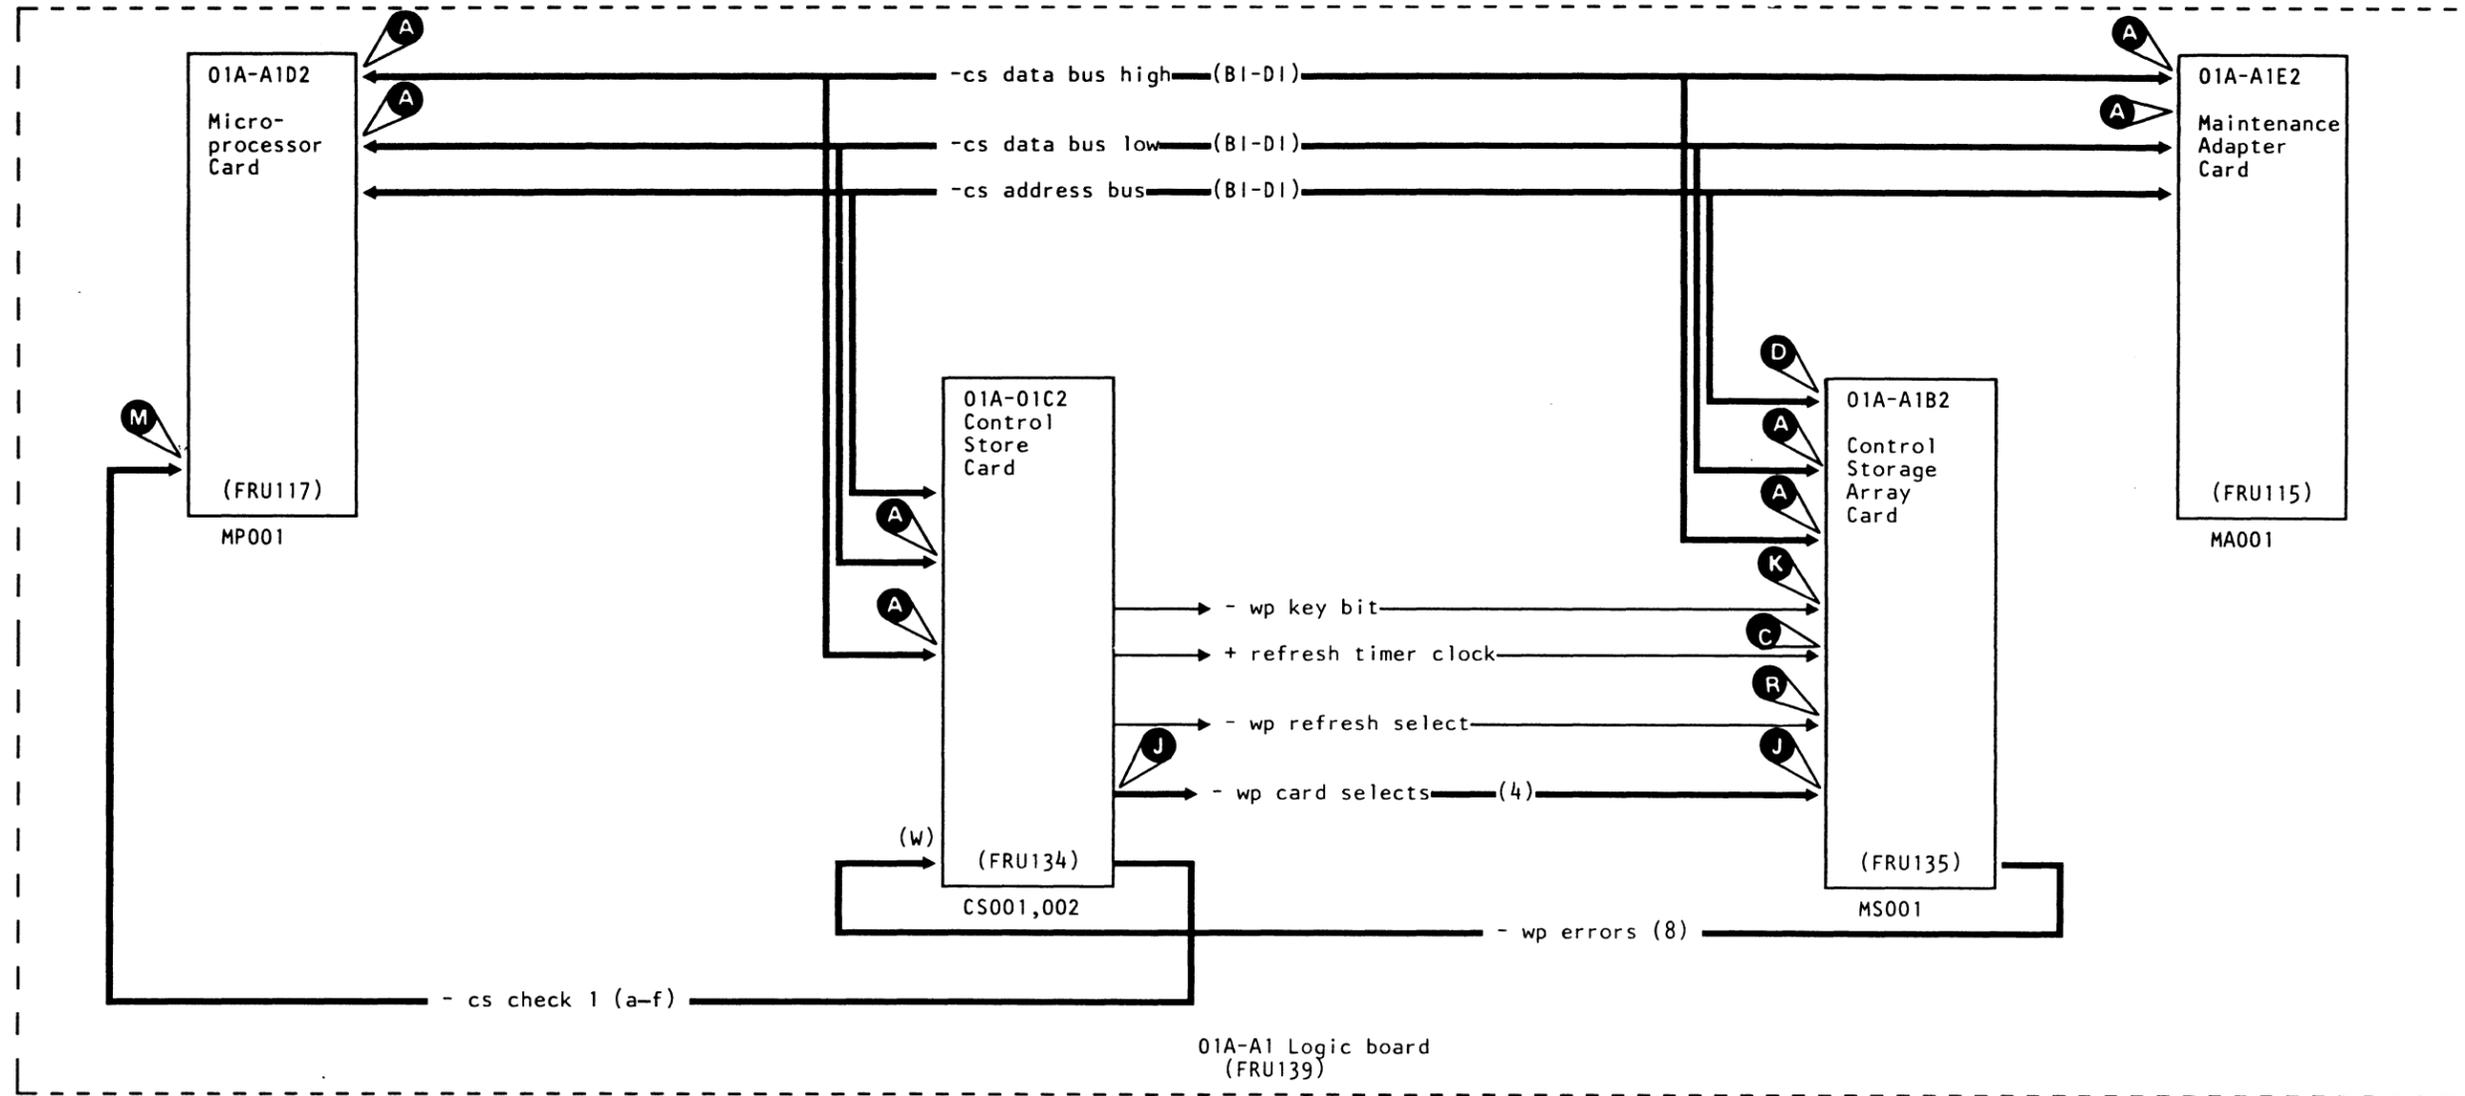
Error Diagram

Point-to-point wiring on a board is shown on the CU and/or DRV net wire lists.
