Collating List of Pages

This reference drawing contains the collating sequence, page side, and EC level of pages for *IBM 3480 Magnetic Tape Subsystem Maintenance Information Manual (MI) Volume A05, SY32-5061-13*.

PUBLICATIONS REFERENCE DRAWING

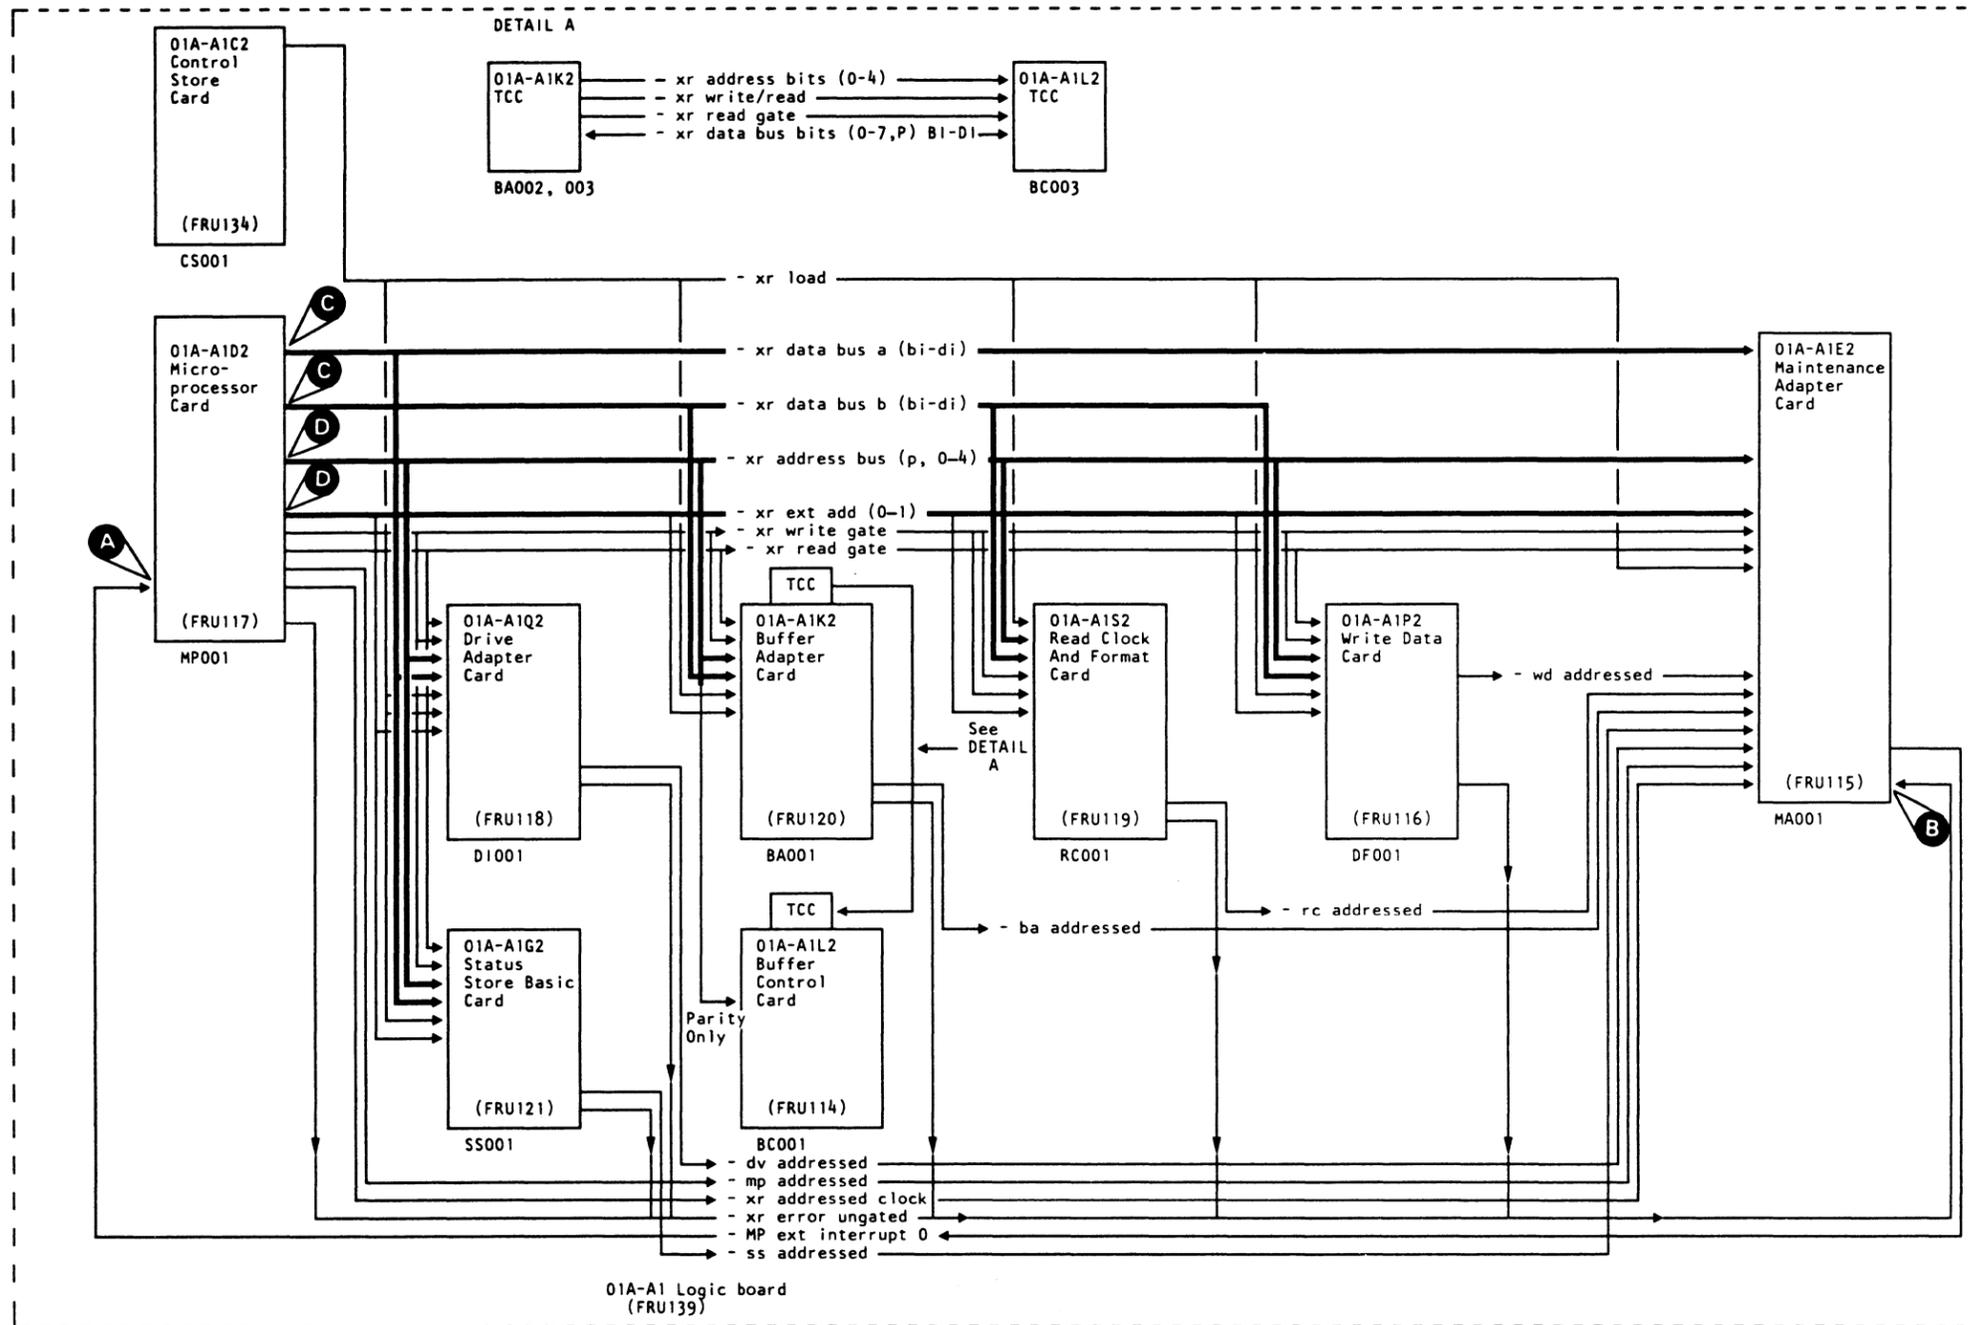
XR Data and Address

Point-to-point wiring on a board is shown on the CU and/or DRV net wire lists.

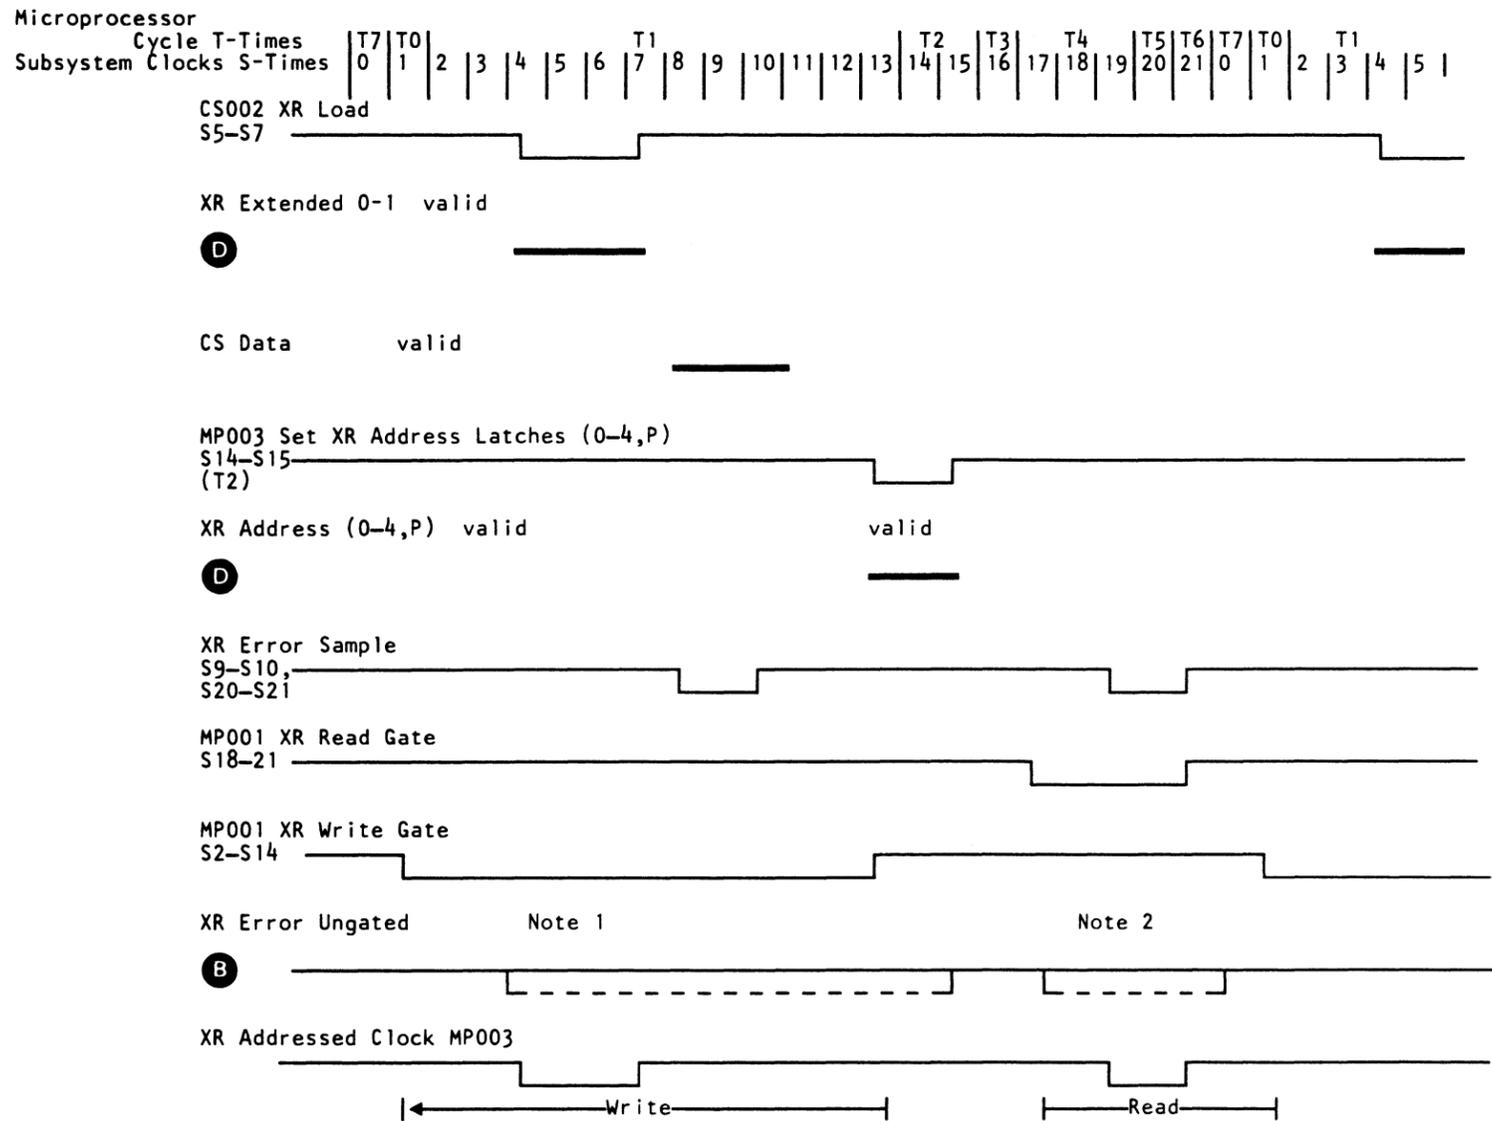
XR Register Address/Data Transfer Timing

Note 1: The line goes down only if an error and a write is included in the instruction.
 Note 2: The line goes down only if an error and a read is included in the instruction.

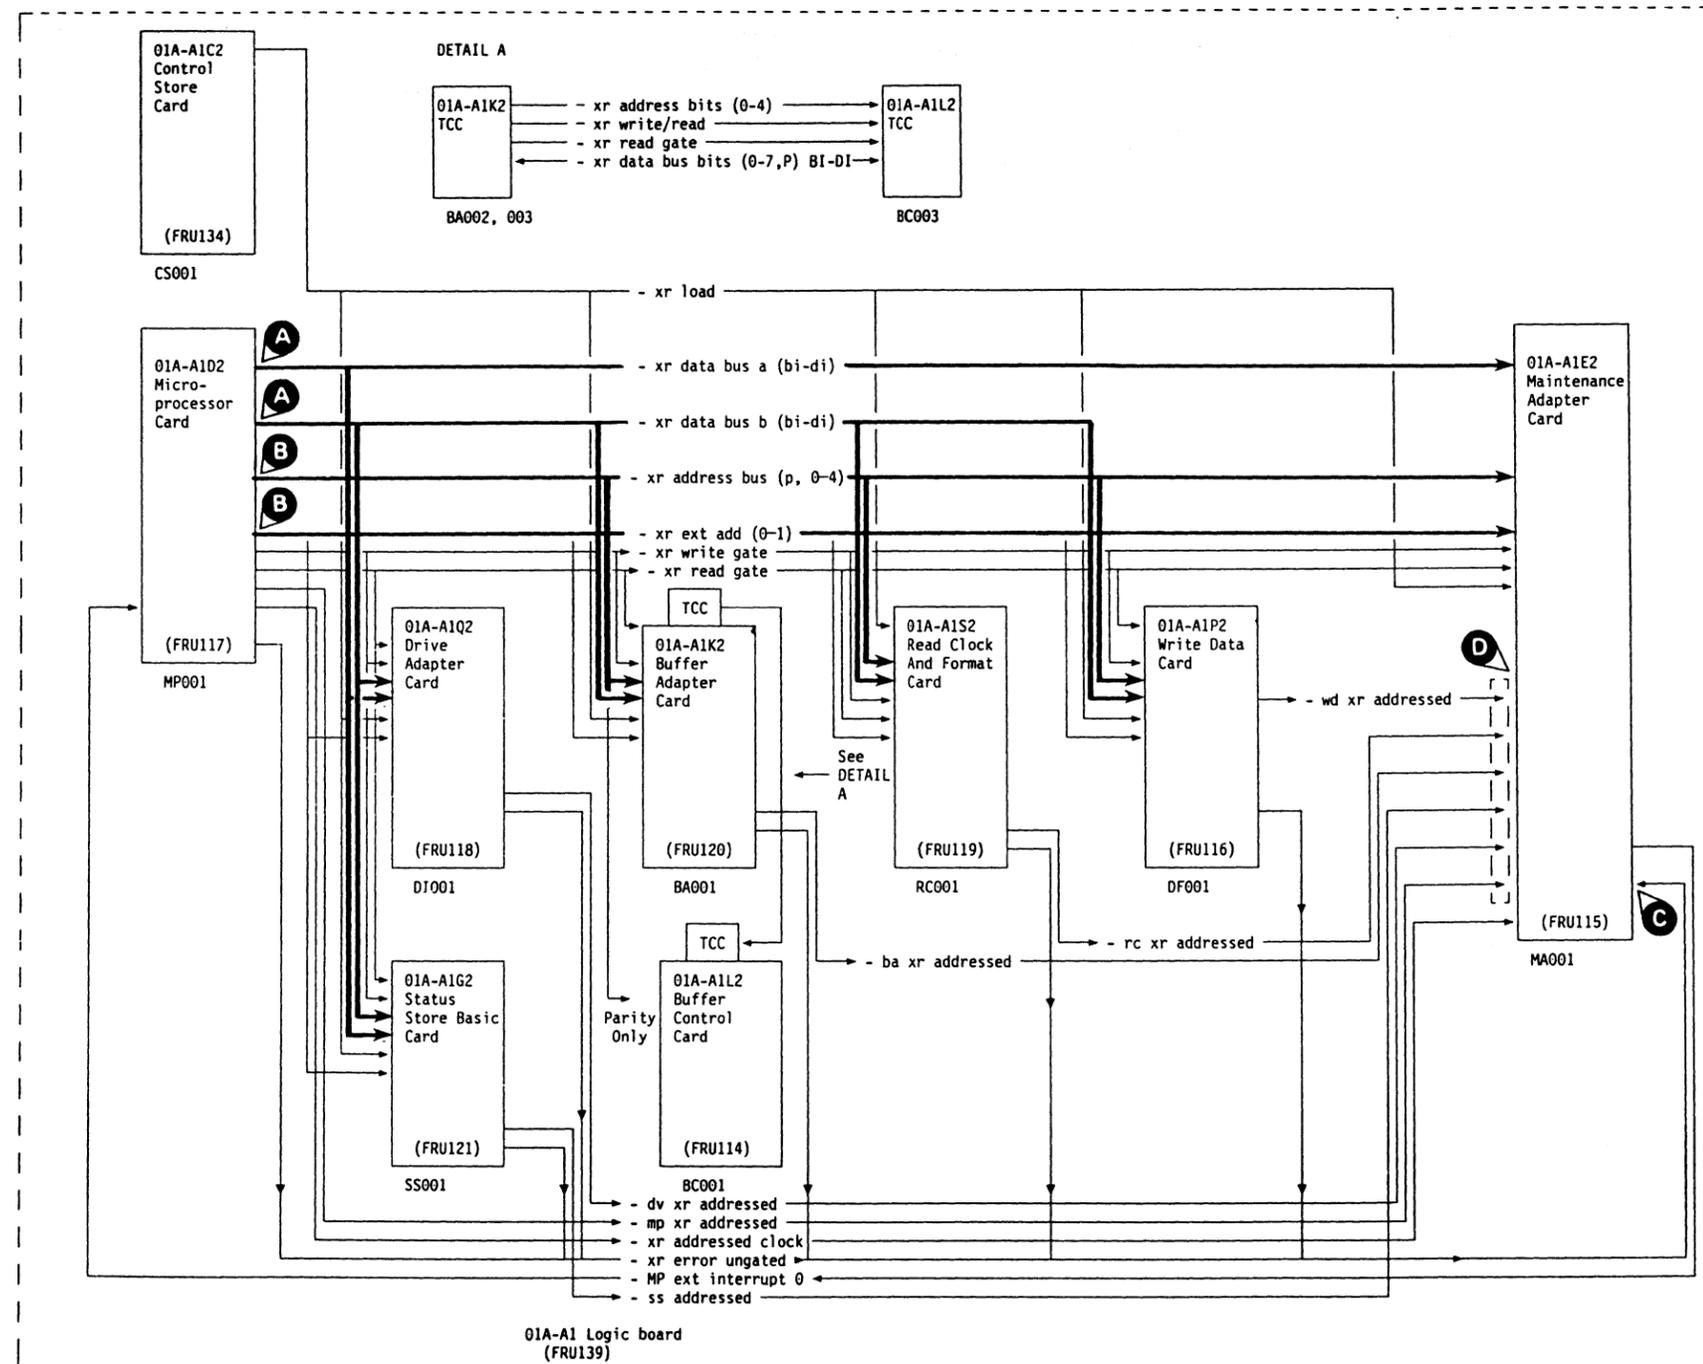
XR Data and Address

Point-to-point wiring on a board is shown on the CU and/or DRV net wire lists.

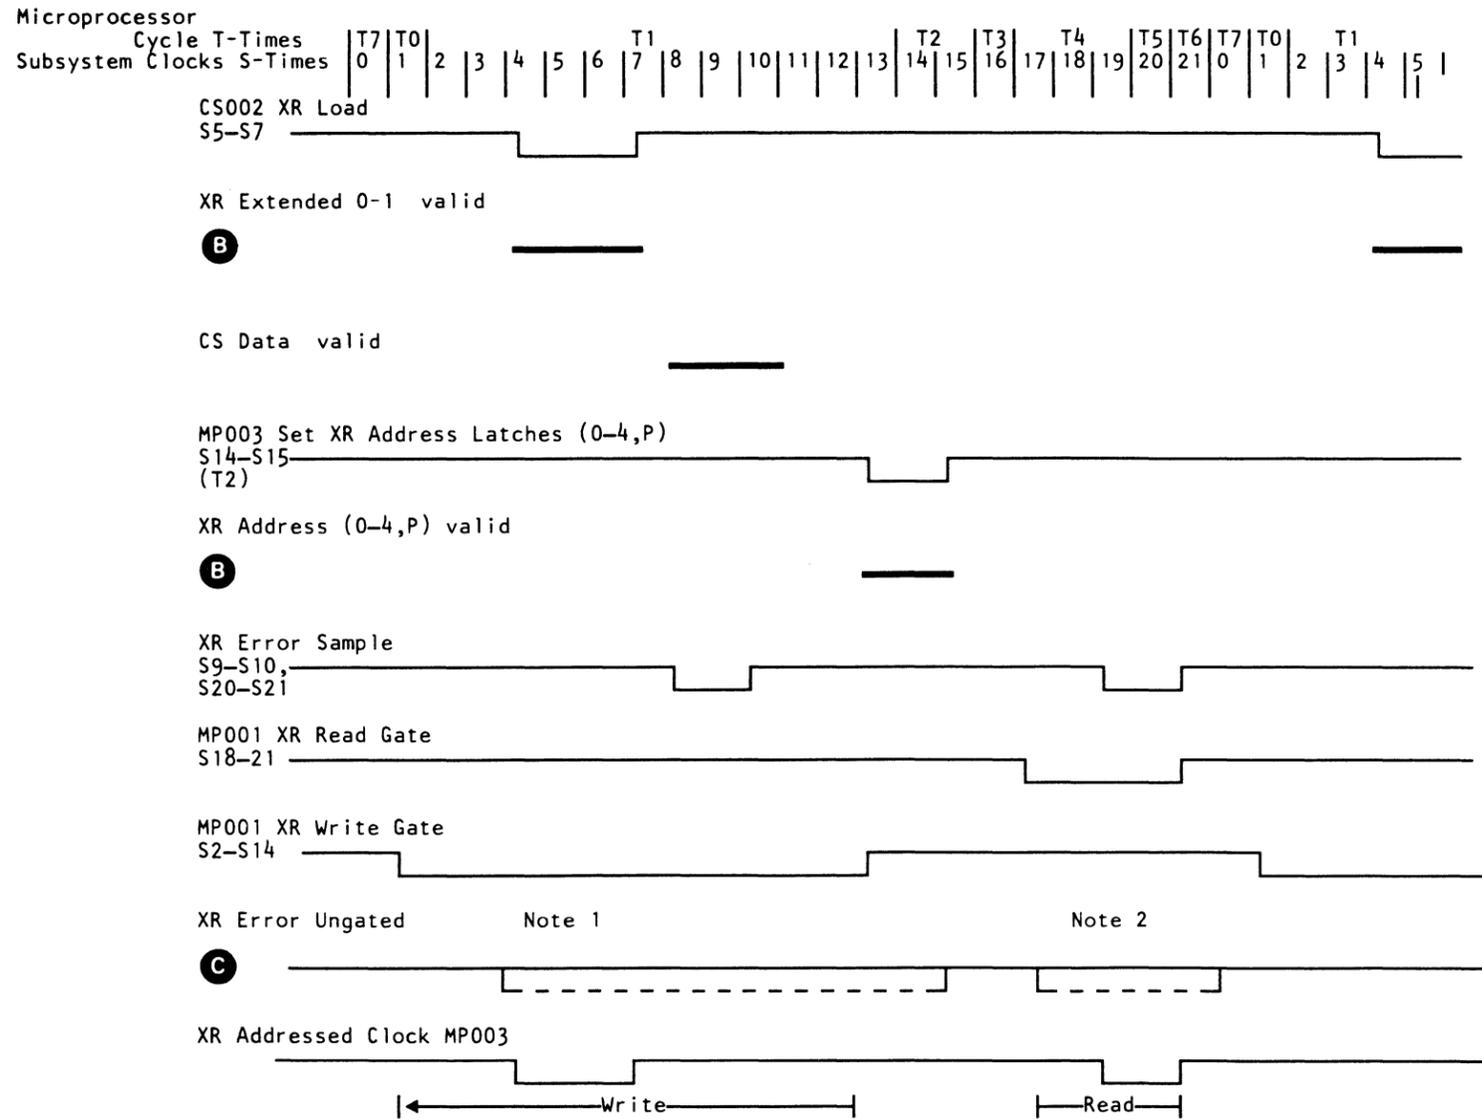
XR Register Address/Data Transfer Timing

Note 1: The line goes down only if an error and a write is included in the instruction.
 Note 2: The line goes down only if an error and a read is included in the instruction.

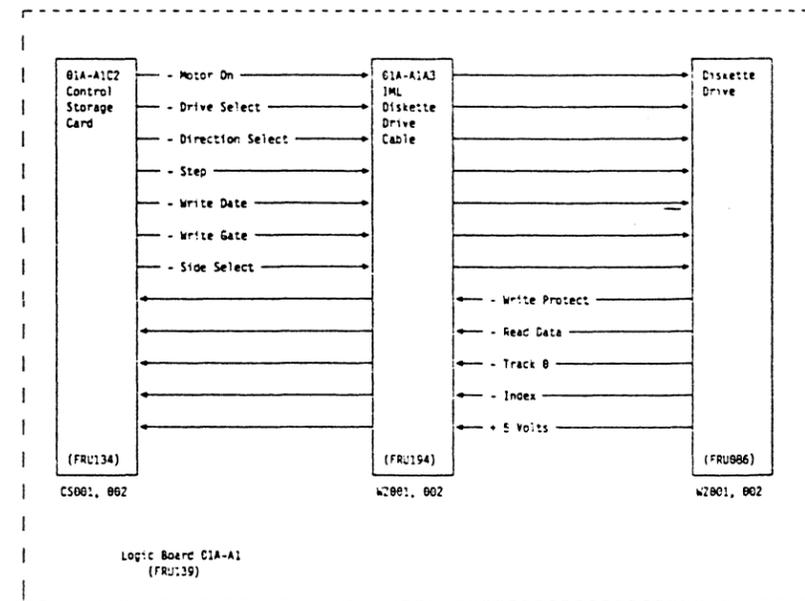
Error Diagram

IML control and data lines may be activated by setting the control unit Online/Offline switch to Offline and then pressing the IML switch.

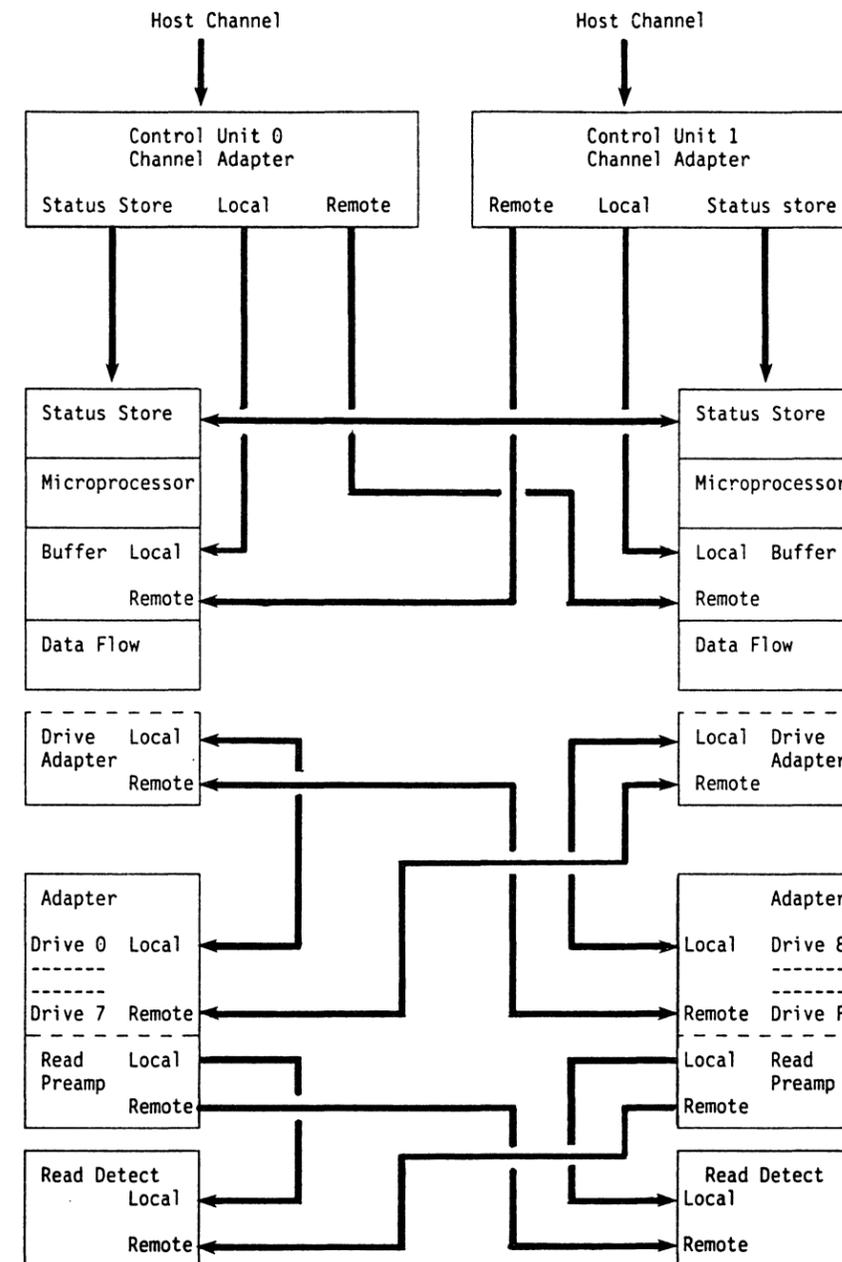
Figure 1. Status Store/Channel Adapter Overview

The channel adapters signal the status store card when errors are detected by raising the 'adapter fail' line. Some of the errors that cause this line to rise are:

- Data parity error on a buffer to channel adapter data transfer
- An irrecoverable error within the channel adapter card
- A parity check on the 'address assign' bus (this is the bus from the control unit address switches).

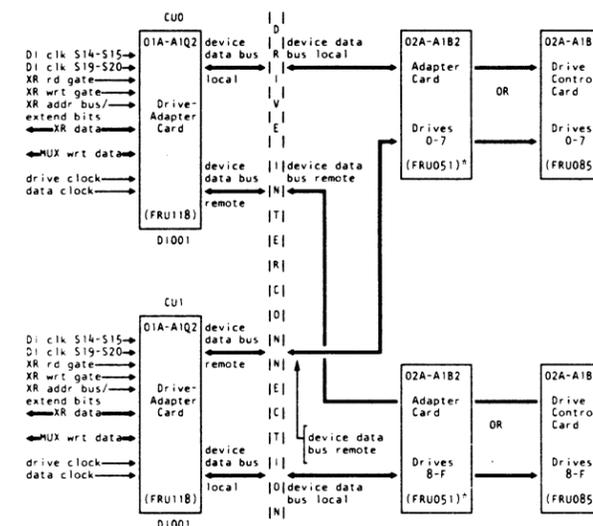
Figure 1. Device Interconnection Overview - DDB

Note: Drive check 82 is a data bus problem and is detected at the drive. For a CHK 82 or an FSC of 0082, troubleshoot following the Troubleshooting Guide for DSE Register, Bit 0 equals 1, Procedures 1 or 2.

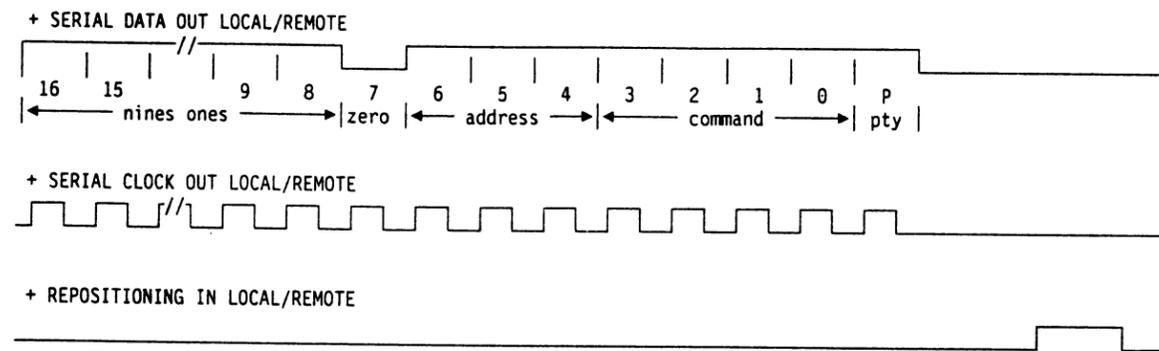
Figure 1. Serial Sequence Device Interconnections (Logic page DI001)

There are specific diagnostics (EE44 and EEA2) that test the internal card logic for the serial interconnection control. However, since logic cards have already been replaced by the product maintenance package, the remainder of the support maintenance package troubleshoots the interconnections between the control unit and the drives. This is the common DDB that has multiple functions (write and control, both parallel and serial).

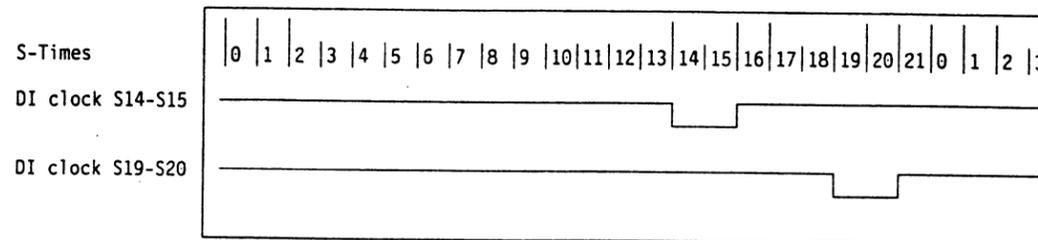
VERT = 2v/cm HORIZ = 1.0 usec/cm
SYNC POINT = -System Clock S0-S1 (logic page CS002)
TEST POINT = -bf/wd clock S2-S3 (logic page DF001)

Note:
One S Clock time equals 23.17 nanoseconds.
For example, S14 becomes active
324.38 nanoseconds after S0 becomes active.

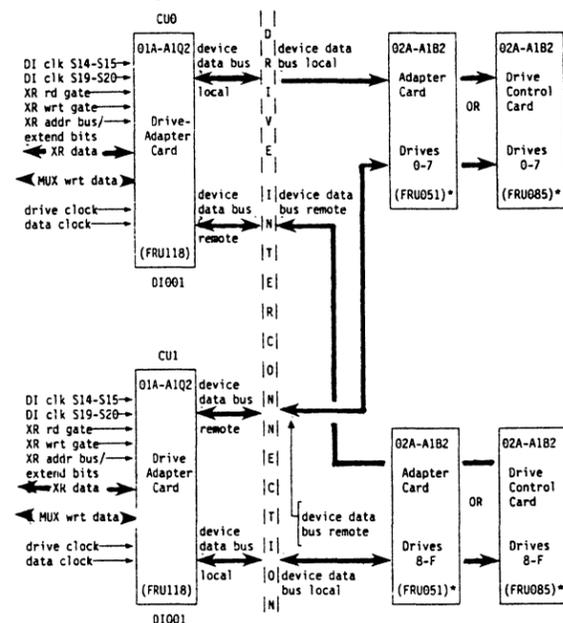
Figure 1. Device Interconnection Overview - DDB

The microcode also detects errors in device data bus functional area. Each FSC is defined in the FSI section of the MI. For Device Data Bus FSCs that reference this EAD (except FSCs 8803-8805, 9602, or CF80) follow the Troubleshooting Guide for DSE Register Bit 0 Equals 1. For FSCs 8803-8805, 9602, or CF80 follow the Troubleshooting Guide for those FSCs (see EAD 5011).

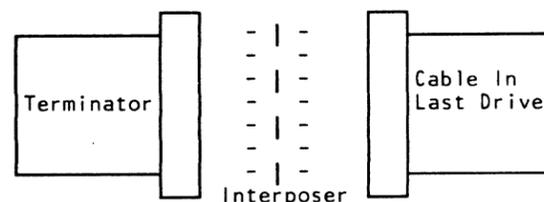
Note: It is not necessary to move the terminator when EE4x diagnostics are used. It is necessary to move the terminator to the last tape unit being tested, when any Read or Write diagnostics are used.

To move a terminator, after removing the cable from the drive TU-P2 connector, install interposer, part 5997533, then install the terminator. See the diagram below.

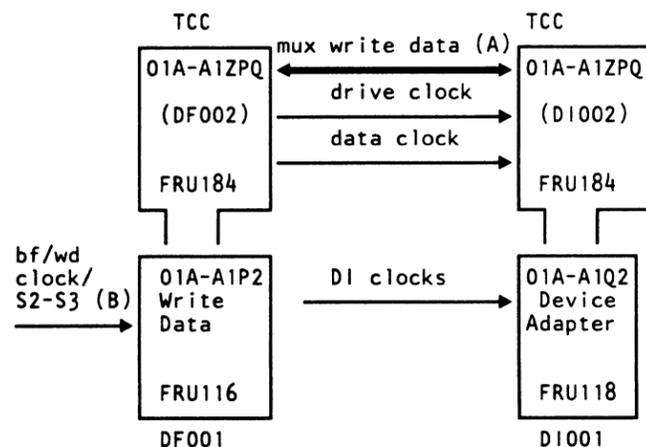
The device adapter card communicates with the write data card over a multiplex write data bus ('MUX data bus'). Parity of the write data is checked as it enters the device adapter card. If even parity is detected on the '+mux write data' bus, the DSE register, bit 1, and a check 2 condition are set to indicate the error condition. See the diagram below.

Note: : All the connections between A1P2 and A1Q2 are on a top card connector.

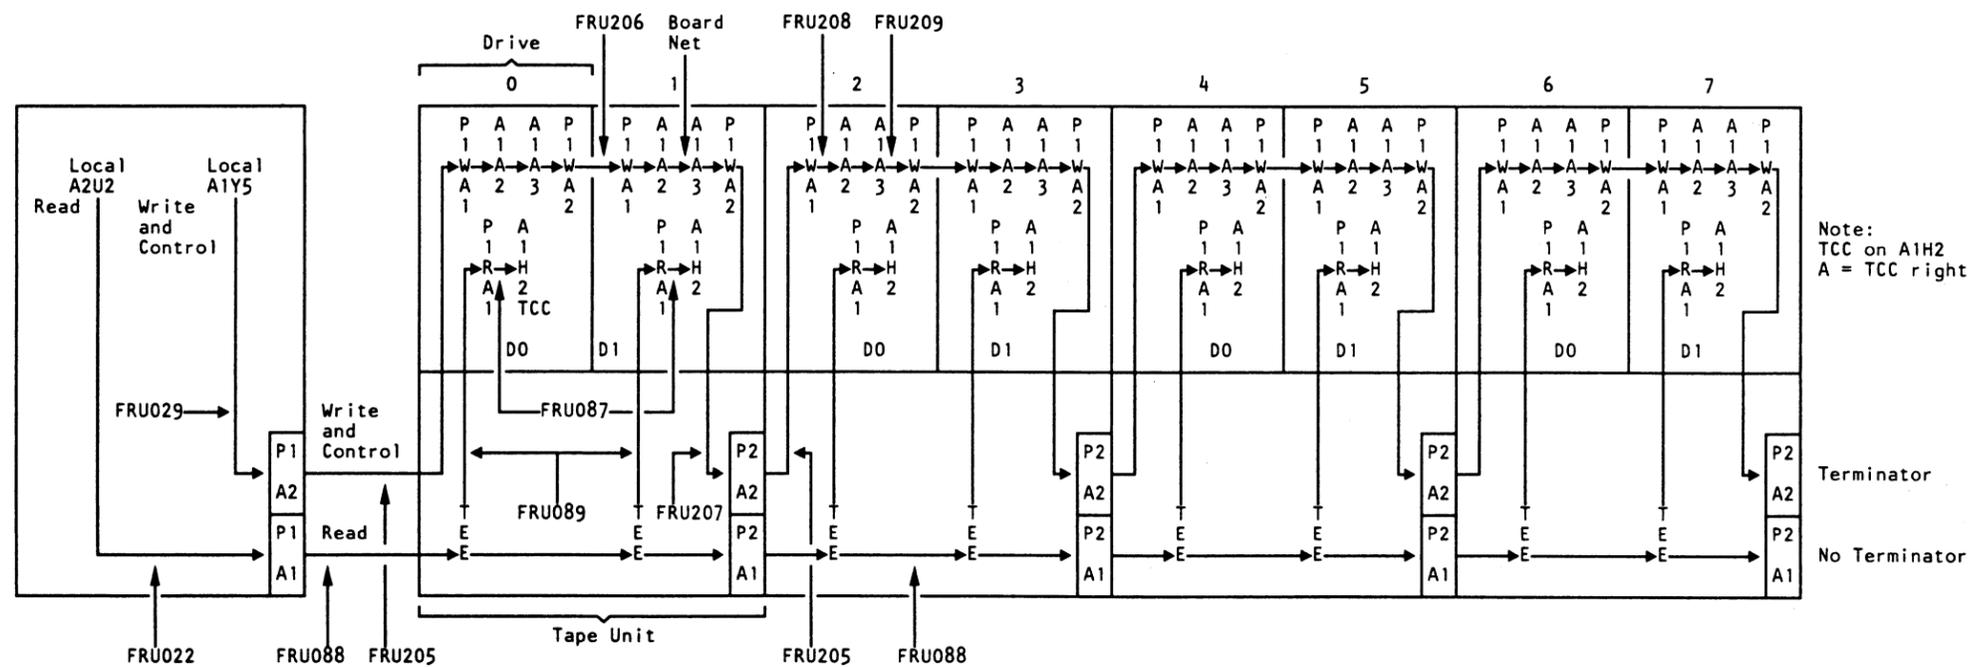
Tape Unit Without Bill of Material 6460006 and
Control Unit Without Bill of Material 6460460

Control Unit Subsystem Cable Diagrams
(Continued)

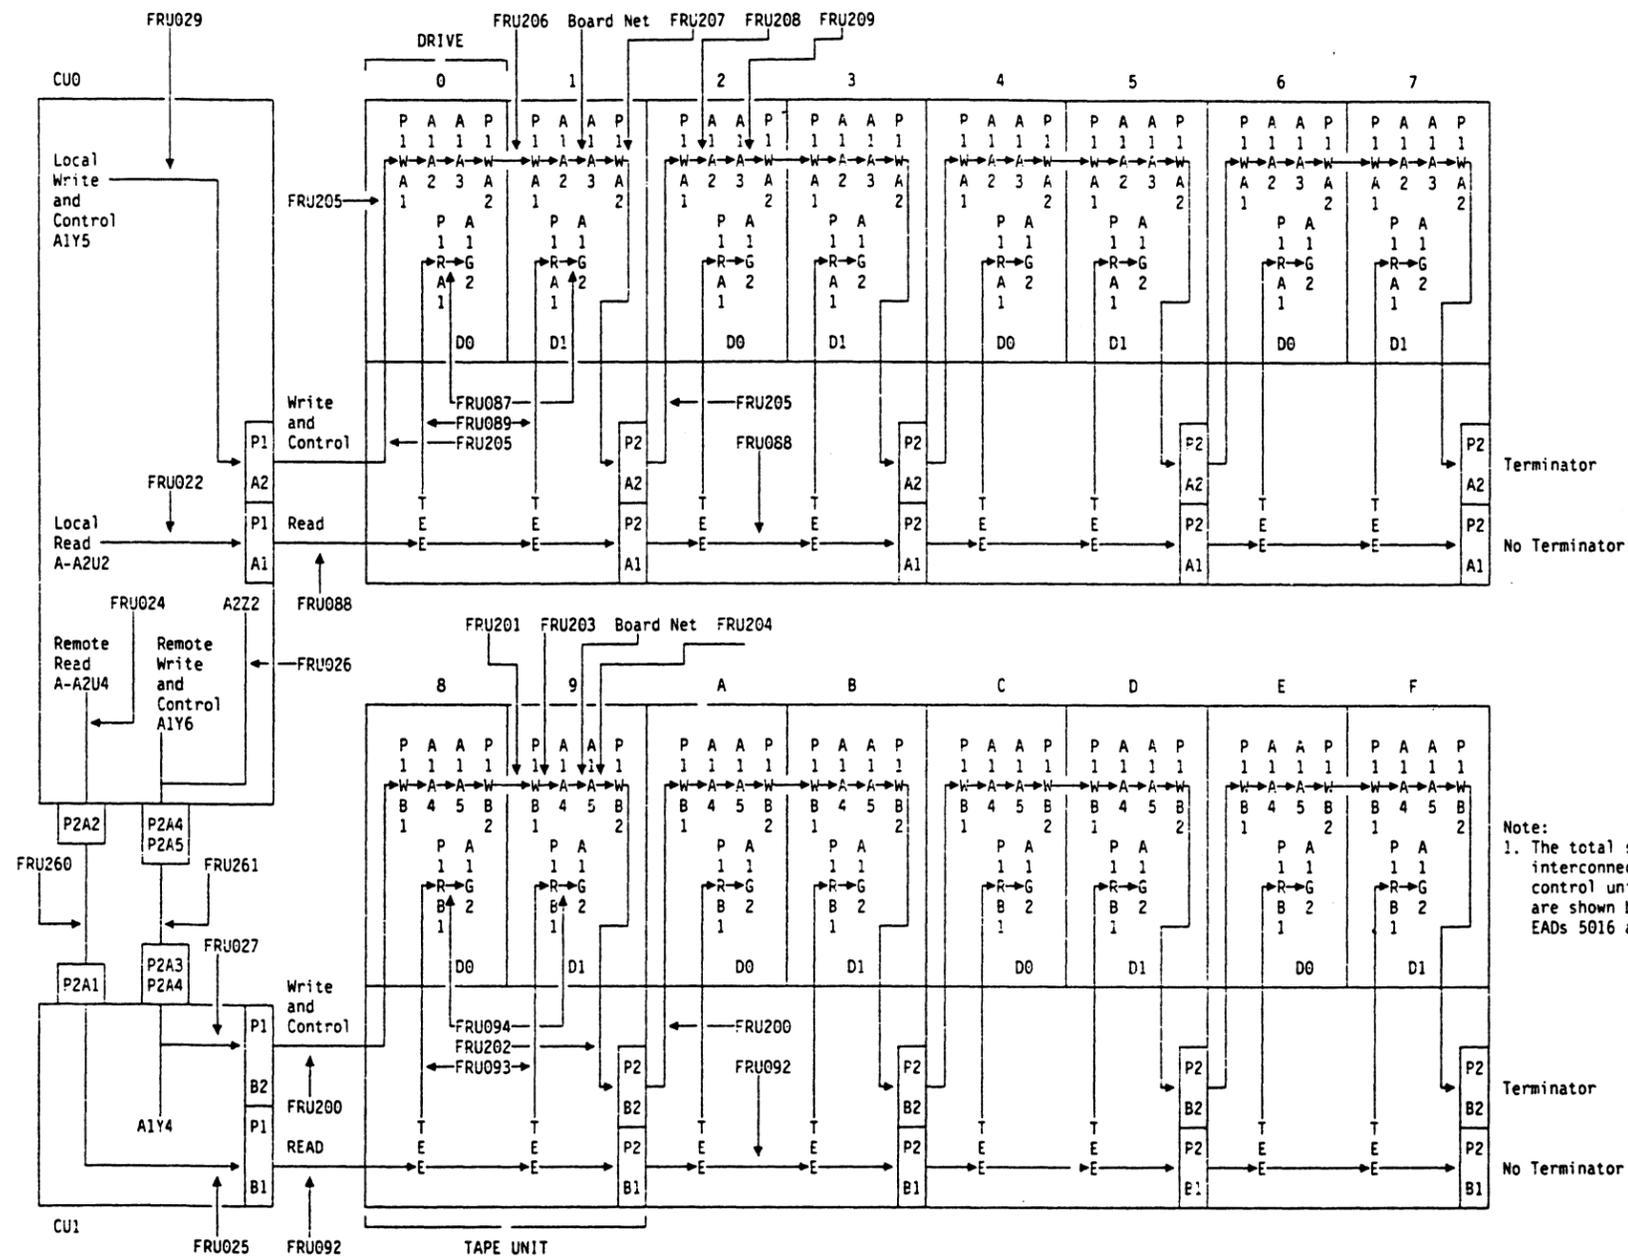
Cables from Control Unit 0 (CU0)

Local = Drives 0-7
Remote = Drives 8-F

Note:
1. The total subsystem drive interconnections for a two control unit configuration are shown by combining EADs 5016 and 5017.

Check for continuity of the read data bus pins between 02A-A1J2 (drive logic RP000) and TU-D0/D1-RA(Tee) or TU-D0/D1-RB(Tee) (drive logic WW020) for the failing drive. See "Control Unit Subsystem Cable Diagrams" on EADs 5015-5017 for reference.

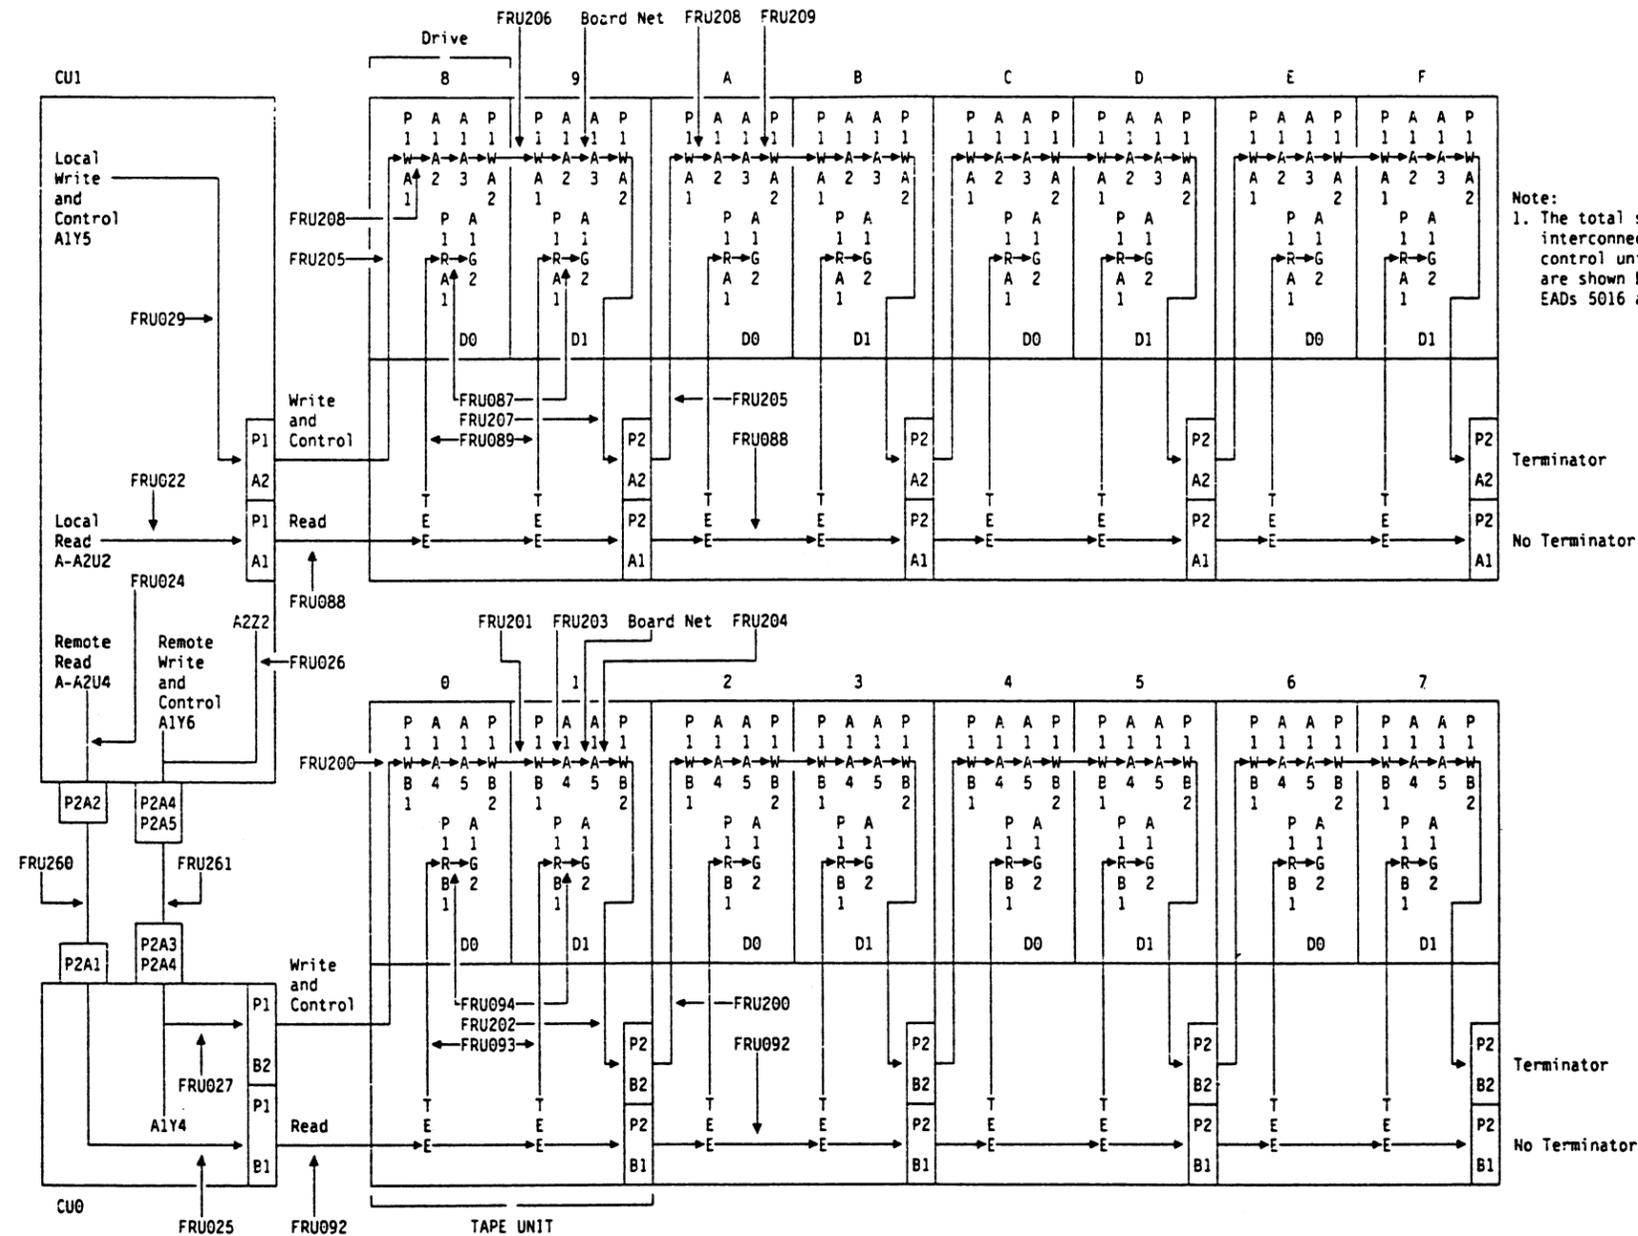
Dual Control Unit Subsystem Cable Diagram
(Continued)

Cables from Control Unit 1 (CU1)
Local = Drives 8-F
Remote = Drives 0-7

Note:
1. The total subsystem drive interconnections for a two control unit configuration are shown by combining EADs 5016 and 5017.

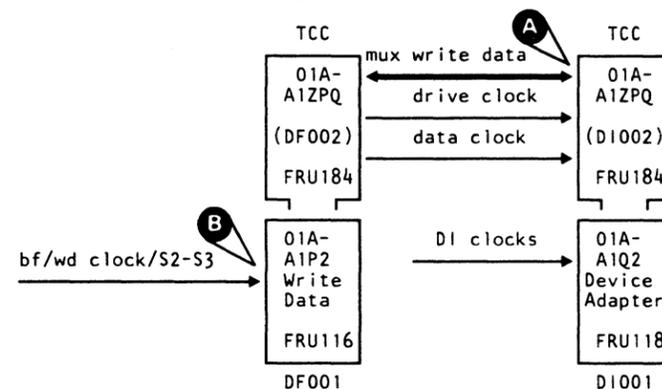
The device adapter card communicates with the write data card over a multiplex write data bus ("MUX data bus"). Parity of the write data is checked as it enters the device adapter card. If even parity is detected on the '+mux write data' bus, the DSE register bit 1, and a check 2 condition are set to indicate the error condition. See the diagram below.

Note: All the connections between A1P2 and A1Q2 are on a top card connector.

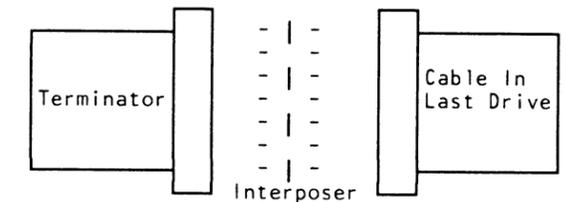
Note: It is not necessary to move the terminator when EE4x diagnostics are used. It is necessary to move the terminator to the last tape unit being tested, when any Read or Write diagnostics are used.

To move a terminator, remove the cable from the drive TU-P2 connector, install interposer part 5997533, then install the terminator. See the diagram below.

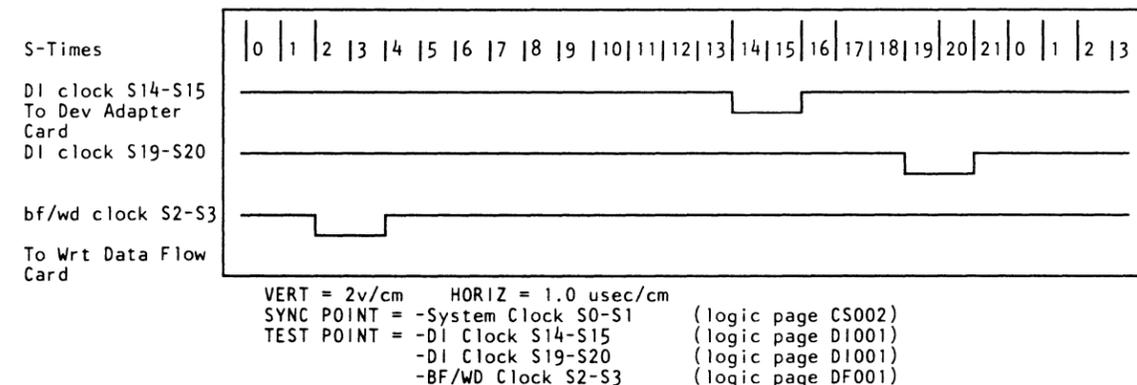
Figure 1. Control Storage Clocks to Device Adapter and Write Data Cards

Figure 1 shows the clocks that are needed for correct operation of the DDB, for both parallel and serial functions. **Additional Information for Device Data Bus (PARALLEL)**

Note:
 One S Clock time equals 23.17 nanoseconds.
 For example, S14 becomes active 324.38 nanoseconds after S0 becomes active.

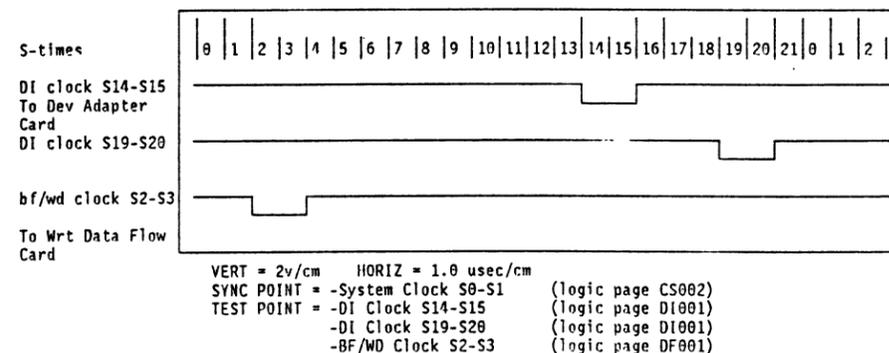
Figure 1. Control Storage Clocks to Device Adapter and Write Data Cards

- The microcode detects errors on the device data bus. The error codes are set in the sense data.
- The hardware parity checkers detects parity errors on the inputs to the adapter card. Error bits are set in the device status error (DSE) register, and D4nn is set in sense bytes 16-17 (D4 nn bits 8-15 equals the contents of the DSE register bits 0-7).

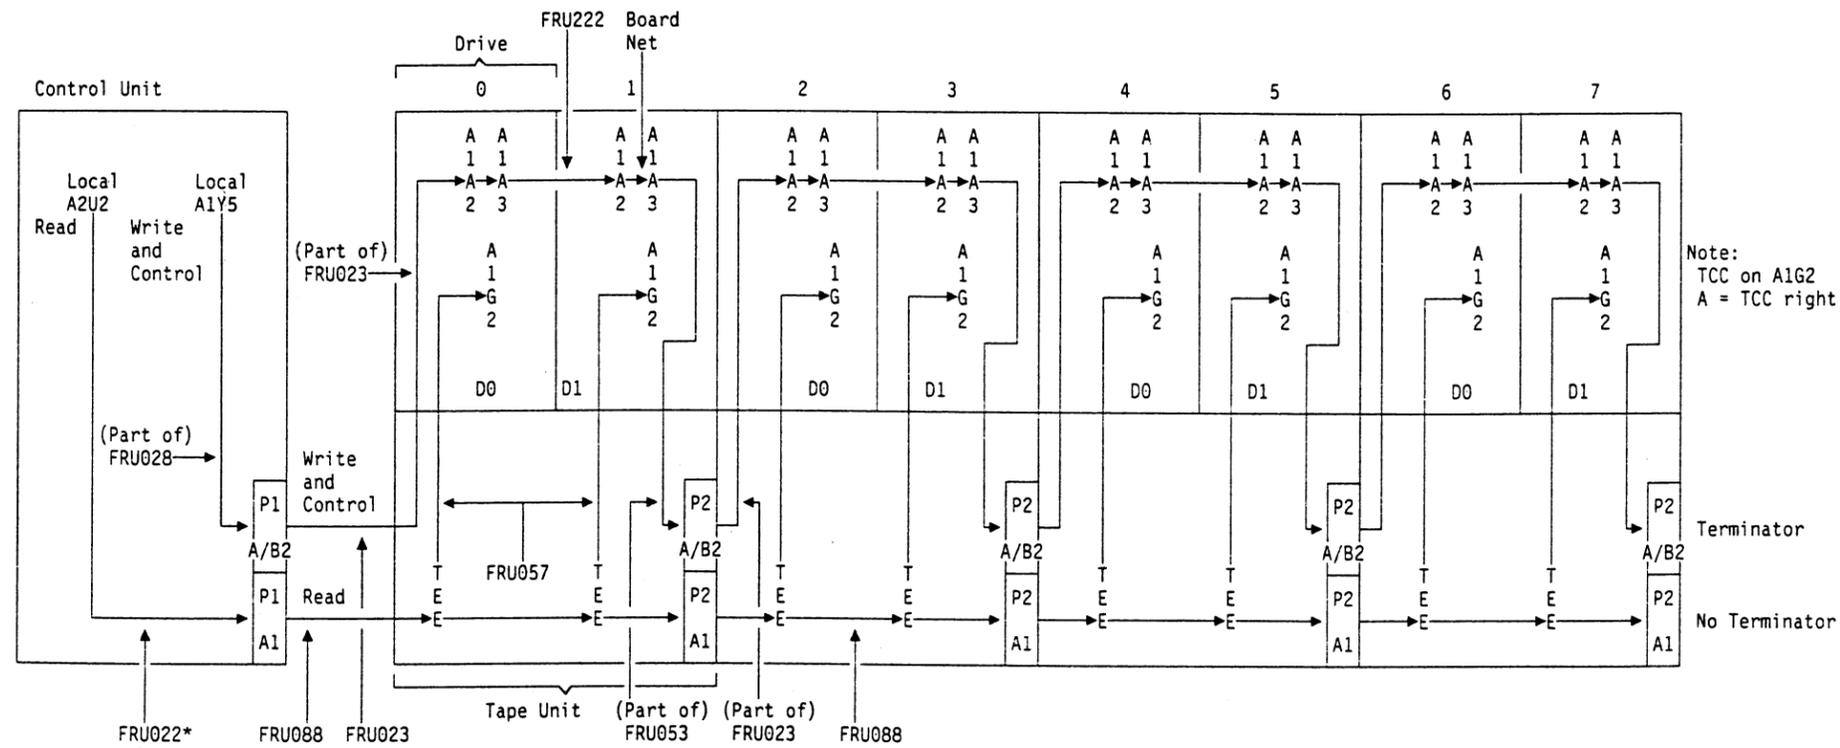
Drive isolation requires you to disconnect cables and move terminator cards. The drawings on this error analysis diagram and the two following show drive to control unit interconnection cable paths.

*FRU022 connects from 01A-A2U2 to CU-P1A1 on control units without EC A57689 installed.
FRU022 connects from 01A-A2Q4 to CU-P1A1 on control units with EC A57689 installed.

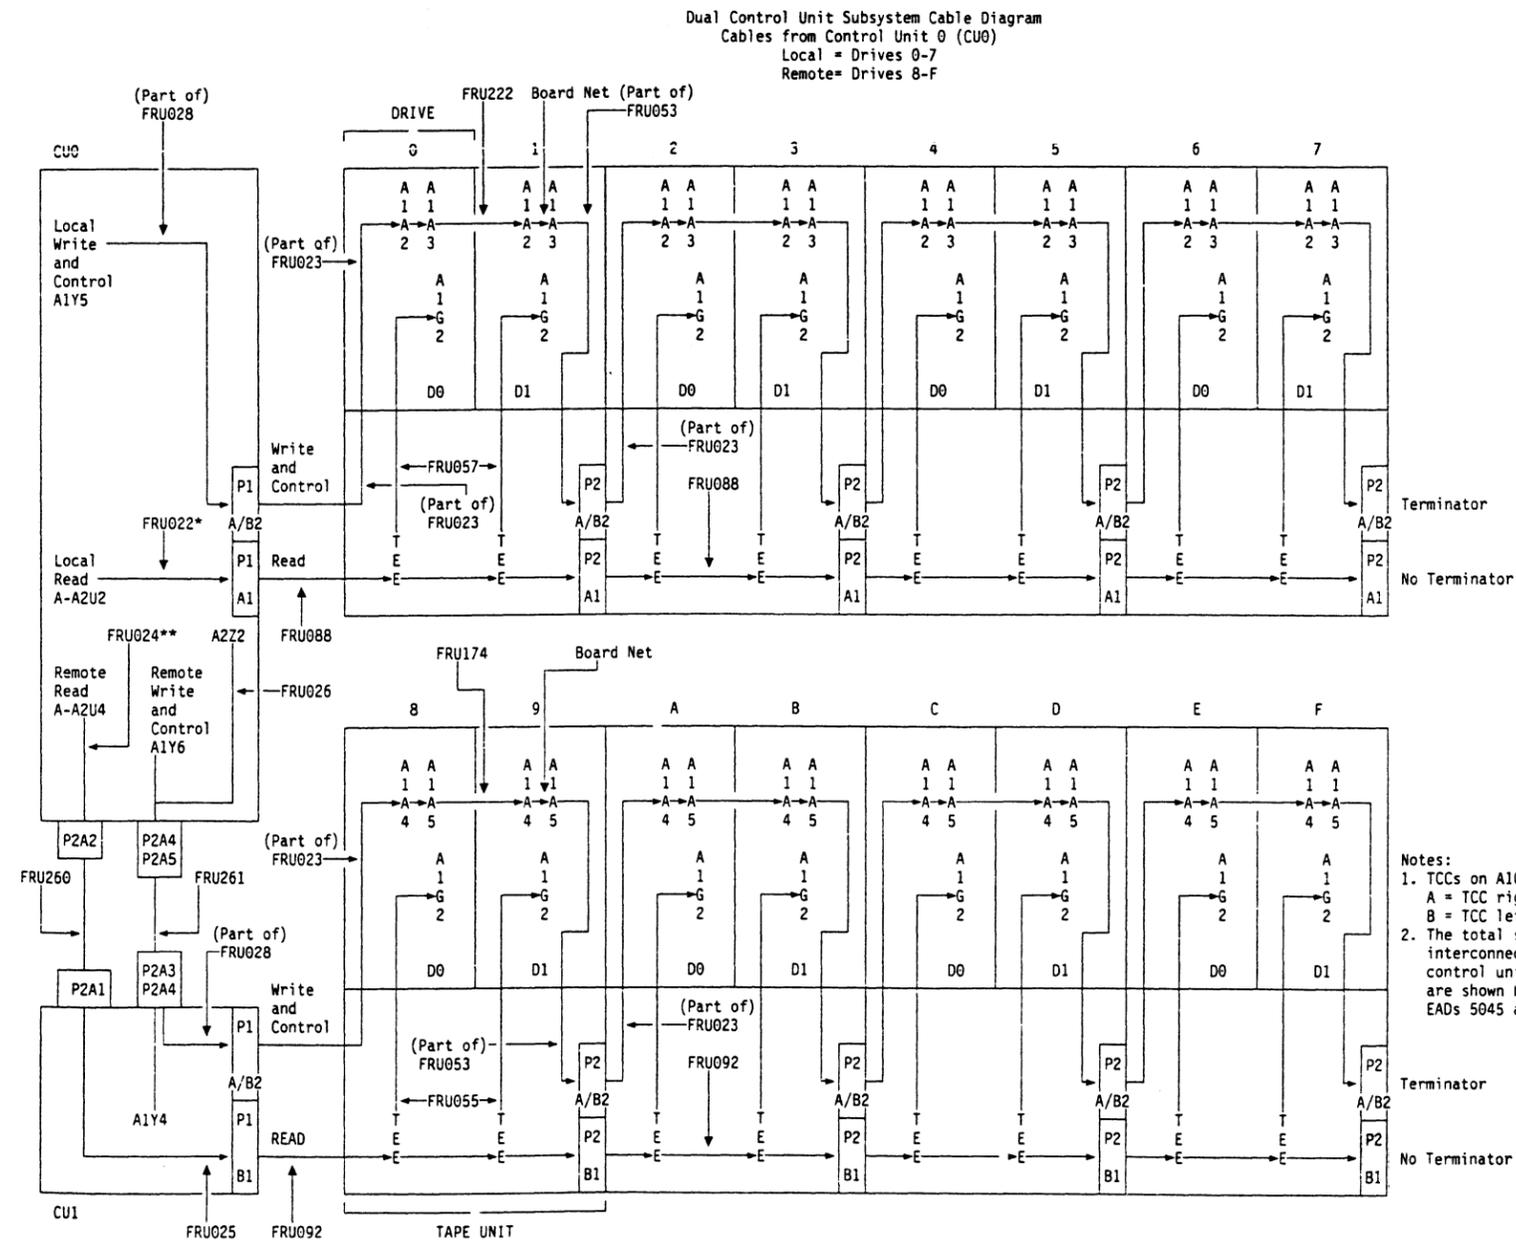
Control Unit Subsystem Cable Diagrams
(Continued)

*FRU022 connects from 01A-A2U2 to CU-P1A1 on control units without ECA57689 installed.
FRU022 connects from 01A-A2Q4 to CU-P1A1 on control units with ECA57689 installed.
**FRU024 connects from 01A-A2U4 to CU-P2A2 on control units without ECA57689 installed.
FRU024 connects from 01A-A2Q2 to CU-P2A2 on control units with ECA57689 installed.
