Collating List of Pages

This reference drawing contains the collating sequence, page side, and EC level of pages for *IBM 3480 Magnetic Tape Subsystem Maintenance Information Manual (MI) Volume A05, SY32-5061-13*.

PUBLICATIONS REFERENCE DRAWING

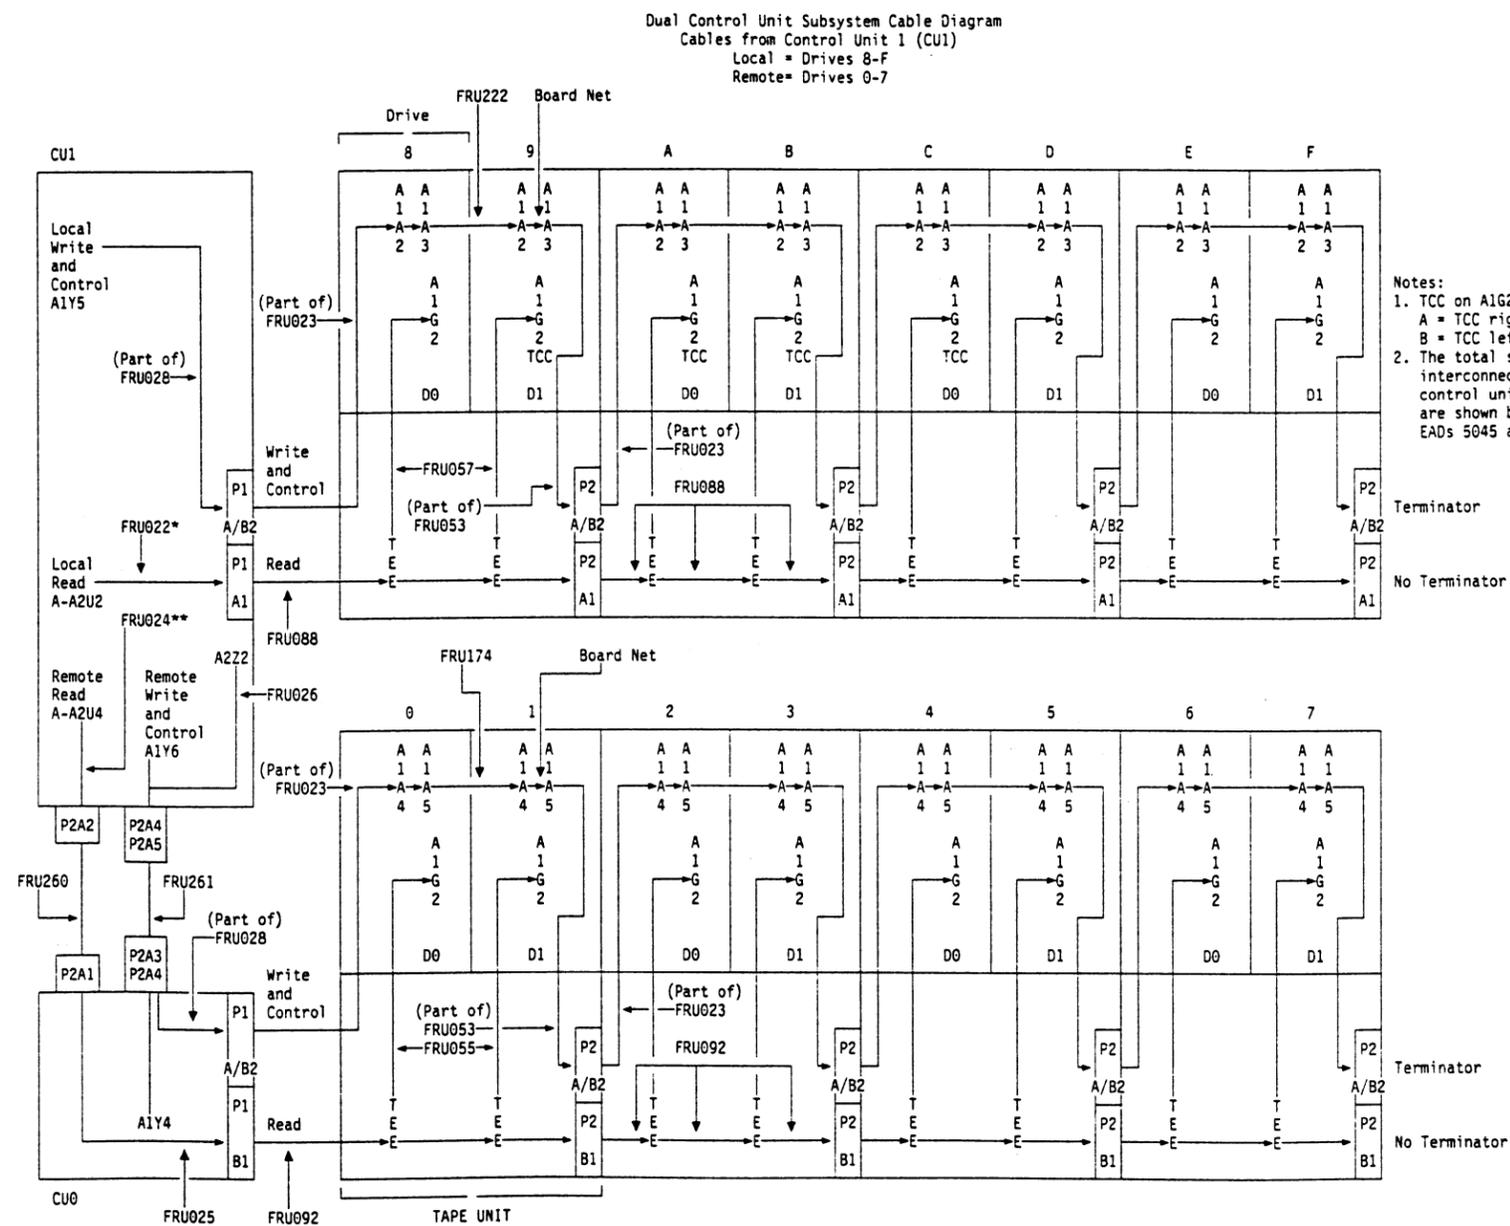
Control Unit Subsystem Cable Diagrams
(Continued)

*FRU022 connects from 01A-A2U2 to CU-P1A1 on control units without ECA57689 installed.
FRU022 connects from 01A-A2Q4 to CU-P1A1 on control units with ECA57689 installed.

**FRU024 connects from 01A-A2U4 to CU-P2A2 on control units without ECA57689 installed.
FRU024 connects from 01A-A2Q2 to CU-P2A2 on control units with ECA57689 installed.

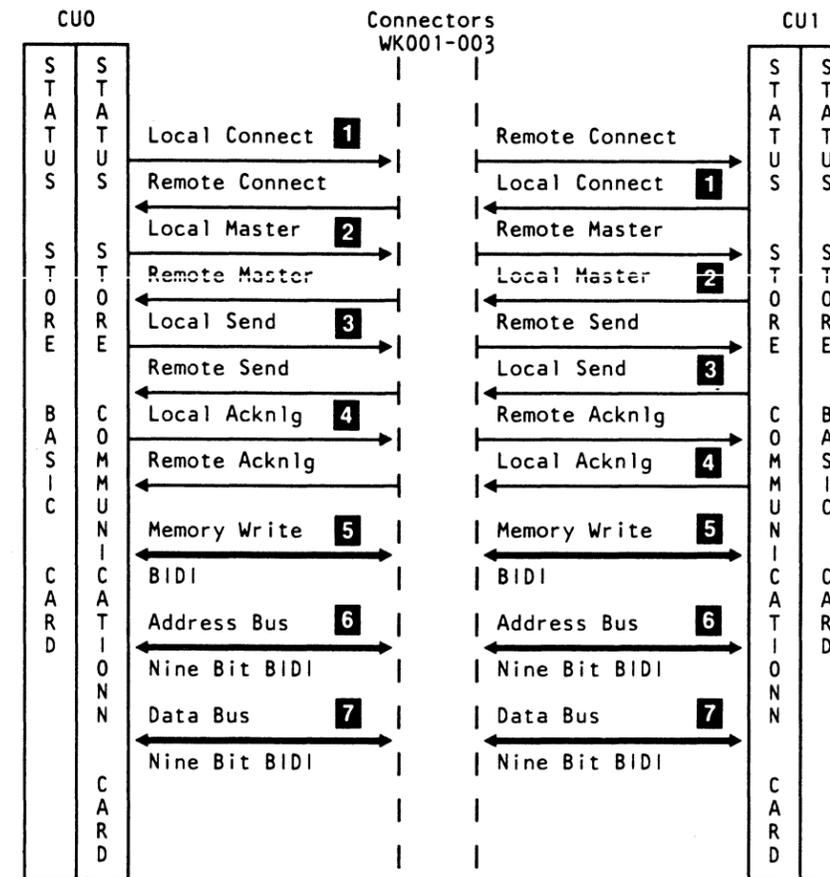
Figure 1. Status Store to Status Store Connections

There are several buses between the status store card and the status store communication card that are parity checked. See DF 1 for the bit definitions for "Channel Error Register." Results of these hardware checks are set in sense data bytes 16 and 17 as D2nn error codes. 'nn' is the contents of the channel error register.

Note: The voltage level of the status store to status store signal lines is NPL (0 Vdc and +3 Vdc).
